# ECO INSPECTION REPORT

Order ID : 21830

## Ford Figo Duratorq Diesel Exi 1.4, 2012

VEHICLE INFORMATION			
MAKE	FORD	TRANSMISSION TYPE	MANUAL
MODEL	FIGO	REGISTRATION NO.	DL10CF0819
YEAR	2012	VIN/CHASIS NUMBER	K89701
TRIM	DURATORQ DIESEL EXI 1.4	KMS RUN	60995
COLOR	BLACK	INSURANCE EXPIRY	2018-10-18
BODY TYPE	HATCHBACK	LOCATION	DELHI
FUEL TYPE	DIESEL	ENGINE SOUND LINK	NIL

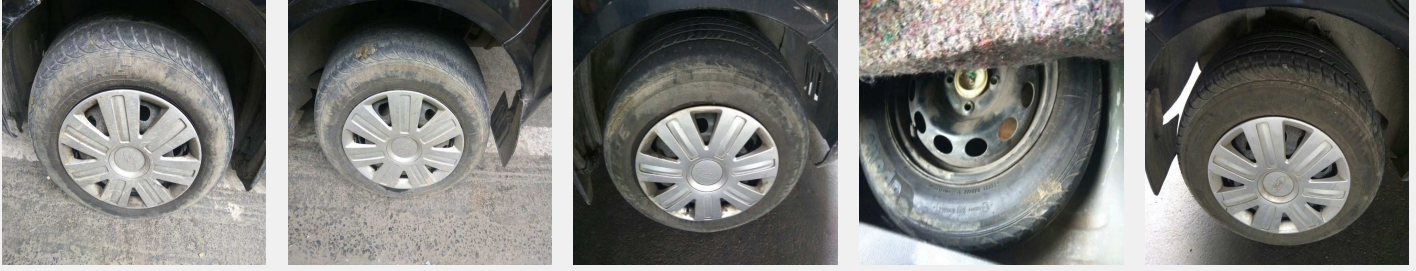
IMAGES

INSPECTION CHECKPOINTS	SCORE(X/10)	REMARKS/COMMENTS	OPTIONAL SPEND EST. (RS)
TYRES	6	AVERAGE	0
SPARE TYRE (YES)	6	AVERAGE	0
WHEEL ASSEMBLY	6	AVERAGE	0

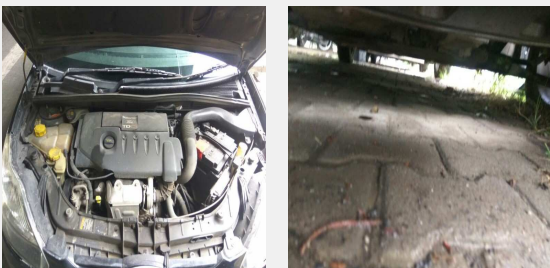
IMAGES

INSPECTION CHECKPOINTS	SCORE(X/10)	REMARKS/COMMENTS	OPTIONAL SPEND EST. (RS)
LH APRON	6	FAIR	0
RH APRON	6	FAIR	0
RADIATOR	6	FAIR	0
WIRING	6	FAIR	0
BATTERY	6	AVERAGE	0
BRAKE FLUID LEVEL	6	AVERAGE	0
ENGINE OIL	6	AVERAGE	0
COOLANT LEVEL	6	AVERAGE	0
BRAKE & COOLANT HOSE PIPES	6	FAIR	0
UNDERCARRIAGE	6	FAIR	0
EXHAUST SYSTEM	6	FAIR	0
