ECO INSPECTION REPORT Premium

Order ID : 22222

Ordered By : Jatin	Inspection Date : 2018-09-01	Valid Till : 2018-12-01

Maruti Suzuki Alto 800 Lxi Cng, 2013

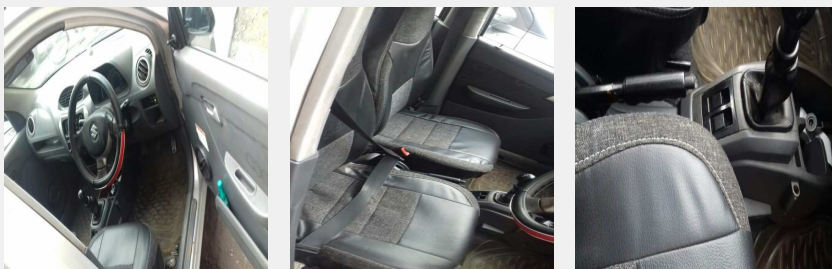
INTERIOR

INSPECTION CHECKPOINTS	SCORE(X/10)	REMARKS/COMMENTS	OPTIONAL SPEND EST. (RS)
DOOR PANEL	6	GOOD	0
DOOR HINGES	6	GOOD	0
CARPET & FLOOR MAT	6	GOOD	0
SEAT & SEAT BELT	6	GOOD	0
DASHBOARD & INSTRUMENT PANEL	6	GOOD	0
HORN	6	GOOD	0
HANDBRAKE	6	GOOD	0
PEDALS	6	GOOD	0
A/C VENTS & HEATER	6	GOOD	0
CUP HOLDERS	6	GOOD	0
ODOMETER	6	GOOD	0
HAZARD LIGHT	6	GOOD	0
SPEAKERS & MUSIC SYSTEM	0	VERY BAD	3000
STEERING-MOUNTED CONTROLS	5	GOOD	0
CENTRAL LOCK	0	NO	0
NAVIGATION (NO)	0	NO	0
POWER WINDOWS (NO)	0	NO	0

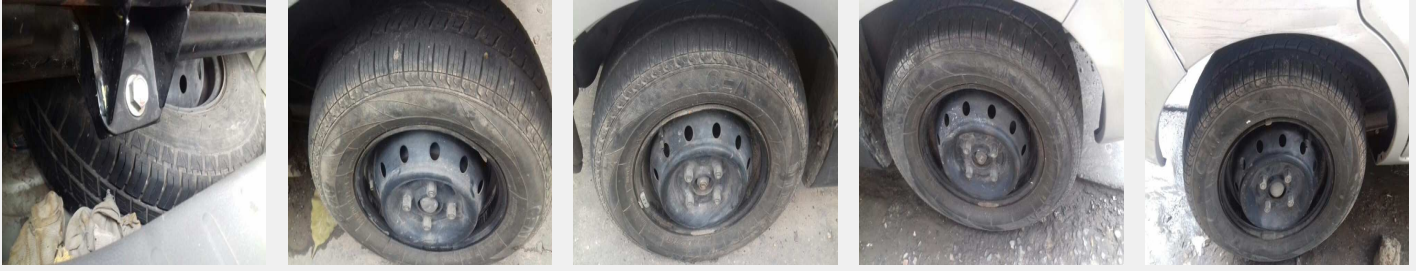
INSPECTION CHECKPOINTS	SCORE(X/10)	REMARKS/COMMENTS	OPTIONAL SPEND EST. (RS)
TYRES	6	GOOD	0
SPARE TYRE (YES)	6	GOOD	0
WHEEL ASSEMBLY	6	GOOD	0

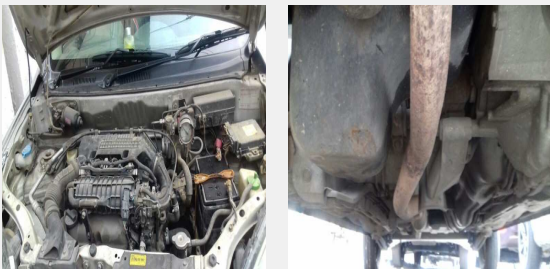
HOOD

INSPECTION CHECKPOINTS	SCORE(X/10)	REMARKS/COMMENTS	OPTIONAL SPEND EST. (RS)
LH APRON	6	GOOD	0
RH APRON	6	GOOD	0
RADIATOR	6	GOOD	0
WIRING	6	GOOD	0
BATTERY	6	GOOD	0
BRAKE FLUID LEVEL	6	GOOD	0
ENGINE OIL	6	GOOD	0
BRAKE & COOLANT HOSE PIPES	6	GOOD	0
EXHAUST SYSTEM	6	GOOD	0
COOLANT LEVEL	5	GOOD	0
UNDERCARRIAGE	5	AVERAGE	0

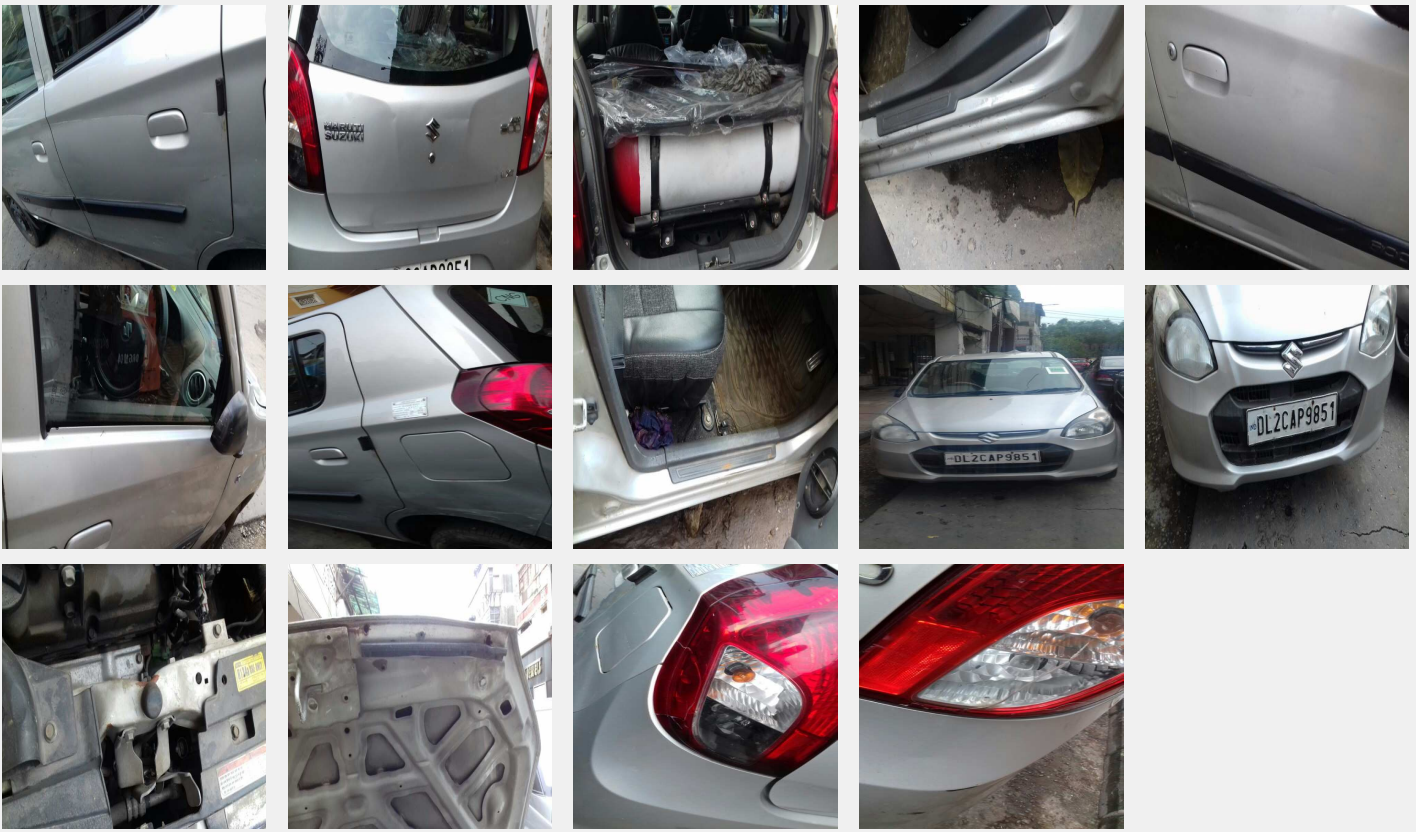
NEED ATTENTION

INSPECTION CHECKPOINTS	SCORE(X/10)	REMARKS/COMMENTS	OPTIONAL SPEND EST. (RS)
LICENSE PLATE	6	GOOD	0
HEAD LIGHTS	6	GOOD	0
GRILLE	6	GOOD	0
PILLAR	6	GOOD	0
SIDE VIEW MIRRORS	6	GOOD	0
REAR WINDSHIELD	6	GOOD	0
BODY RUST	6	GOOD	0
ROOF (REGULAR)	6	GOOD	0
FRONT BUMPER	5	PAINTED	0
TURN SIGNAL	4	RIGHT SIDE INDICATOR NOT WORKING	500
FOG LAMPS	0	NO	0
HOOD	3	ACCIDENT	8000
FRONT WINDSHIELD	3	BROKEN	4000
LH FENDER	5	PAINTED AND MINOR SCRATCH	1000
LH FRONT DOOR	5	PAINTED	0
LH REAR DOOR	5	PAINTED AND SCRATCH	2500
LH RUNNING BOARD	3	MINOR ACCIDENT	5000
LH QUARTER PANEL	5	PAINTED AND SCRATCH	2500
FUEL LID	5	PAINTED	0
REAR BUMPER	5	MINOR SCRATCH	0
TAIL LIGHT	3	BROKEN	3000
TRUNK LID/TAIL GATE	5	PAINTED	0
LUGGAGE COMPARTMENT LIGHT	4	NO SPECE CNG AVAILABLE	0
RH QUARTER PANEL	5	PAINTED AND MINOR SCRATCH	0

INSPECTION CHECKPOINTS	SCORE(X/10)	REMARKS/COMMENTS	OPTIONAL SPEND EST. (RS)
RH RUNNING BOARD	5	PAINTED	0
RH REAR DOOR	5	DENT AND SCRATCH	2500
RH FRONT DOOR	5	SCRATCH AND PAINTED WIDING NOT AVAILABLE	3500
RH FENDER	5	PAINTED	0
PAINT CONDITION	5	ALL CAR IS PAINTED	0

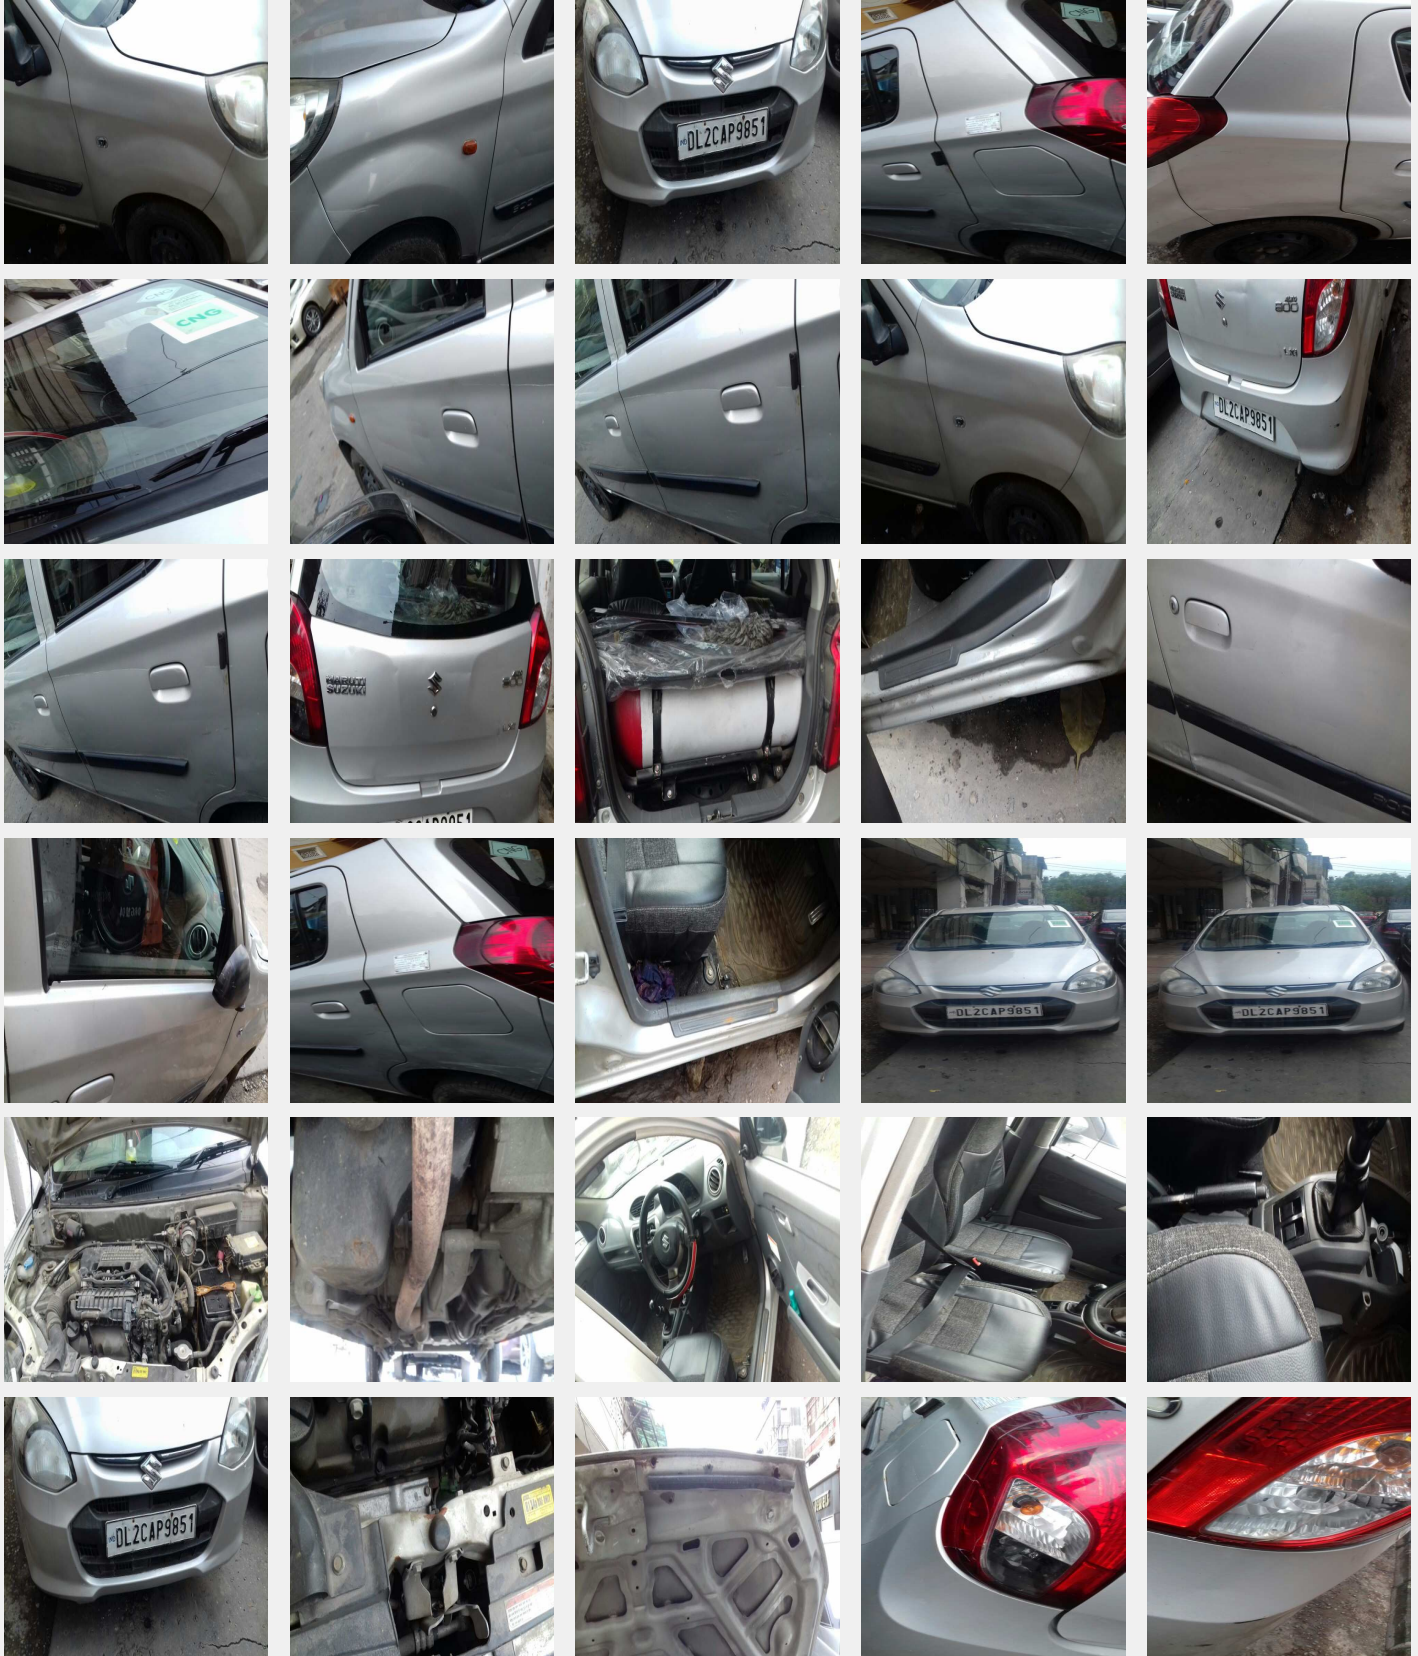
car is all painted frant side accident Engine is average candition
