ECO INSPECTION REPORT

Order ID : 22293

Hyundai Verna 1.6 Crdi Ex, 2013

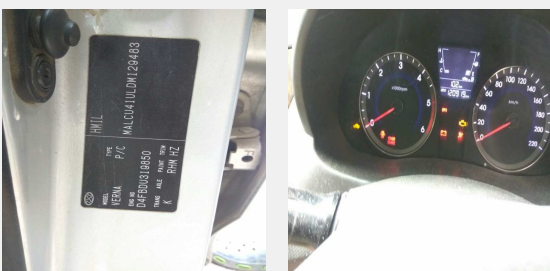
INSPECTION CHECKPOINTS	SCORE(X/10)	REMARKS/COMMENTS	OPTIONAL SPEND EST. (RS)
STEERING PERFORMANCE	6	NOISE	10000
BRAKE PERFORMANCE	6	FAIR	0
CLUTCH PERFORMANCE	6	FAIR	0
ENGINE NOISE	6	YESS	0
IGNITION SYSTEM	6	FAIR	0
SUSPENSION PERFORMANCE	6	FAIR	0
SUSPENSION FRONT SHOCKS	6	FAIR	0
SUSPENSION REAR SHOCKS	6	FAIR	0
TRANSMISSION ENGAGE	6	FAIR	0
CRUISE CONTROL (NO)	6		0
REAR PARKING SENSORS (YES)	6		0
REAR VIEW CAMERA (NO)	10		0

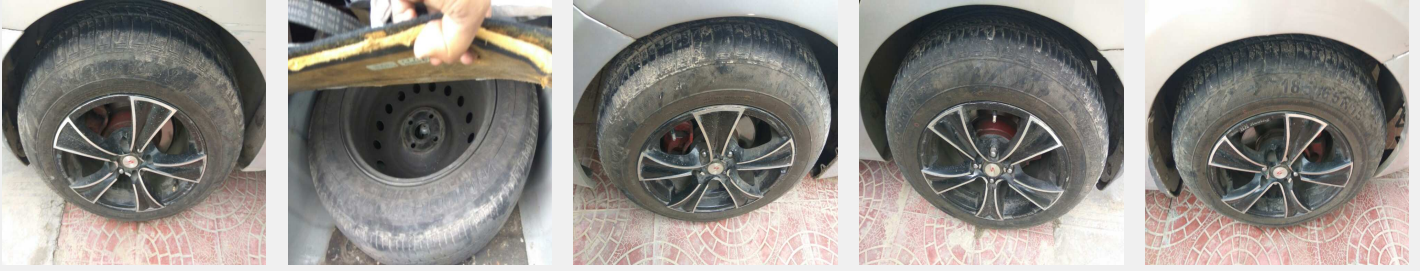
INSPECTION CHECKPOINTS	SCORE(X/10)	REMARKS/COMMENTS	OPTIONAL SPEND EST. (RS)
TYRES	6	AVERAGE	0
SPARE TYRE (YES)	6		0
WHEEL ASSEMBLY	6		0

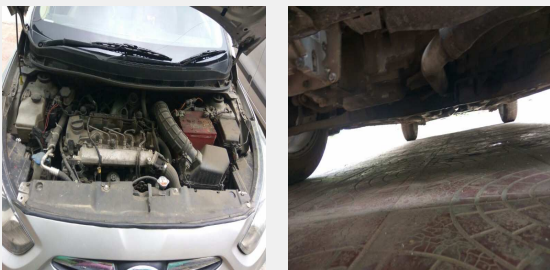
INSPECTION CHECKPOINTS	SCORE(X/10)	REMARKS/COMMENTS	OPTIONAL SPEND EST. (RS)
LH APRON	6	FAIR	0
RH APRON	6	FAIR	0
RADIATOR	6	FAIR	0
WIRING	6	FAIR	0
BATTERY	6	AVERAGE	0
BRAKE FLUID LEVEL	6	FAIR	0
ENGINE OIL	6	AVERAGE	0
COOLANT LEVEL	6	FAIR	0
BRAKE & COOLANT HOSE PIPES	6	FAIR	0
UNDERCARRIAGE	6	FAIR	0
EXHAUST SYSTEM	6	FAUR	0

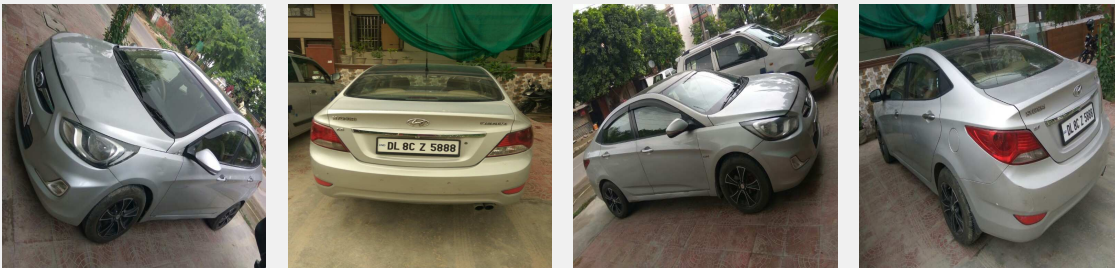
INSPECTION CHECKPOINTS	SCORE(X/10)	REMARKS/COMMENTS	OPTIONAL SPEND EST. (RS)
LICENSE PLATE	6	FAIR	0
FRONT BUMPER	6	PAINTED ,SCRATCH	0
HEAD LIGHTS	6	FAIR	0
GRILLE	6	FAIR	0
TURN SIGNAL	6	FAIR	0
FOG LAMPS	6	FAIR	0
HOOD	6	FAIR	0
PILLAR	6	FAIR	0
FRONT WINDSHIELD	6	FAIR	0
SIDE VIEW MIRRORS	6	FAIR	0
LH FENDER	6	FULL DENT PAINTED	0
FUEL LID	6	FAIR	0
REAR WINDSHIELD	6	FAIR	0
TAIL LIGHT	6	FAIR	0
TRUNK LID/TAIL GATE	6	FAIR	0
LUGGAGE COMPARTMENT LIGHT	6	FAIR	0
BODY RUST	6	FAIR	0
ROOF (REGULAR)	6	FAIR	0
PAINT CONDITION	6	BED	0
LH FRONT DOOR	5	DENT PAINTED	0
LH REAR DOOR	5	DENT PAINTED	0
LH RUNNING BOARD	5	DENT PAINTED	0
LH QUARTER PANEL	5	FULL DENT PAINTED	0
REAR BUMPER	5	REPAIR ,PAINTED	0

INSPECTION CHECKPOINTS	SCORE(X/10)	REMARKS/COMMENTS	OPTIONAL SPEND EST. (RS)
RH QUARTER PANEL	5	DENT ,PAINTED	0
RH RUNNING BOARD	5	DENT,PAINTED	0
RH REAR DOOR	5	DENT ,PAINTED	0
RH FRONT DOOR	5	DENT,PAINTED	0
RH FENDER	5	DENT,PAINTED	0

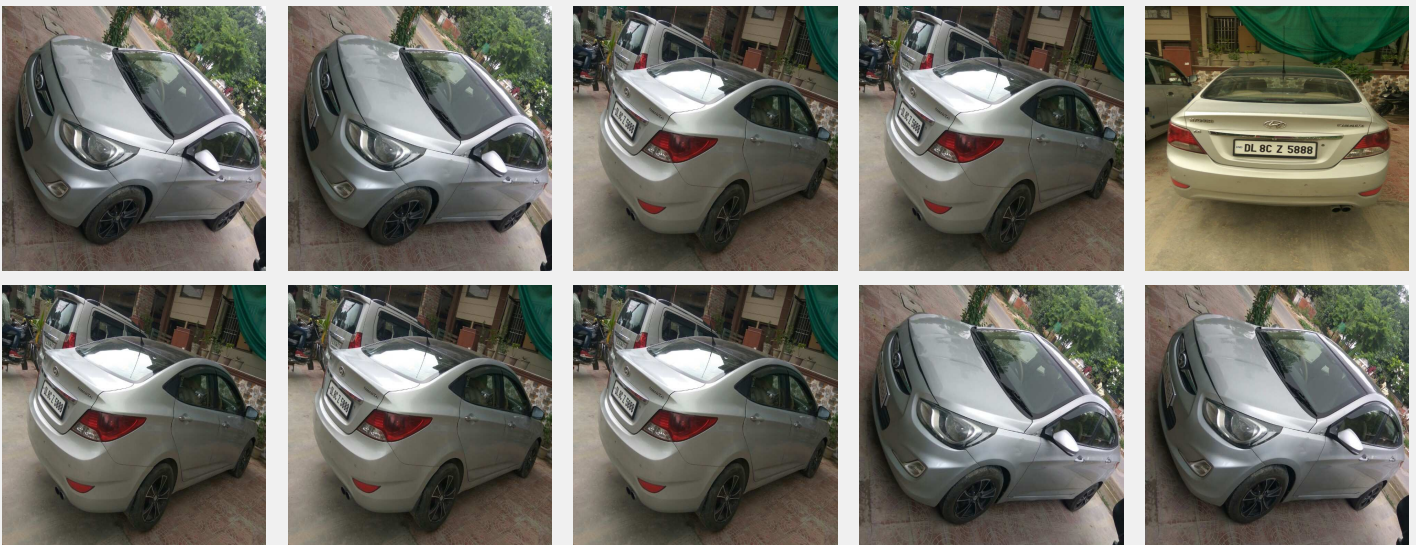
NEED ATTENTION ⚠️

1 car condition very bed 2accendiatial car 3 noise engine 4 full body dent painted
