ECO INSPECTION REPORT Premium

Order ID : 23825

Toyota Innova 2.5 V 7 Str, 2012

VEHICLE INFORMATION			
MAKE	TOYOTA	TRANSMISSION TYPE	MANUAL
MODEL	INNOVA	REGISTRATION NO.	UP16AH8906
YEAR	2012	VIN/CHASIS NUMBER	308260
TRIM	2.5 V 7 STR	KMS RUN	108525
COLOR	SILVER	INSURANCE EXPIRY	2019-1-27
BODY TYPE	SUV	LOCATION	NOIDA
FUEL TYPE	DIESEL	ENGINE SOUND LINK	NIL

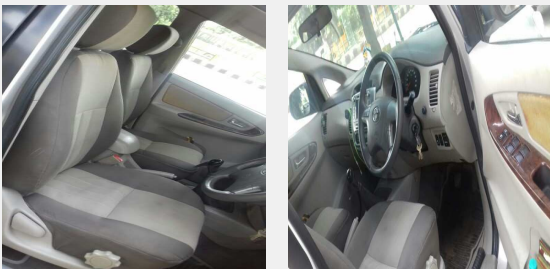
IMAGES

INSPECTION CHECKPOINTS	SCORE(X/10)	REMARKS/COMMENTS	OPTIONAL SPEND EST. (RS)
DOOR PANEL	6	GOOD	0
DOOR HINGES	6	GOOD	0
CARPET & FLOOR MAT	6	GOOD	0
SEAT & SEAT BELT	7	GOOD	0
DASHBOARD & INSTRUMENT PANEL	7	GOOD	0
HORN	6	GOOD	0
SPEAKERS & MUSIC SYSTEM	6	GOOD	0
HANDBRAKE	6	GOOD	0
STEERING-MOUNTED CONTROLS	7	GOOD	0
PEDALS	7	GOOD	0
CENTRAL LOCK	6	GOOD	0
A/C VENTS & HEATER	6	GOOD	0
CUP HOLDERS	6	GOOD	0
ODOMETER	6	GOOD	0
POWER WINDOWS (YES)	7	GOOD	0
HAZARD LIGHT	6	GOOD	0
NAVIGATION (NO)	0	NO	0

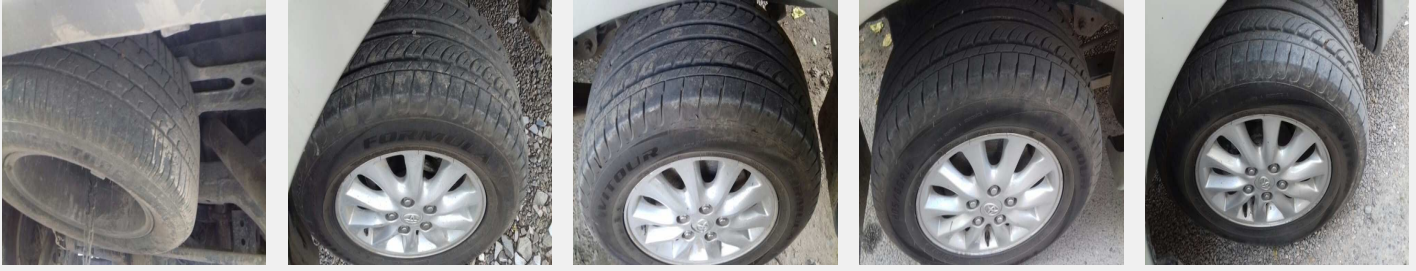
IMAGES

INSPECTION CHECKPOINTS	SCORE(X/10)	REMARKS/COMMENTS	OPTIONAL SPEND EST. (RS)
TYRES	7	GOOD	0
SPARE TYRE (YES)	6	GOOD	0
WHEEL ASSEMBLY	7	GOOD	0

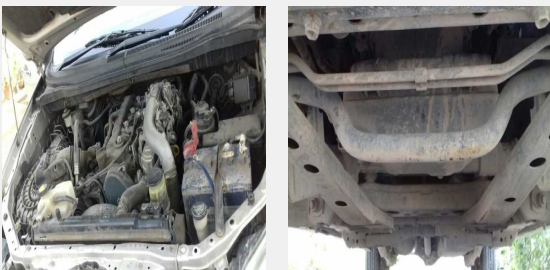
IMAGES

INSPECTION CHECKPOINTS	SCORE(X/10)	REMARKS/COMMENTS	OPTIONAL SPEND EST. (RS)
LH APRON	6	GOOD	0
RH APRON	6	GOOD	0
RADIATOR	6	GOOD	0
WIRING	6	GOOD	0
BATTERY	6	GOOD	0
BRAKE FLUID LEVEL	6	GOOD	0
ENGINE OIL	6	GOOD	0
COOLANT LEVEL	6	GOOD	0
BRAKE & COOLANT HOSE PIPES	6	GOOD	0
UNDERCARRIAGE	6	GOOD	0
EXHAUST SYSTEM	7	GOOD	0

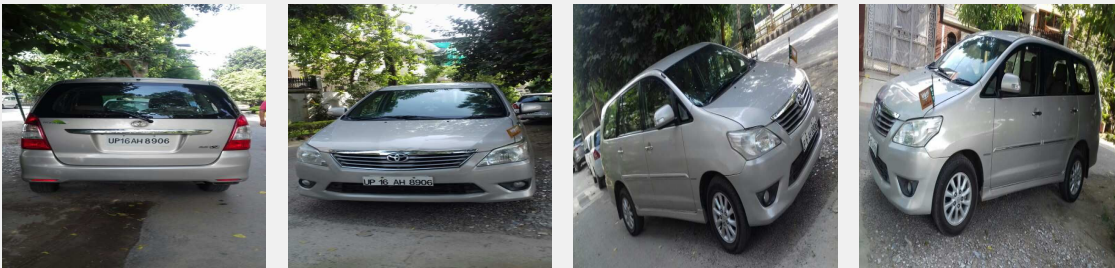
IMAGES

INSPECTION CHECKPOINTS	SCORE(X/10)	REMARKS/COMMENTS	OPTIONAL SPEND EST. (RS)
LICENSE PLATE	6	GOOD	0
HEAD LIGHTS	6	GOOD	0
GRILLE	6	GOOD	0
TURN SIGNAL	6	GOOD	0
FOG LAMPS	6	GOOD	0
PILLAR	6	GOOD	0
FRONT WINDSHIELD	6	GOOD	0
REAR WINDSHIELD	6	GOOD	0
TAIL LIGHT	6	GOOD	0
LUGGAGE COMPARTMENT LIGHT	6	GOOD	0
BODY RUST	6	GOOD	0
ROOF (REGULAR)	6	GOOD	0
FRONT BUMPER	5	PAINTED	0
HOOD	5	PAINTED AND MINOR SCRATCH	3000
SIDE VIEW MIRRORS	5	PAINTED AND MINOR SCRATCH	500
LH FENDER	5	PAINTED	0
LH FRONT DOOR	5	PAINTED	0
LH REAR DOOR	5	PAINTED AND MINOR DENT	0
LH RUNNING BOARD	5	PAINTED	0
LH QUARTER PANEL	5	PAINTED	0
FUEL LID	5	PAINTED	0
REAR BUMPER	5	PAINTED	0
TRUNK LID/TAIL GATE	5	PAINTED	0
RH QUARTER PANEL	5	PAINTED	0

INSPECTION CHECKPOINTS	SCORE(X/10)	REMARKS/COMMENTS	OPTIONAL SPEND EST. (RS)
RH RUNNING BOARD	5	PAINTED	0
RH REAR DOOR	5	PAINTED	0
RH FRONT DOOR	5	PAINTED	0
RH FENDER	5	PAINTED	0
PAINT CONDITION	5	ALL CAR IS PAINTED WITHOUT ROOF	0

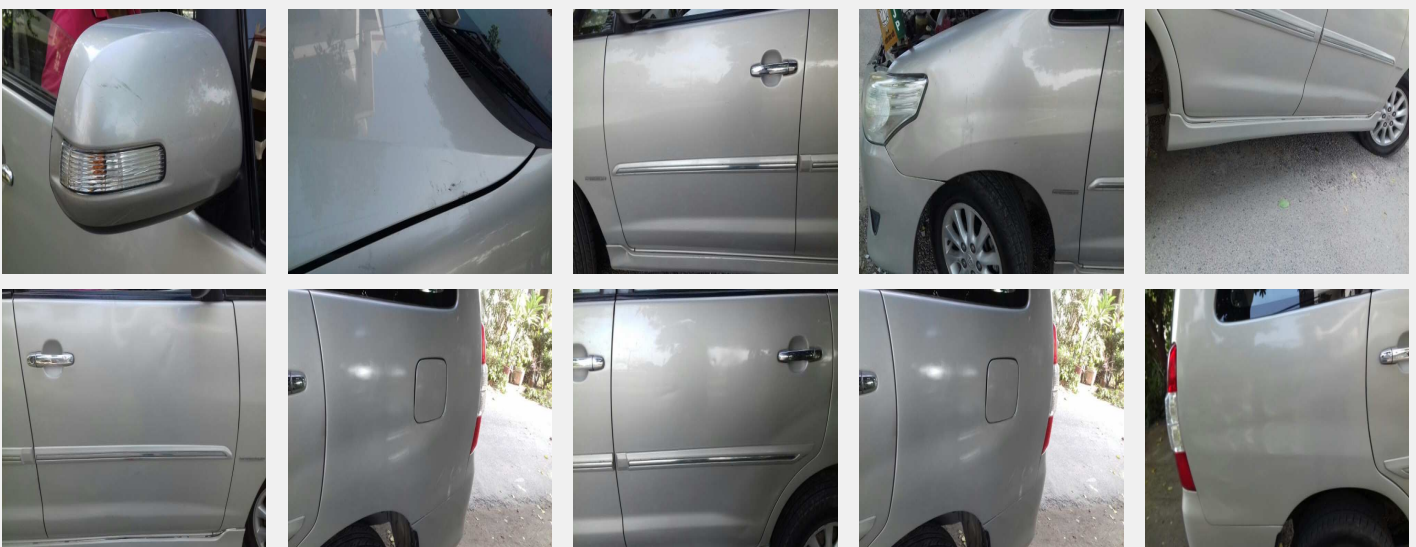
NEED ATTENTION ⚠️

all car is painted without roof rear camera available car is better condition right side rear mi
