# ECO INSPECTION REPORT

Order ID : 24627

## Maruti Suzuki Eeco 7 Str, 2013

VEHICLE INFORMATION			
MAKE	MARUTI SUZUKI	TRANSMISSION TYPE	MANUAL
MODEL	EECO	REGISTRATION NO.	WB06H8753
YEAR	2013	VIN/CHASIS NUMBER	MA3ERLF1S00229880
TRIM	7 STR	KMS RUN	35018
COLOR	WHITE	INSURANCE EXPIRY	2019-3-1
BODY TYPE	SEDAN	LOCATION	KALINDI
FUEL TYPE	PETROL	ENGINE SOUND LINK	NIL

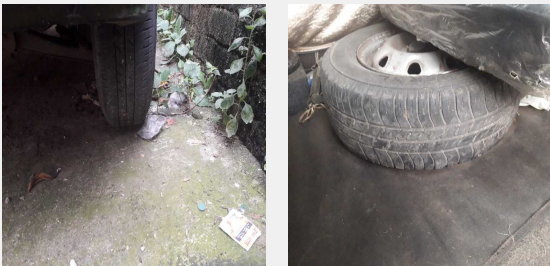
## NEED ATTENTION ⚠

INSPECTION CHECKPOINTS	SCORE(X/10)	REMARKS/COMMENTS	OPTIONAL SPEND EST. (RS)
TYRES	6	AVERAGE	0
WHEEL ASSEMBLY	6	AVERAGE	0
SPARE TYRE (YES)	5	REQUIRED	2500

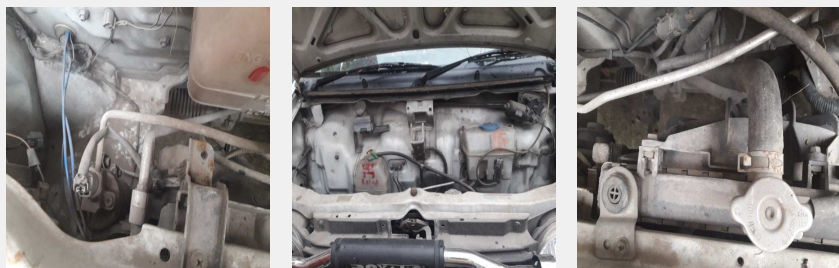
## NEED ATTENTION

COOLANT LEVEL	6	OK	0
BRAKE & COOLANT HOSE PIPES	6	OK	0
UNDERCARRIAGE	7	OK	0
EXHAUST SYSTEM	6	OK	0
WIRING	5	REQUIRED	20000

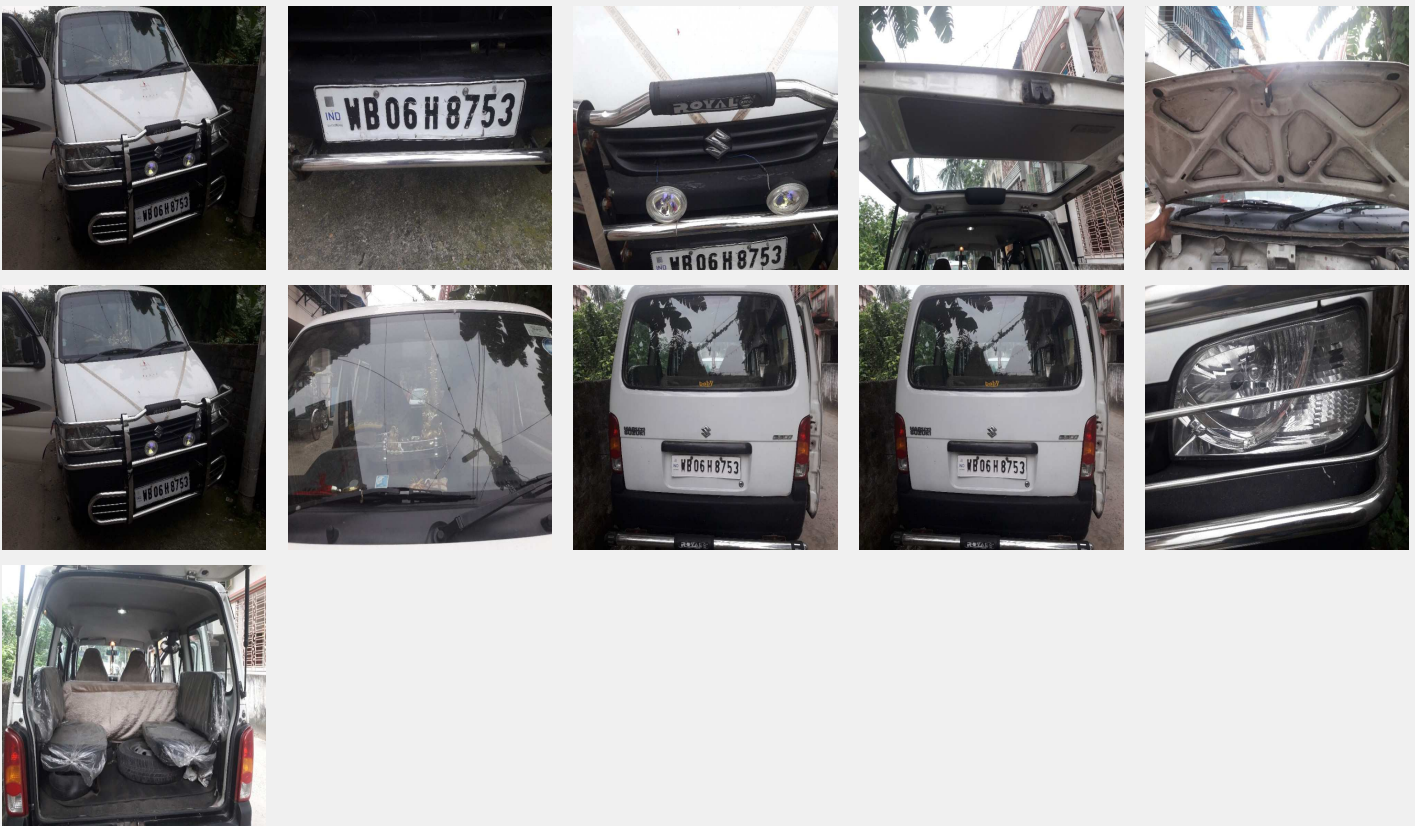
NEED ATTENTION ⚠

INSPECTION CHECKPOINTS	SCORE(X/10)	REMARKS/COMMENTS	OPTIONAL SPEND EST. (RS)
RH FRONT DOOR	6	OK	0
RH FENDER	7	OK	0
BODY RUST	6	OK	0
ROOF (REGULAR)	6	OK	0
<b>PAINT CONDITION</b>	<b>5</b>	<b>REQUIRED</b>	<b>40000</b>
