ECO INSPECTION REPORT

Order ID : 24885

Ordered By : MINTU	Inspection Date : 2018-09-29	Valid Till : 2018-12-29
-----------------------	---------------------------------	----------------------------

Tata Indigo Ecs Lx, 2012

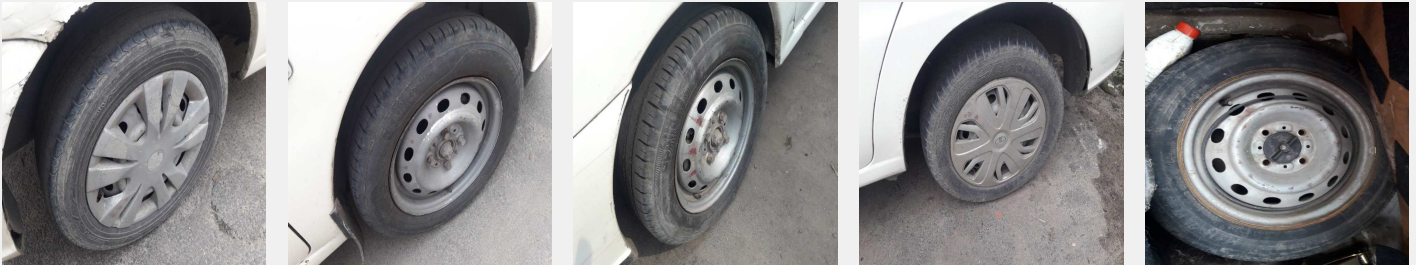
INSPECTION CHECKPOINTS	SCORE(X/10)	REMARKS/COMMENTS	OPTIONAL SPEND EST. (RS)
TYRES	6	OK	0
WHEEL ASSEMBLY	6	OK	0
SPARE TYRE (YES)	5	NEED TO CHANGE	2500

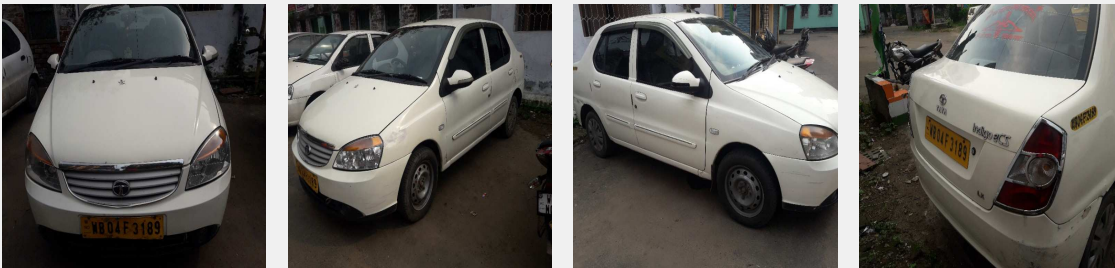
INSPECTION CHECKPOINTS	SCORE(X/10)	REMARKS/COMMENTS	OPTIONAL SPEND EST. (RS)
LICENSE PLATE	5	CHANGES	500
HOOD	5	NEED TO CHANGE	1000
LH FENDER	5	DENT	500
LH QUARTER PANEL	5	DENT	500
PAINT CONDITION	5	REQUIRED	25000
