ECO INSPECTION CERTIFICATE

Order ID : 24943

121 Points Vehicle Inspection Certificate

Toyota Innova 2.5 Gx 7 Str Bs Iv, 2013

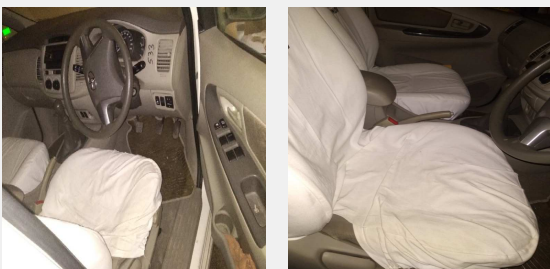
INSPECTION CHECKPOINTS	SCORE(X/10)	REMARKS/COMMENTS	OPTIONAL SPEND EST. (RS)
DOOR PANEL	6	GOOD	0
DOOR HINGES	6	GOOD	0
CARPET & FLOOR MAT	6	GOOD	0
SEAT & SEAT BELT	6	GOOD	0
DASHBOARD & INSTRUMENT PANEL	6	GOOD	0
HORN	6	GOOD	0
SPEAKERS & MUSIC SYSTEM	6	GOOD	0
HANDBRAKE	6	GOOD	0
PEDALS	6	GOOD	0
CENTRAL LOCK	6	GOOD	0
A/C VENTS & HEATER	6	GOOD	0
CUP HOLDERS	6	GOOD	0
ODOMETER	6	GOOD	0
POWER WINDOWS (YES)	6	GOOD	0
HAZARD LIGHT	6	GOOD	0
STEERING-MOUNTED CONTROLS	0	NA	0
NAVIGATION (NO)	0	NA	0

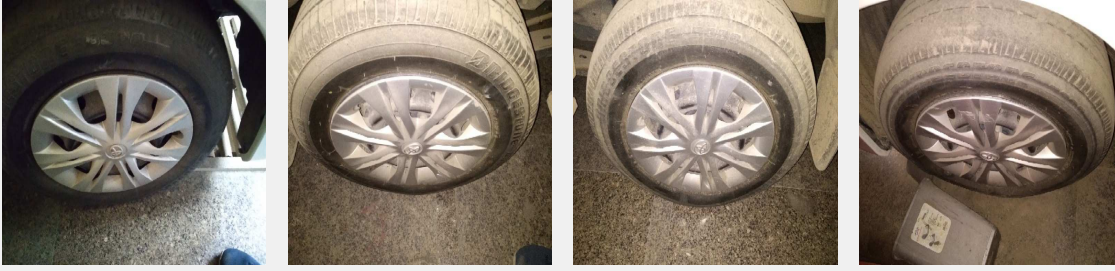
INSPECTION CHECKPOINTS	SCORE(X/10)	REMARKS/COMMENTS	OPTIONAL SPEND EST. (RS)
TYRES	6	GOOD	0
SPARE TYRE (YES)	6	GOOD	0
WHEEL ASSEMBLY	6	GOOD	0

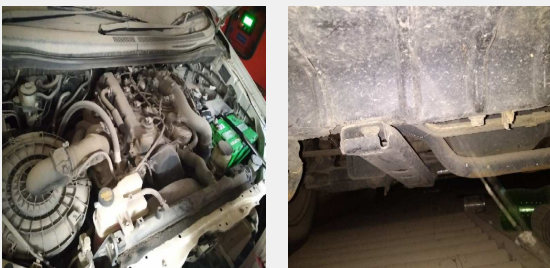
INSPECTION CHECKPOINTS	SCORE(X/10)	REMARKS/COMMENTS	OPTIONAL SPEND EST. (RS)
LH APRON	7	GOOD	0
RH APRON	7	GOOD	0
RADIATOR	6	GOOD	0
WIRING	6	GOOD	0
BATTERY	6	GOOD	0
BRAKE FLUID LEVEL	6	GOOD	0
ENGINE OIL	6	GOOD	0
COOLANT LEVEL	6	GOOD	0
BRAKE & COOLANT HOSE PIPES	6	GOOD	0
UNDERCARRIAGE	6	GOOD	0
EXHAUST SYSTEM	6	GOOD	0

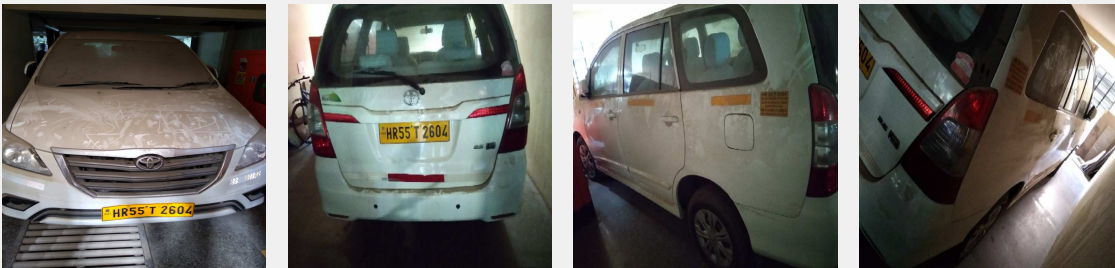
INSPECTION CHECKPOINTS	SCORE(X/10)	REMARKS/COMMENTS	OPTIONAL SPEND EST. (RS)
LH RUNNING BOARD	5	NEED TO REPAIR	5000
LH QUARTER PANEL	5	NEED TO REPAIR	5000
REAR BUMPER	5	NEED TO REPAIR	6000
TAIL LIGHT	5	NEED TO REPAIR	5000
RH QUARTER PANEL	5	NEED TO REPAIR	5000

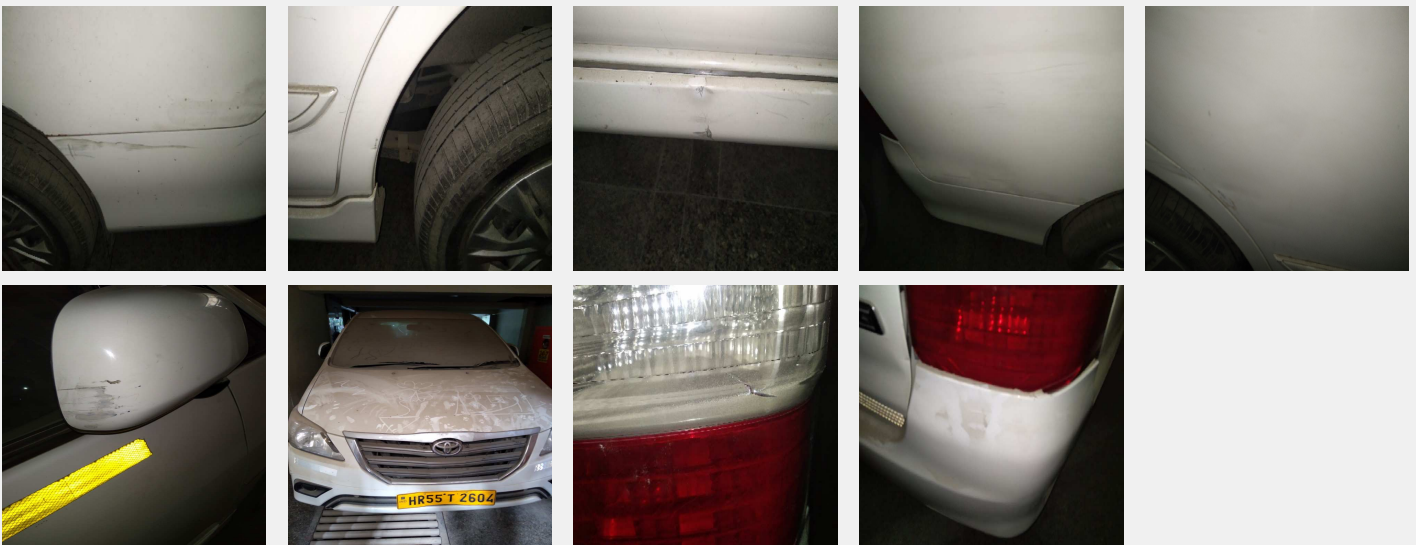
NEED ATTENTION

INSPECTION CHECKPOINTS	SCORE(X/10)	REMARKS/COMMENTS	OPTIONAL SPEND EST. (RS)
LICENSE PLATE	7	GOOD	0
FRONT BUMPER	7	GOOD	0
HEAD LIGHTS	7	GOOD	0
GRILLE	7	GOOD	0
TURN SIGNAL	6	GOOD	0
HOOD	7	GOOD	0
PILLAR	7	GOOD	0
FRONT WINDSHIELD	6	GOOD	0
LH FENDER	6	GOOD	0
LH FRONT DOOR	6	GOOD	0
LH REAR DOOR	6	GOOD	0
FUEL LID	6	GOOD	0
REAR WINDSHIELD	6	GOOD	0
TRUNK LID/TAIL GATE	6	GOOD	0
LUGGAGE COMPARTMENT LIGHT	6	GOOD	0
RH RUNNING BOARD	6	GOOD	0
RH REAR DOOR	6	GOOD	0
RH FRONT DOOR	6	GOOD	0
RH FENDER	6	GOOD	0
BODY RUST	7	GOOD	0
ROOF (REGULAR)	6	GOOD	0
PAINT CONDITION	6	GOOD	0
FOG LAMPS	0	NA	0
SIDE VIEW MIRRORS	5	NEED TO REPAIR	5000
