ECO INSPECTION REPORT

Order ID : 24987

Ordered By : Anil | Inspection Date : 2018-09-28 | Valid Till : 2018-12-28

Mahindra Quanto C6, 2012

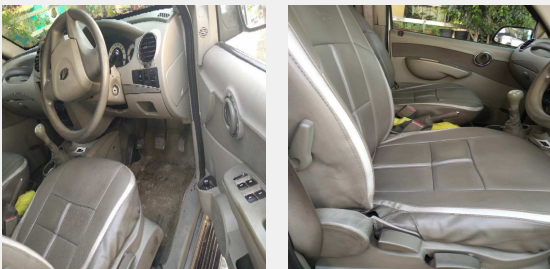
IMAGES

INSPECTION CHECKPOINTS	SCORE(X/10)	REMARKS/COMMENTS	OPTIONAL SPEND EST. (RS)
DOOR PANEL	7	GOOD	0
DOOR HINGES	7	GOOD	0
CARPET & FLOOR MAT	7	GOOD	0
SEAT & SEAT BELT	7	GOOD	0
DASHBOARD & INSTRUMENT PANEL	7	GOOD	0
HORN	7	GOOD	0
SPEAKERS & MUSIC SYSTEM	7	GOOD	0
HANDBRAKE	7	GOOD	0
STEERING-MOUNTED CONTROLS	7	GOOD	0
PEDALS	7	GOOD	0
CENTRAL LOCK	7	GOOD	0
A/C VENTS & HEATER	7	GOOD	0
CUP HOLDERS	7	GOOD	0
NAVIGATION (YES)	6	NA	0
ODOMETER	7	GOOD	0
POWER WINDOWS (YES)	7	GOOD	0
HAZARD LIGHT	7	GOOD	0

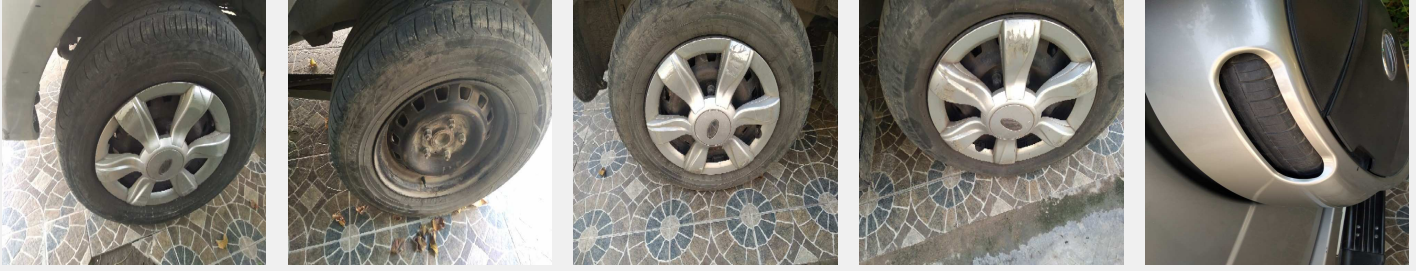
IMAGES

INSPECTION CHECKPOINTS	SCORE(X/10)	REMARKS/COMMENTS	OPTIONAL SPEND EST. (RS)
TYRES	7	GOOD	0
SPARE TYRE (YES)	6	GOOD	0
WHEEL ASSEMBLY	7	GOOD	0

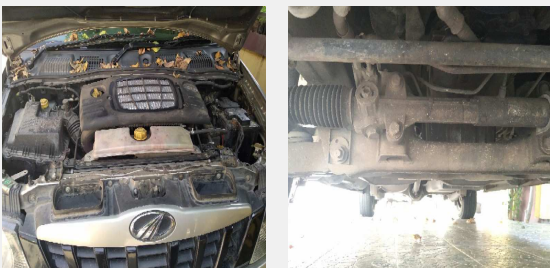
IMAGES

INSPECTION CHECKPOINTS	SCORE(X/10)	REMARKS/COMMENTS	OPTIONAL SPEND EST. (RS)
LH APRON	7	GOOD	0
RH APRON	7	GOOD	0
RADIATOR	7	GOOD	0
WIRING	7	GOOD	0
BATTERY	6	AVERAGE	0
BRAKE FLUID LEVEL	7	GOOD	0
ENGINE OIL	7	GOOD	0
COOLANT LEVEL	7	GOOD	0
BRAKE & COOLANT HOSE PIPES	7	GOOD	0
UNDERCARRIAGE	7	GOOD	0
EXHAUST SYSTEM	7	GOOD	0

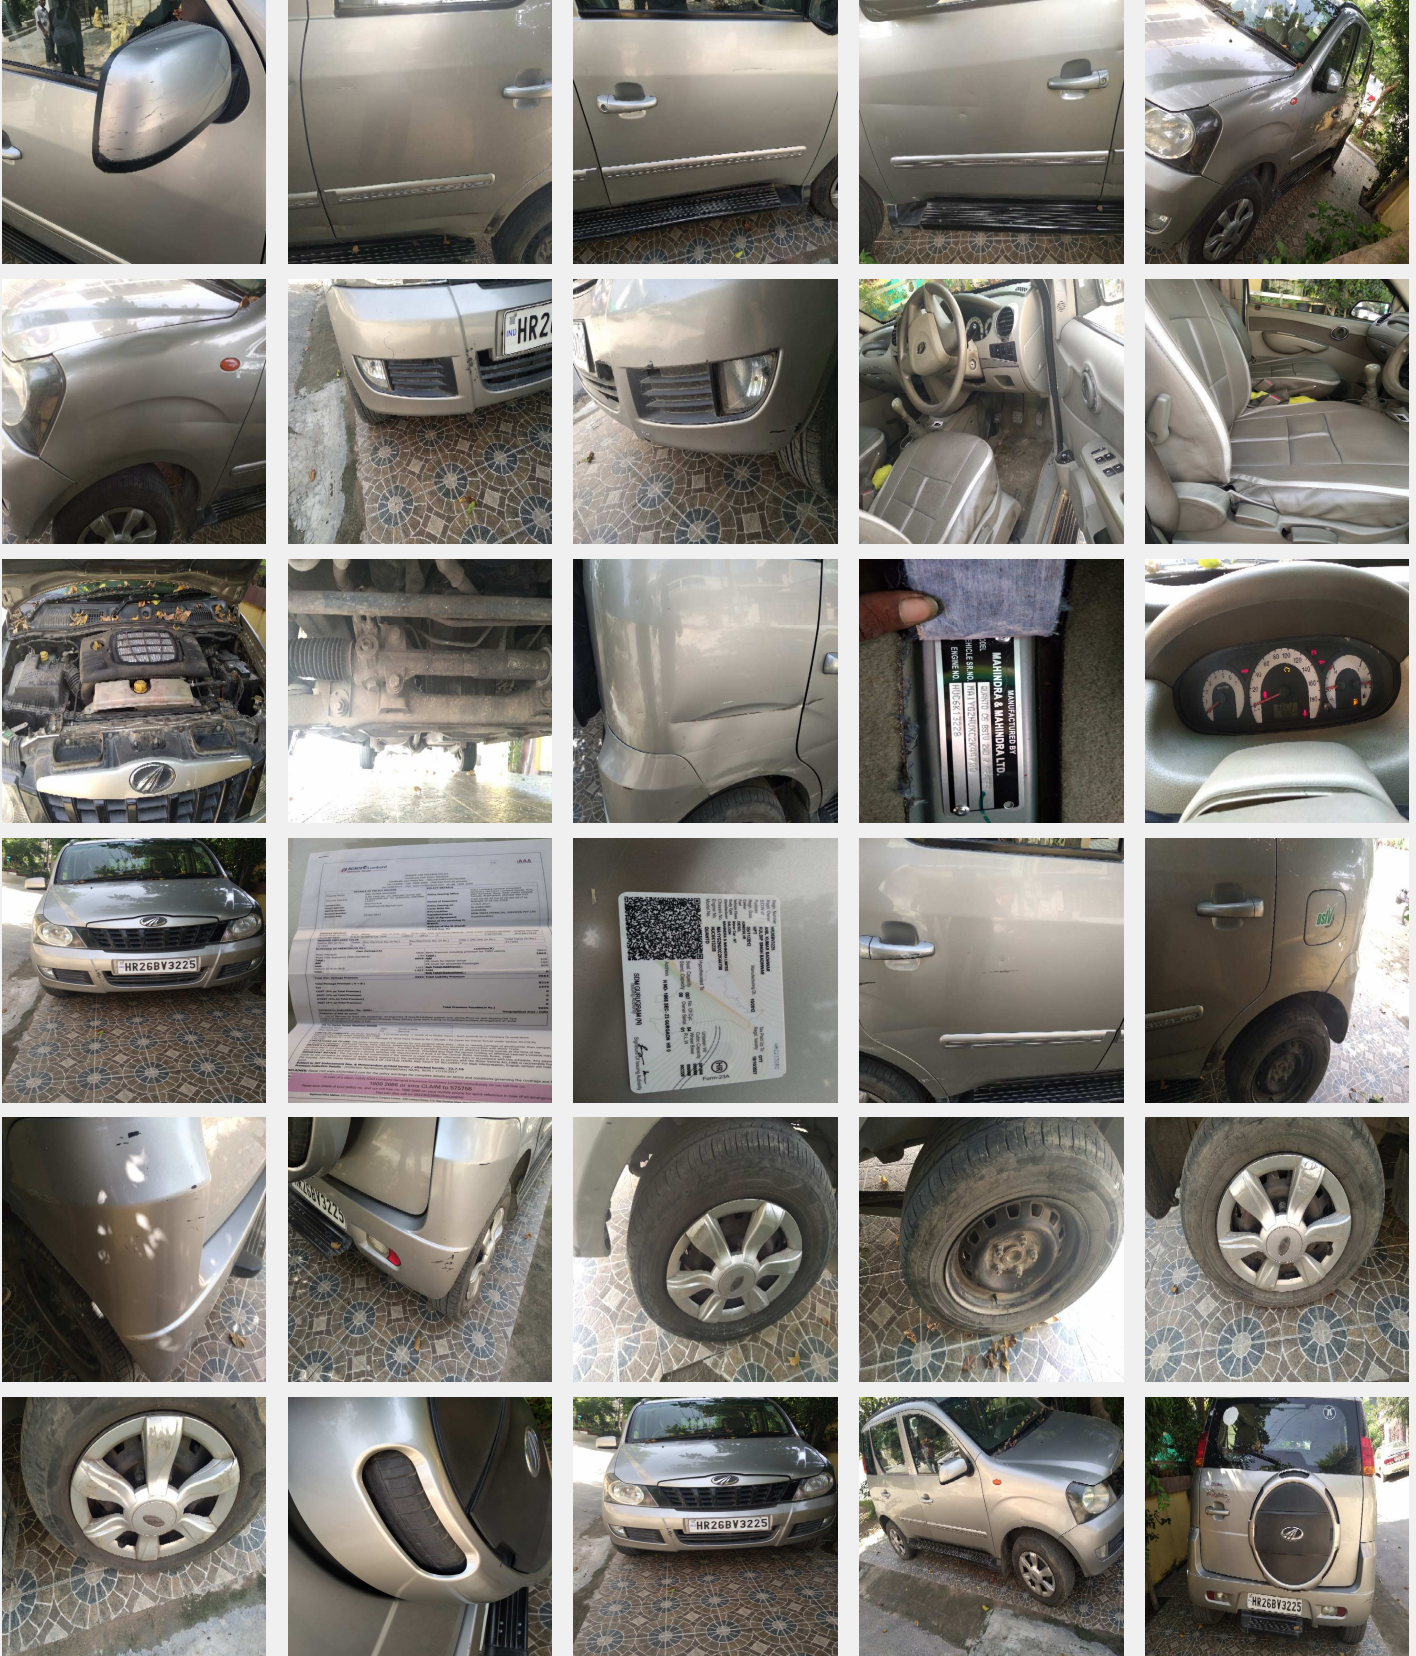
IMAGES

INSPECTION CHECKPOINTS	SCORE(X/10)	REMARKS/COMMENTS	OPTIONAL SPEND EST. (RS)
LICENSE PLATE	7	GOOD	0
HEAD LIGHTS	7	GOOD	0
GRILLE	7	GOOD	0
TURN SIGNAL	7	GOOD	0
FOG LAMPS	7	GOOD	0
HOOD	7	GOOD	0
PILLAR	7	GOOD	0
FRONT WINDSHIELD	7	GOOD	0
LH RUNNING BOARD	7	GOOD	0
FUEL LID	7	GOOD	0
REAR WINDSHIELD	7	GOOD	0
TAIL LIGHT	7	GOOD	0
TRUNK LID/TAIL GATE	7	GOOD	0
LUGGAGE COMPARTMENT LIGHT	7	GOOD	0
RH RUNNING BOARD	7	GOOD	0
RH FENDER	7	GOOD	0
BODY RUST	7	GOOD	0
ROOF (REGULAR)	7	GOOD	0
PAINT CONDITION	7	GOOD	0
FRONT BUMPER	5	NEED TO BE REPAIR	4000
SIDE VIEW MIRRORS	5	NEED TO BE REPAIR	3000
LH FENDER	5	NEED TO BE REPAIR	4000
LH FRONT DOOR	5	NEED TO REPAIR	5000
LH REAR DOOR	5	NEED TO REPAIR	5000

INSPECTION CHECKPOINTS	SCORE(X/10)	REMARKS/COMMENTS	OPTIONAL SPEND EST. (RS)
LH QUARTER PANEL	5	NEED TO REPAIR	400
REAR BUMPER	5	NEED TO REPAIR	4000
RH QUARTER PANEL	5	NEED TO REPAIR	4000
RH REAR DOOR	5	NEED TO REPAIR	5000
RH FRONT DOOR	5	NEED TO REPAIR	5000

minor scratches spare wheel also need to replace after 5000 km both rear tyres need to be replaced a
