ECO INSPECTION CERTIFICATE

Order ID : 26708

121 Points Vehicle Inspection Certificate

Maruti Suzuki Wagon R LXI, 2011

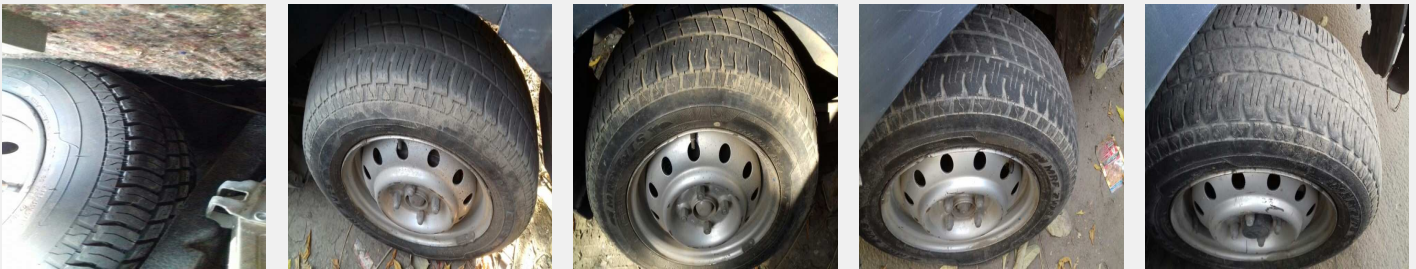
| INSPECTION CHECKPOINTS | SCORE(X/10) | REMARKS/COMMENTS | OPTIONAL SPEND EST. (RS) |
|---|---|---|---|
| TYRES | 5 | AVERAGE CANDITION | 0 |

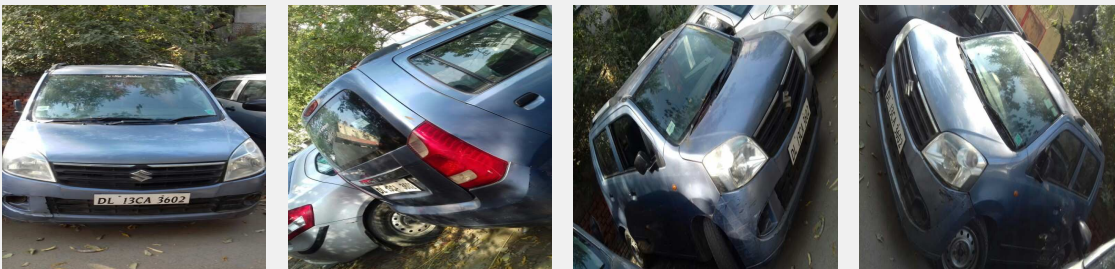
| INSPECTION CHECKPOINTS | SCORE(X/10) | REMARKS/COMMENTS | OPTIONAL SPEND EST. (RS) |
|---|---|--|---|
| RH REAR DOOR | 5 | PAINTED | 0 |
| RH FRONT DOOR | 4 | PAINTED AND SCRATCH | 2500 |
| RH FENDER | 4 | PAINTED AND SCRATCH | 2500 |
| PAINT CONDITION | 5 | CAR IS PAINTED BUT NEED TO BE RE PAINT | 0 |

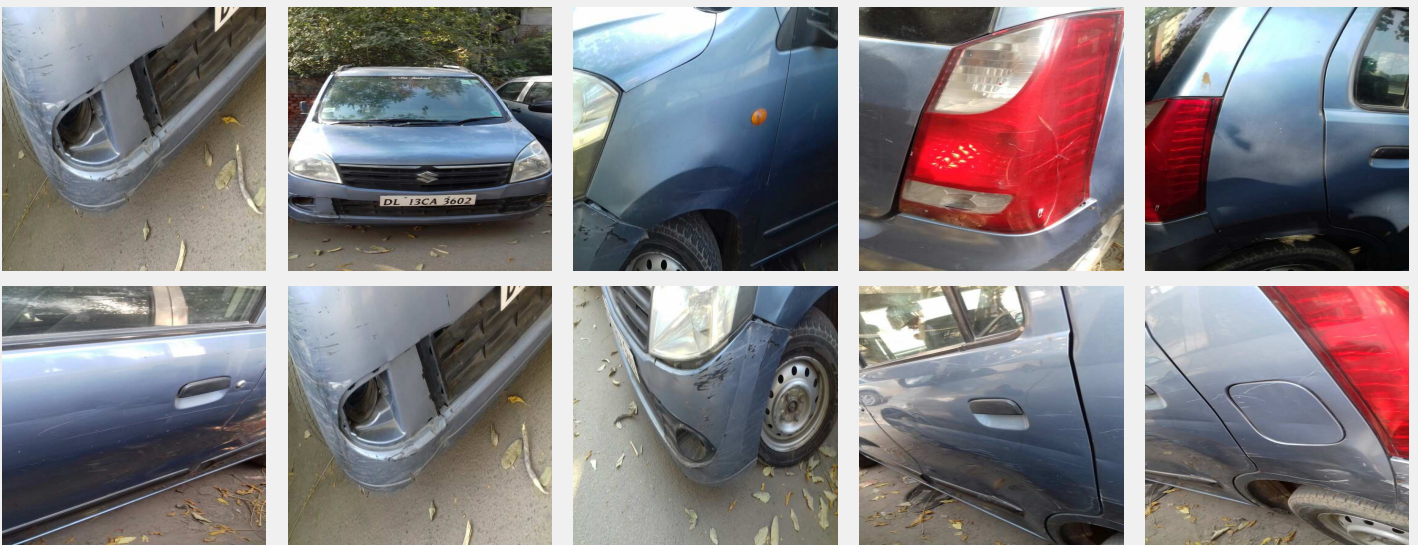
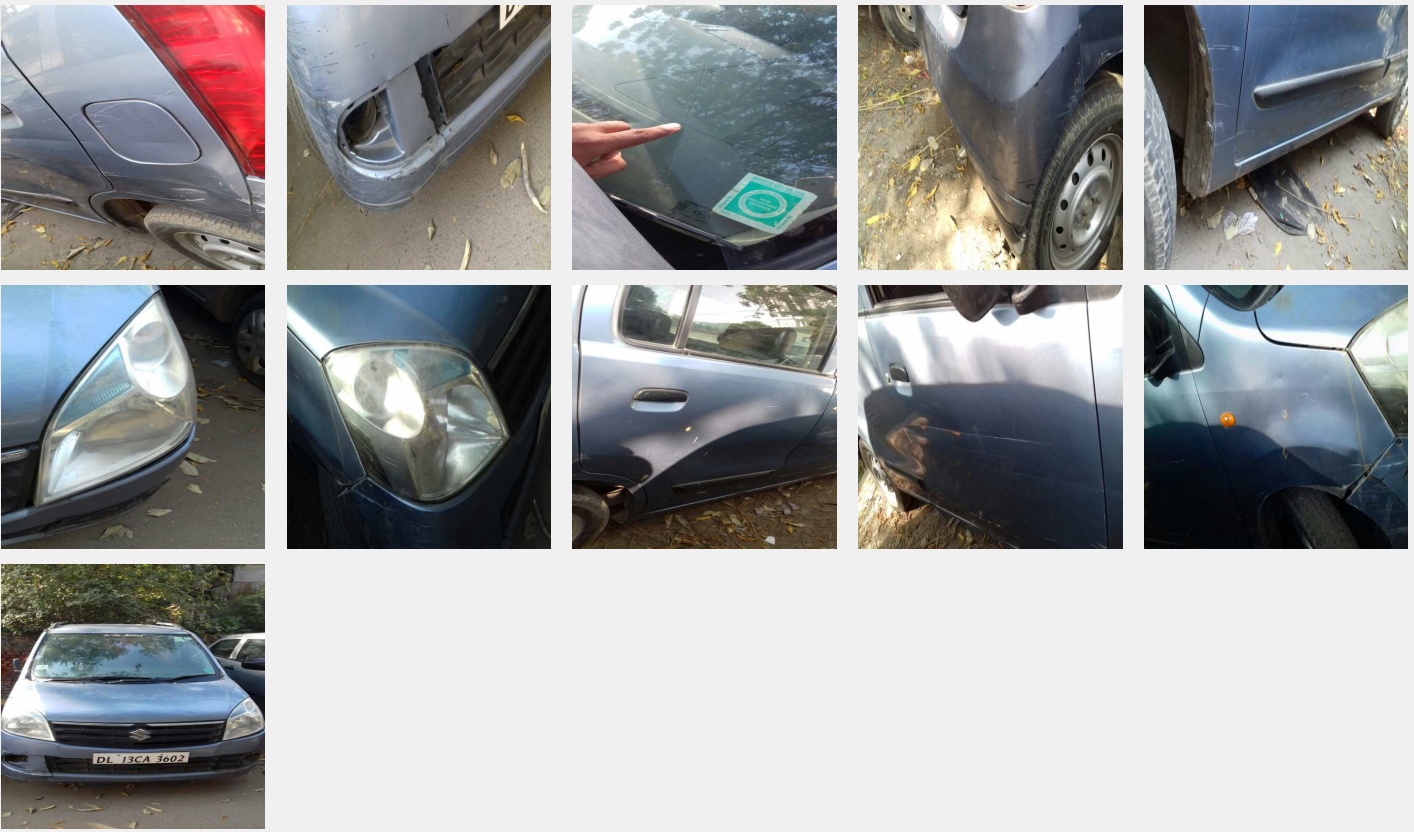
| INSPECTION CHECKPOINTS | SCORE(X/10) | REMARKS/COMMENTS | OPTIONAL SPEND EST. (RS) |
|---|---|---|---|
| FRONT BUMPER | 3 | BROKEN | 7000 |
| GRILLE | 3 | BROKEN | 1100 |
| FRONT WINDSHIELD | 3 | BROKEN | 4500 |
| TAIL LIGHT | 3 | RIGHT SIDE TELL LIGHT IS BROKEN | 1250 |

car is need to be re paint car is better candition frant windshild is broken
