ECO INSPECTION CERTIFICATE

Order ID : 27468

121 Points Vehicle Inspection Certificate

Hyundai Verna 1.6 Vtvt Sx (O) At, 2013

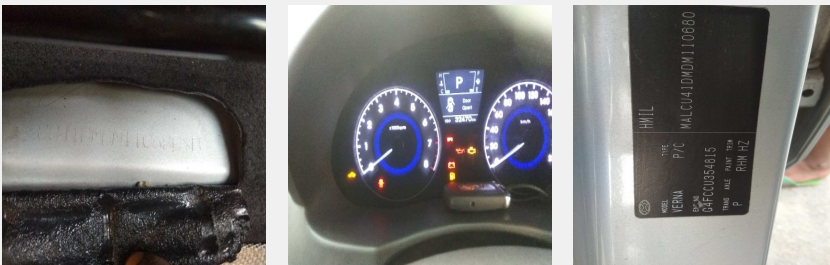
INSPECTION CHECKPOINTS	SCORE(X/10)	REMARKS/COMMENTS	OPTIONAL SPEND EST. (RS)
STEERING PERFORMANCE	8	GOOD	0
BRAKE PERFORMANCE	8	GOOD	0
CLUTCH PERFORMANCE	8	GOOD	0
ENGINE NOISE	7	GOOD	0
IGNITION SYSTEM	8	GOOD	0
SUSPENSION PERFORMANCE	8	GOOD	0
SUSPENSION FRONT SHOCKS	8	GOOD	0
SUSPENSION REAR SHOCKS	7	GOOD	0
TRANSMISSION ENGAGE	8	GOOD	0

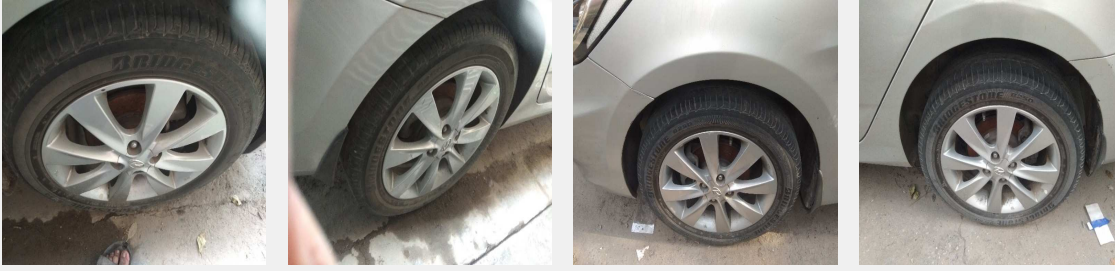
INSPECTION CHECKPOINTS	SCORE(X/10)	REMARKS/COMMENTS	OPTIONAL SPEND EST. (RS)
TYRES	8	GOOD	0

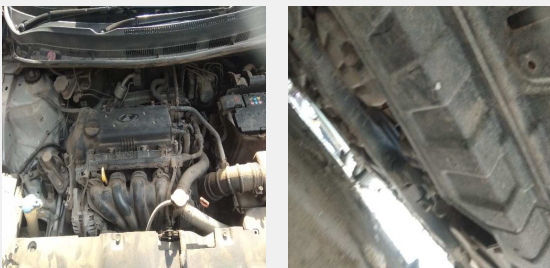
INSPECTION CHECKPOINTS	SCORE(X/10)	REMARKS/COMMENTS	OPTIONAL SPEND EST. (RS)
LH APRON	7	GOOD	0
RH APRON	7	GOOD	0
RADIATOR	8	GOOD	0
WIRING	7	GOOD	0
BATTERY	7	GOOD	0
BRAKE FLUID LEVEL	7	GOOD	0
ENGINE OIL	7	GOOD	0
COOLANT LEVEL	7	GOOD	0
BRAKE & COOLANT HOSE PIPES	7	GOOD	0
UNDERCARRIAGE	7	GOOD	0
EXHAUST SYSTEM	7	GOOD	0
