# ECO INSPECTION CERTIFICATE

Order ID : 28276

121 Points Vehicle Inspection Certificate

## Skoda Superb ELEGANCE 1.8 TSI AT, 2012

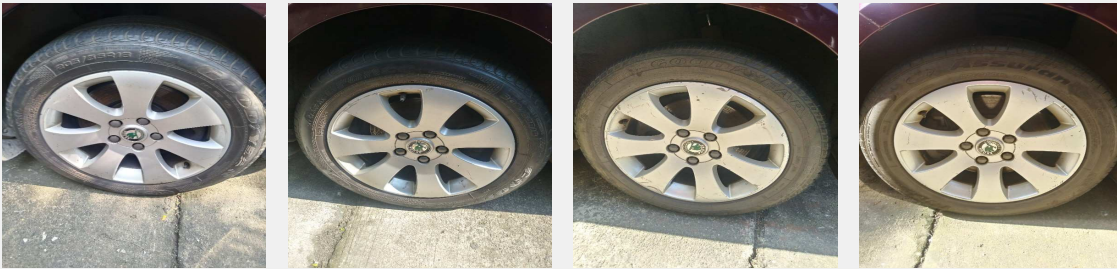
## IMAGES

INSPECTION CHECKPOINTS	SCORE(X/10)	REMARKS/COMMENTS	OPTIONAL SPEND EST. (RS)
TYRES	7	GOOD TREAD	0

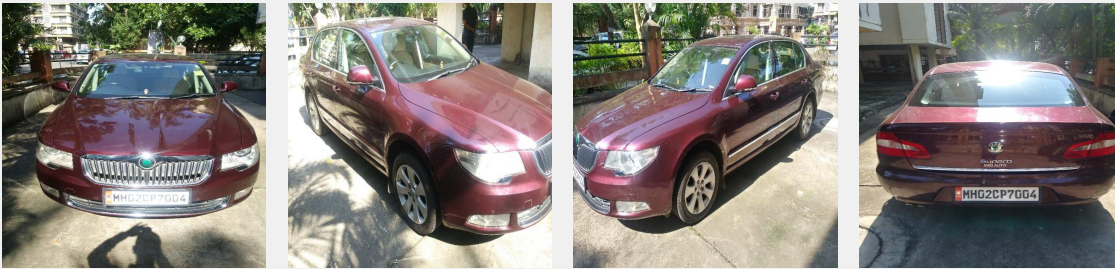
**IMAGES**

INSPECTION CHECKPOINTS	SCORE(X/10)	REMARKS/COMMENTS	OPTIONAL SPEND EST. (RS)
BODY RUST	6	NO RUSH	0
PAINT CONDITION	6	GOOD PAINT	0
FRONT BUMPER	5	PAINTING	2000
REAR BUMPER	5	PAINTING	2000
