# ECO INSPECTION CERTIFICATE

Order ID : 28397

121 Points Vehicle Inspection Certificate

## Hyundai I10 MAGNA 1.2, 2012

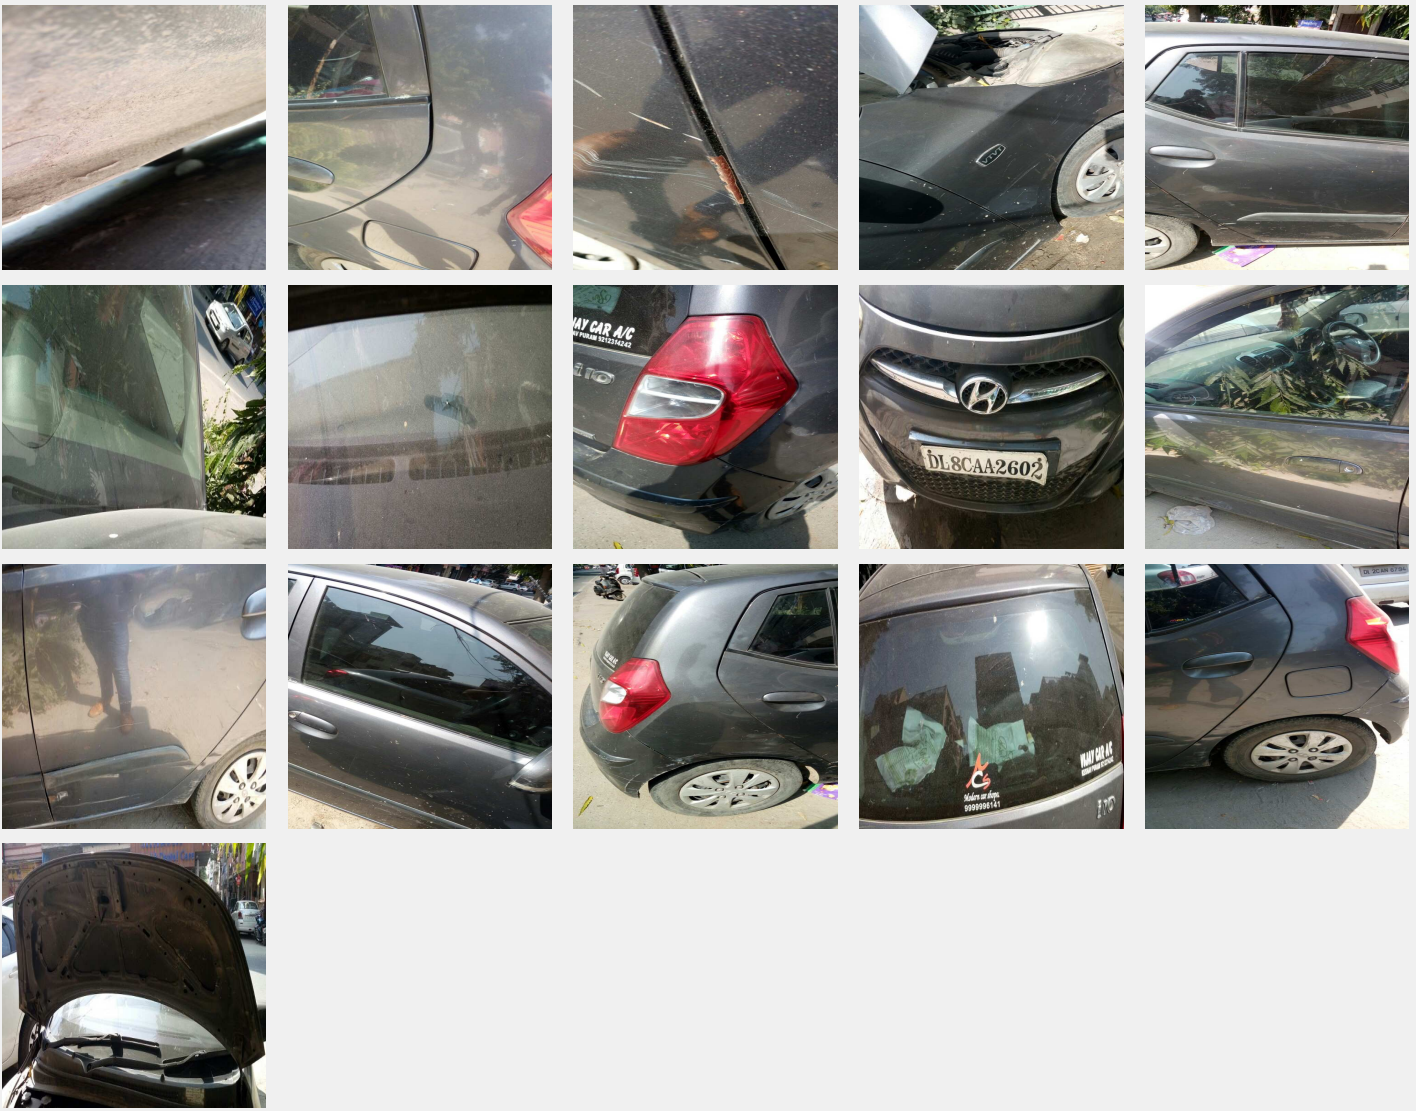
## NEED ATTENTION

INSPECTION CHECKPOINTS	SCORE(X/10)	REMARKS/COMMENTS	OPTIONAL SPEND EST. (RS)
LH QUARTER PANEL	4	SCRATCH	1500
RH REAR DOOR	5	SCRATCH AND DANT	3000
RH FENDER	5	SCRATCH	1500
BODY RUST	5	SOME PART RUSTED	1000

all body scratches rear and front bumper broken minor damage windscreen all body minor dant steel
