# ECO INSPECTION CERTIFICATE

Order ID : 28493

121 Points Vehicle Inspection Certificate

## Mahindra Xuv500 W8, 2012

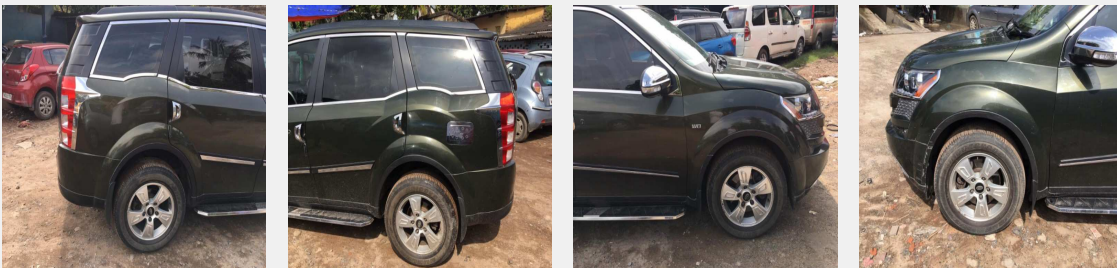
## IMAGES

INSPECTION CHECKPOINTS	SCORE(X/10)	REMARKS/COMMENTS	OPTIONAL SPEND EST. (RS)
TYRES	7	OK	0

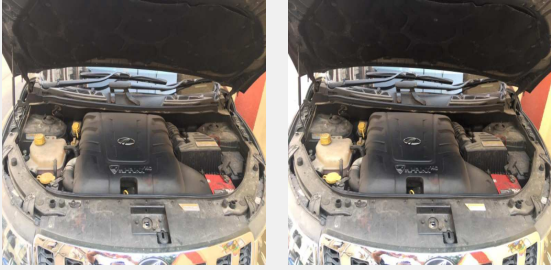
## IMAGES

INSPECTION CHECKPOINTS	SCORE(X/10)	REMARKS/COMMENTS	OPTIONAL SPEND EST. (RS)
LH APRON	7	OK	0
RH APRON	6	OK	0
RADIATOR	7	OK	0
WIRING	6	OK	0
BATTERY	7	OK	0
BRAKE FLUID LEVEL	6	OK	0
ENGINE OIL	7	OK	0
COOLANT LEVEL	7	OK	0

BRAKE & COOLANT HOSE PIPES	7	OK	0
UNDERCARRIAGE	6	OK	0
EXHAUST SYSTEM	7	OK	0
