# ECO INSPECTION CERTIFICATE

Order ID : 29039

121 Points Vehicle Inspection Certificate

## Audi A6 2.0 TDI, 2013

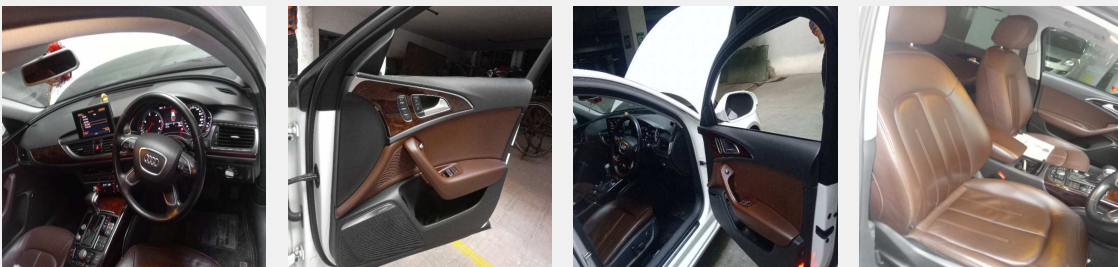
INSPECTION CHECKPOINTS	SCORE(X/10)	REMARKS/COMMENTS	OPTIONAL SPEND EST. (RS)
DOOR PANEL	8	GOOD	0
DOOR HINGES	8	GOOD	0
CARPET & FLOOR MAT	8	GOOD	0
SEAT & SEAT BELT	8	GOOD	0
DASHBOARD & INSTRUMENT PANEL	8	GOOD	0
HORN	8	GOOD	0
SPEAKERS & MUSIC SYSTEM	8	GOOD	0
HANDBRAKE	8	GOOD	0
STEERING-MOUNTED CONTROLS	8	GOOD	0
PEDALS	7	GOOD	0
CENTRAL LOCK	8	GOOD	0
A/C VENTS & HEATER	8	GOOD	0
CUP HOLDERS	8	GOOD	0
ODOMETER	8	GOOD	0
HAZARD LIGHT	8	GOOD	0

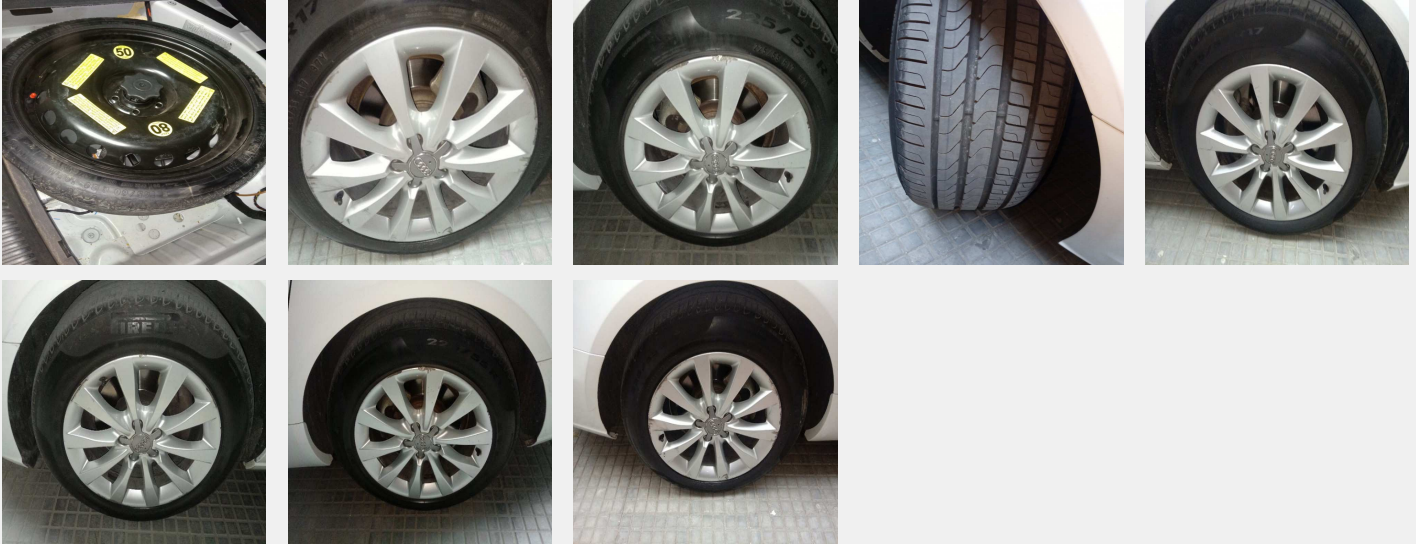
INSPECTION CHECKPOINTS	SCORE(X/10)	REMARKS/COMMENTS	OPTIONAL SPEND EST. (RS)
TYRES	8	GOOD	0

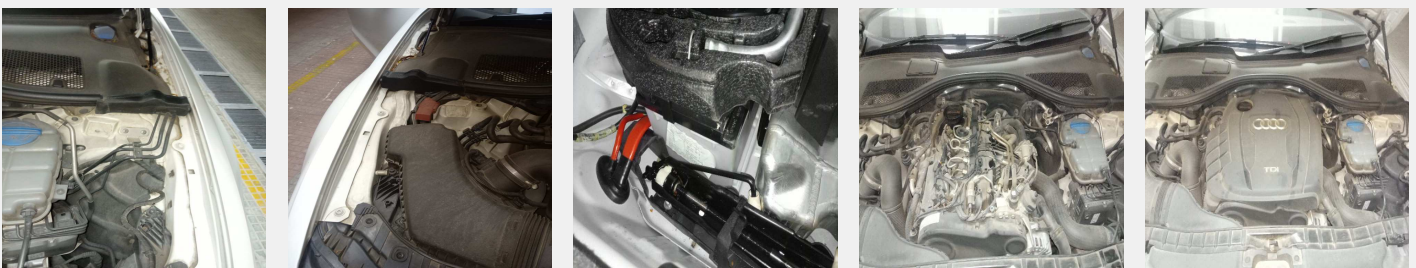
INSPECTION CHECKPOINTS	SCORE(X/10)	REMARKS/COMMENTS	OPTIONAL SPEND EST. (RS)
LH APRON	8	GOOD	0
RH APRON	8	GOOD	0
RADIATOR	8	GOOD	0
WIRING	8	GOOD	0
BATTERY	8	GOOD	0
BRAKE FLUID LEVEL	7	GOOD	0
COOLANT LEVEL	7	GOOD	0
BRAKE & COOLANT HOSE PIPES	7	GOOD	0
UNDERCARRIAGE	7	GOOD	0
EXHAUST SYSTEM	7	GOOD	0
ENGINE OIL	1	NEED REPLACE SERVICE DUE	40000

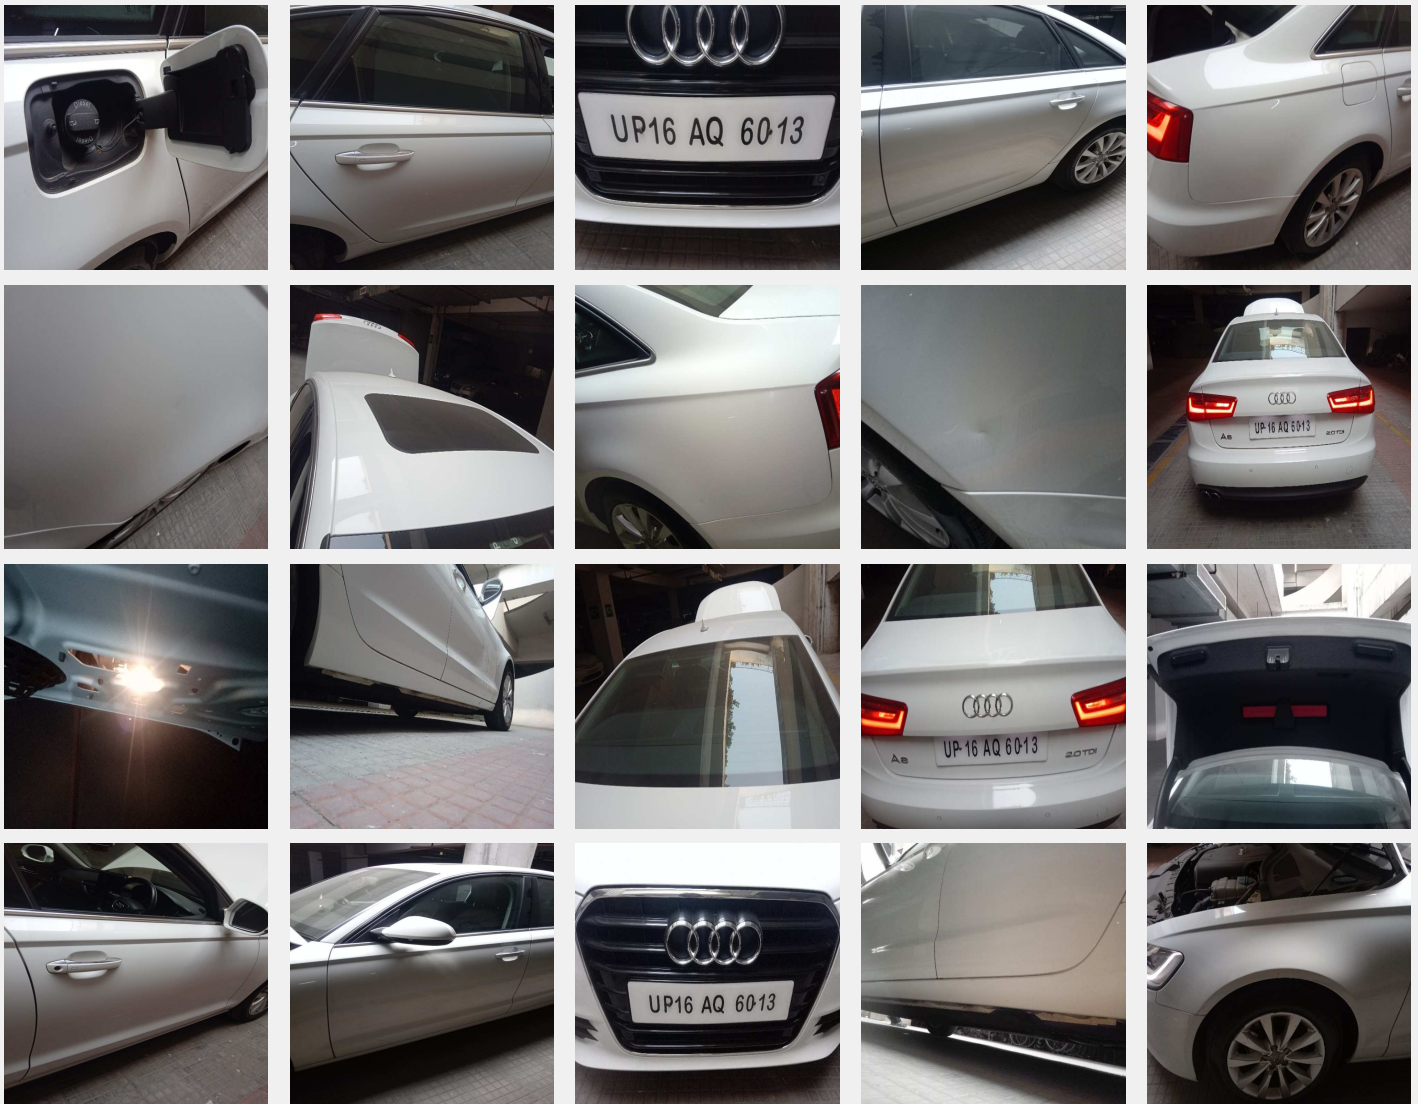
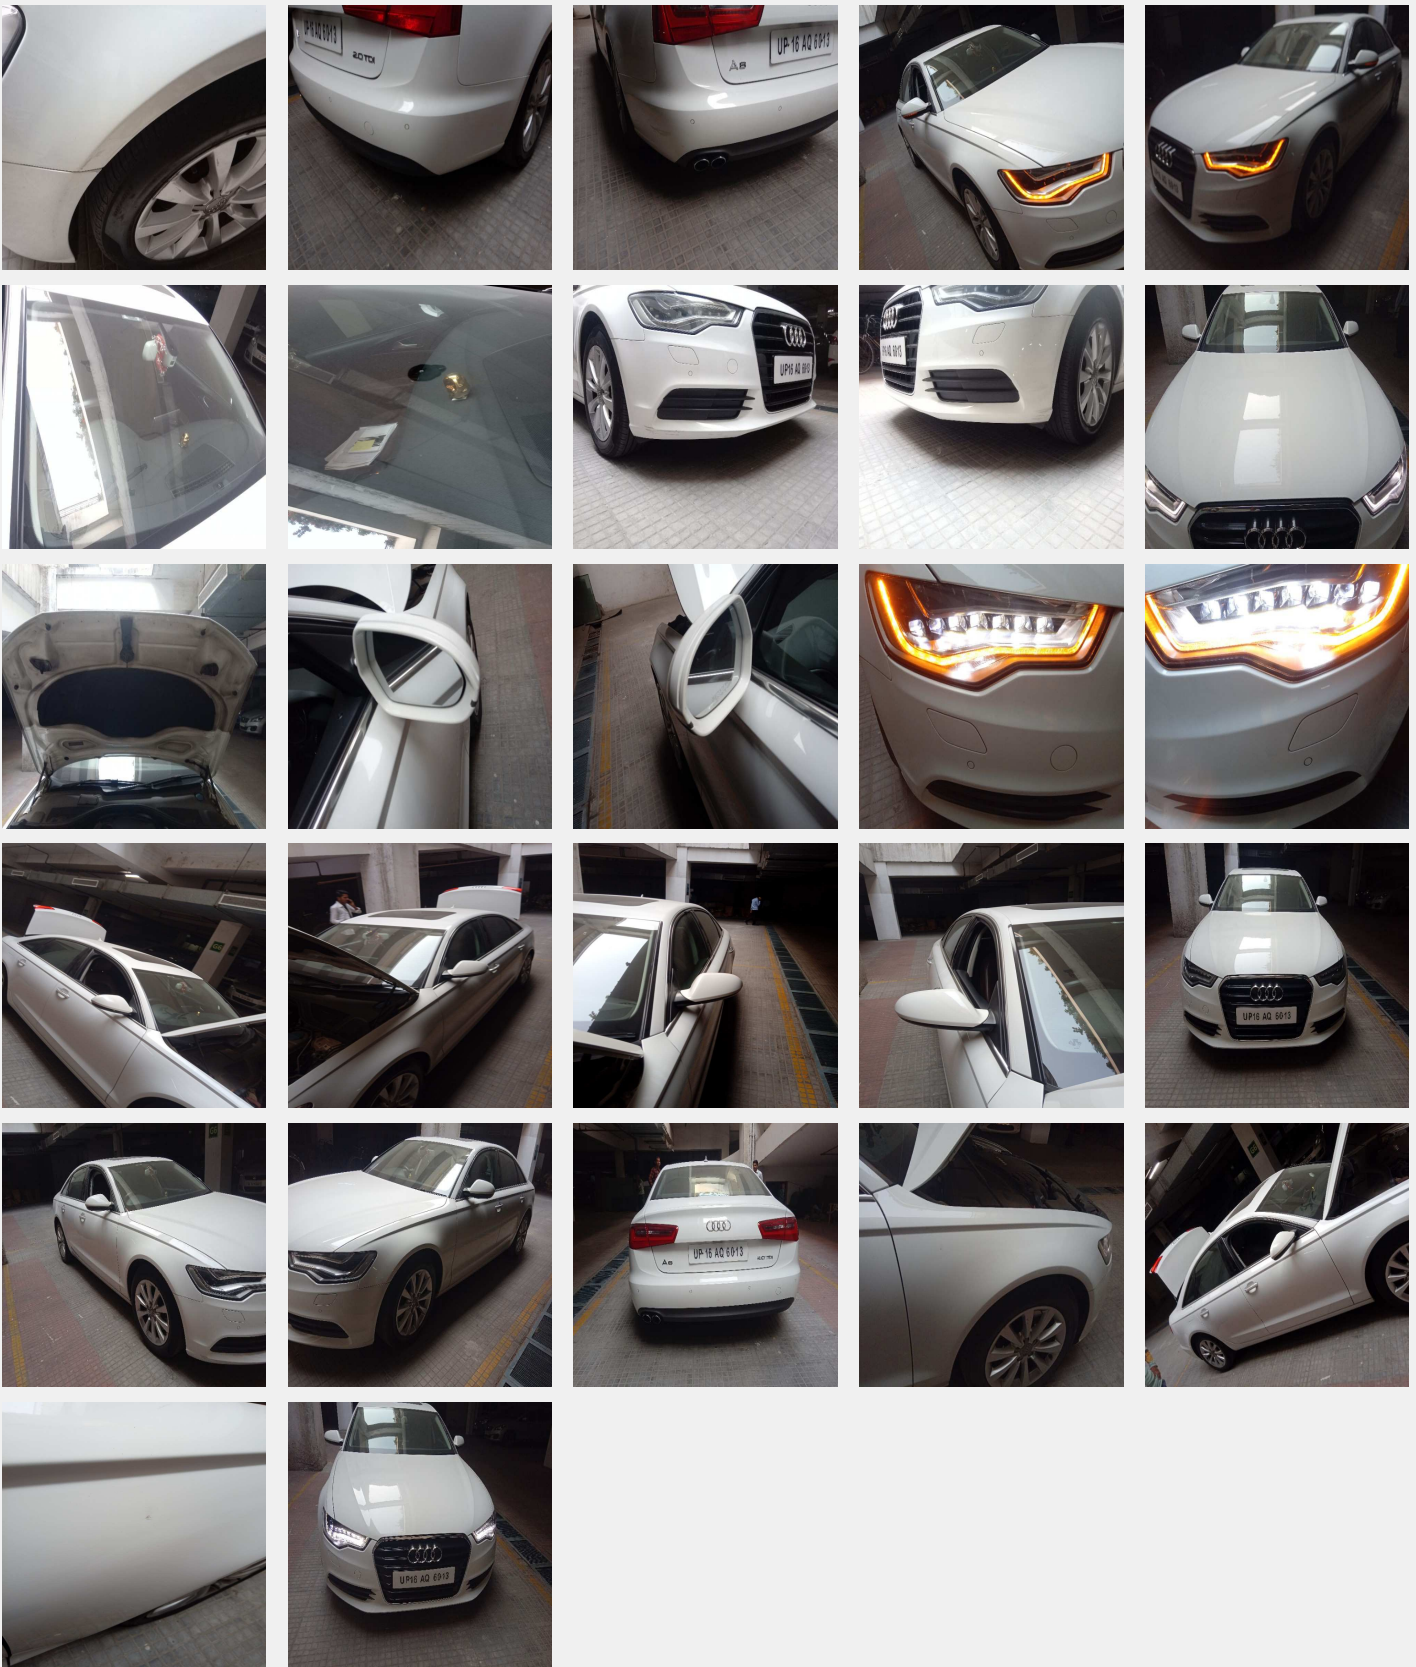
INSPECTION CHECKPOINTS	SCORE(X/10)	REMARKS/COMMENTS	OPTIONAL SPEND EST. (RS)
LICENSE PLATE	8	GOOD	0
FRONT BUMPER	6	MINOR SCRATCHES	0
HEAD LIGHTS	8	GOOD	0
GRILLE	8	GOOD	0
TURN SIGNAL	8	GOOD	0
FOG LAMPS	8	GOOD	0
HOOD	8	GOOD	0
PILLAR	8	GOOD	0
SIDE VIEW MIRRORS	8	GOOD	0
LH FENDER	6	SCRATCHES	0
LH FRONT DOOR	8	GOOD	0
LH REAR DOOR	8	GOOD	0
LH RUNNING BOARD	6	MINOR SCRATCHES	0
LH QUARTER PANEL	6	MINOR SCRATCHES AND DENT	0
FUEL LID	8	GOOD	0
REAR WINDSHIELD	8	GOOD	0
REAR BUMPER	6	MINOR SCRATCHES	0
TAIL LIGHT	8	GOOD	0
TRUNK LID/TAIL GATE	8	GOOD	0
LUGGAGE COMPARTMENT LIGHT	8	GOOD	0
RH QUARTER PANEL	6	MINOR DENT	0
RH RUNNING BOARD	6	MINOR SCRATCHES	0
RH REAR DOOR	8	GOOD	0
RH FRONT DOOR	8	GOOD	0

INSPECTION CHECKPOINTS	SCORE(X/10)	REMARKS/COMMENTS	OPTIONAL SPEND EST. (RS)
RH FENDER	6	MINOR PAINT REMOVED	0
BODY RUST	8	GOOD	0
PAINT CONDITION	6	NEED TO TOUCHING	30000
FRONT WINDSHIELD	4	STONE CHIP MARK	35000

front and rear bumper having scratches body having minor Dent and scratches need touching front tyre
