ECO INSPECTION CERTIFICATE

Order ID : 29787

121 Points Vehicle Inspection Certificate

Volkswagen Polo HIGHLINE 1.5L (D), 2016

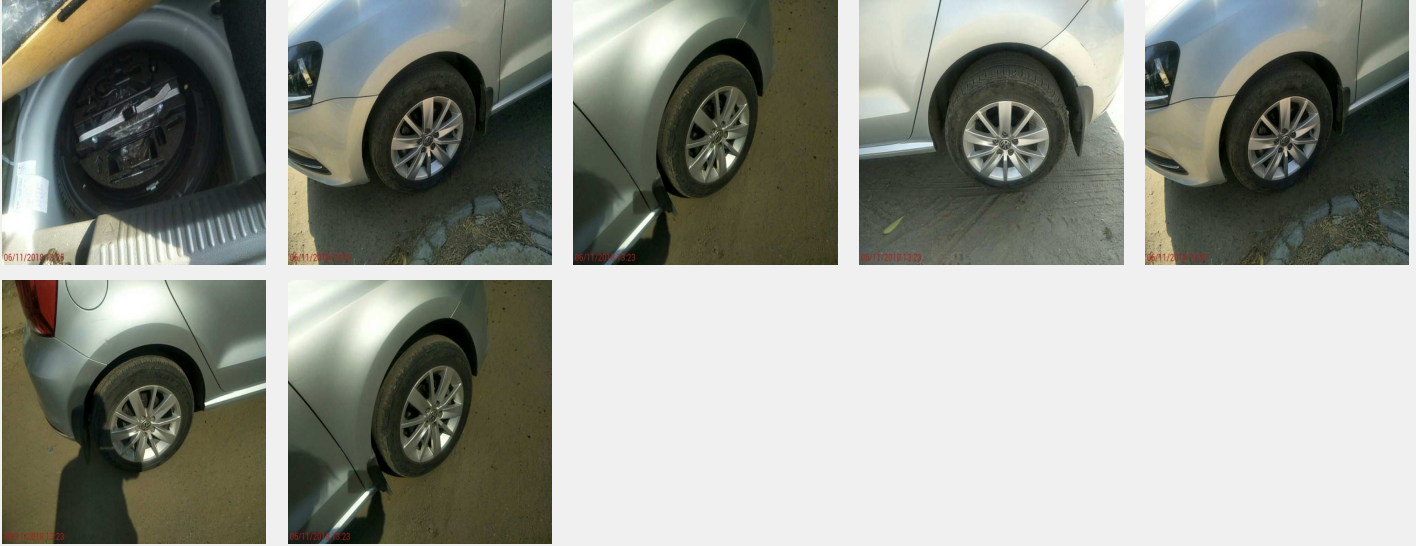
WHEEL

INSPECTION CHECKPOINTS	SCORE(X/10)	REMARKS/COMMENTS	OPTIONAL SPEND EST. (RS)
TYRES	6		0

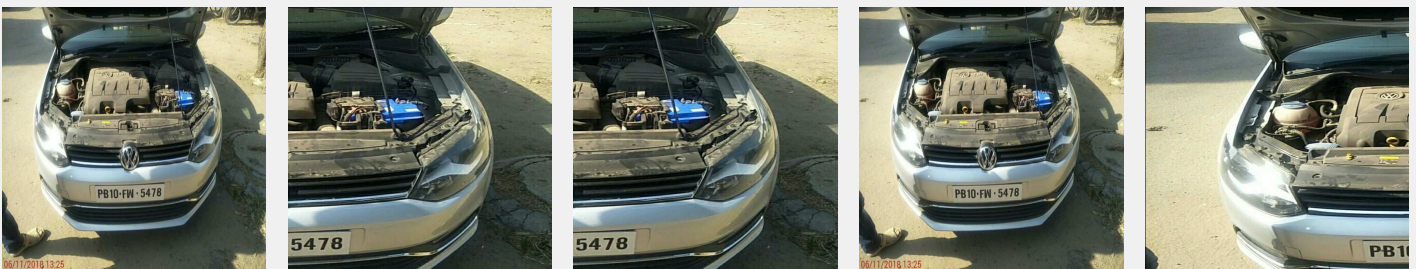
HOOD

INSPECTION CHECKPOINTS	SCORE(X/10)	REMARKS/COMMENTS	OPTIONAL SPEND EST. (RS)
LH APRON	6		0
RH APRON	7		0
RADIATOR	6		0
WIRING	7		0
BATTERY	7		0
BRAKE FLUID LEVEL	6		0
ENGINE OIL	7		0
COOLANT LEVEL	7		0
BRAKE & COOLANT HOSE PIPES	7		0
UNDERCARRIAGE	7		0
EXHAUST SYSTEM	7		0

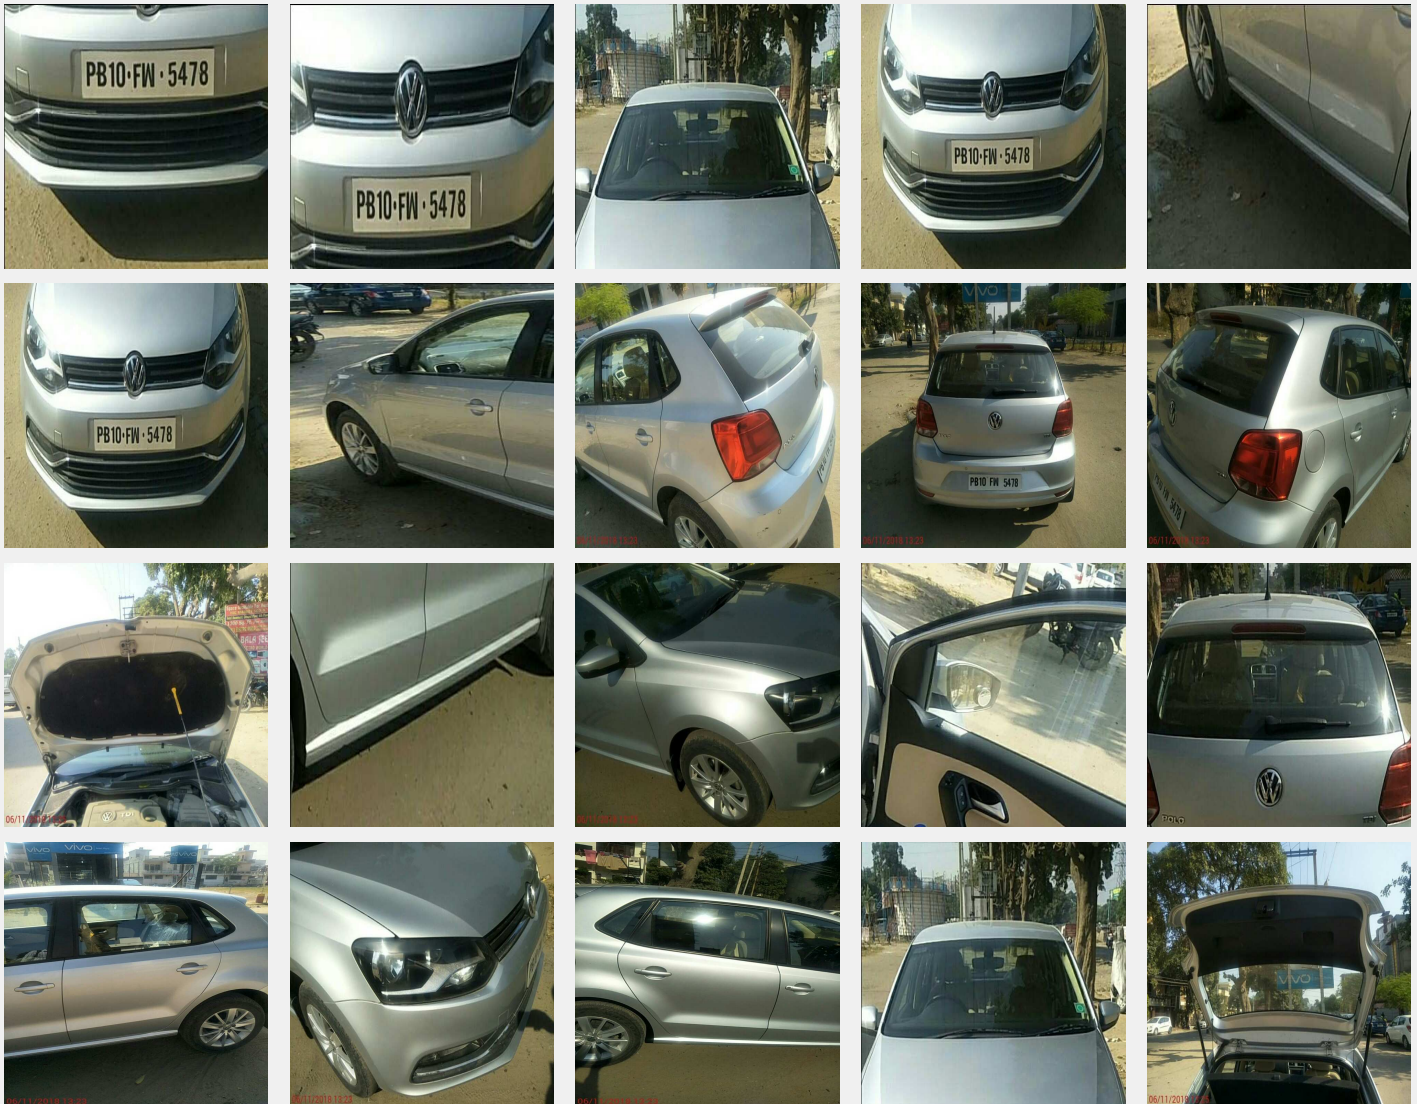
EXTERIOR (CONTINUED)

INSPECTION CHECKPOINTS	SCORE(X/10)	REMARKS/COMMENTS	OPTIONAL SPEND EST. (RS)
RH FRONT DOOR	6		0
RH FENDER	6		0
BODY RUST	7		0
PAINT CONDITION	7		0

good
