# ECO INSPECTION CERTIFICATE

Order ID : 29817

121 Points Vehicle Inspection Certificate

## Hyundai I10 Magna 1.1 Irde2, 2015

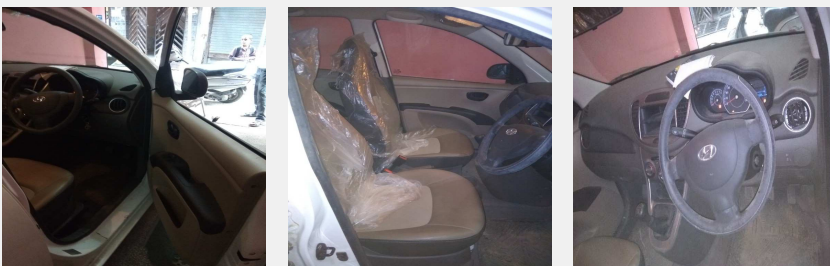
## IMAGES

INSPECTION CHECKPOINTS	SCORE(X/10)	REMARKS/COMMENTS	OPTIONAL SPEND EST. (RS)
DOOR PANEL	8	GOOD	0
DOOR HINGES	7	GOOD	0
CARPET & FLOOR MAT	8	GOOD	0
SEAT & SEAT BELT	7	GOOD	0
DASHBOARD & INSTRUMENT PANEL	8	GOOD	0
HANDBRAKE	7	GOOD	0
PEDALS	7	GOOD	0
CENTRAL LOCK	7	GOOD	0
A/C VENTS & HEATER	7	GOOD	0
CUP HOLDERS	7	GOOD	0
ODOMETER	8	GOOD	0
HAZARD LIGHT	8	GOOD	0
HORN	5	NEED TO BE REPAIR (NOT WORKING)	1500
SPEAKERS & MUSIC SYSTEM	0	NA	0
STEERING-MOUNTED CONTROLS	0	NA	0

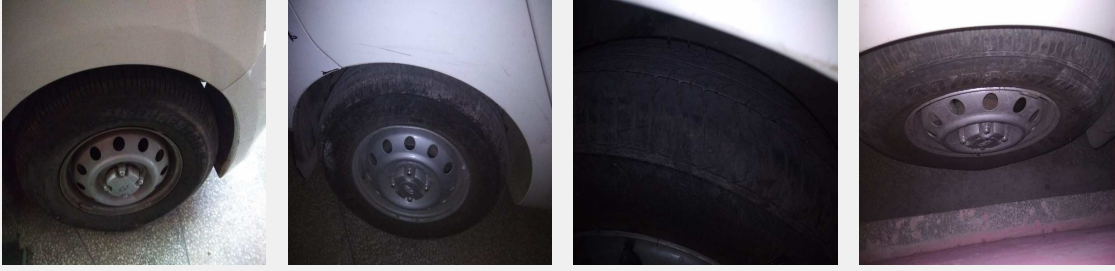
IMAGES

INSPECTION CHECKPOINTS	SCORE(X/10)	REMARKS/COMMENTS	OPTIONAL SPEND EST. (RS)
TYRES	7	GOOD	0

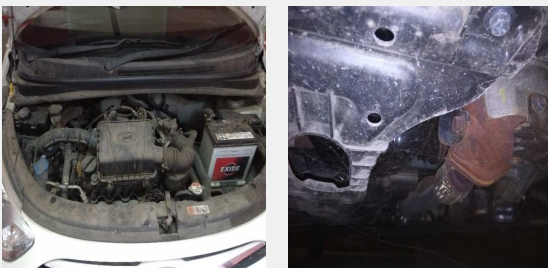
IMAGES

INSPECTION CHECKPOINTS	SCORE(X/10)	REMARKS/COMMENTS	OPTIONAL SPEND EST. (RS)
LH APRON	6	GOOD	0
RH APRON	7	GOOD	0
RADIATOR	7	GOOD	0
WIRING	7	GOOD	0
BATTERY	7	GOOD	0
BRAKE FLUID LEVEL	7	GOOD	0
ENGINE OIL	7	GOOD	0
COOLANT LEVEL	7	GOOD	0
BRAKE & COOLANT HOSE PIPES	7	GOOD	0
UNDERCARRIAGE	7	GOOD	0
EXHAUST SYSTEM	7	GOOD	0

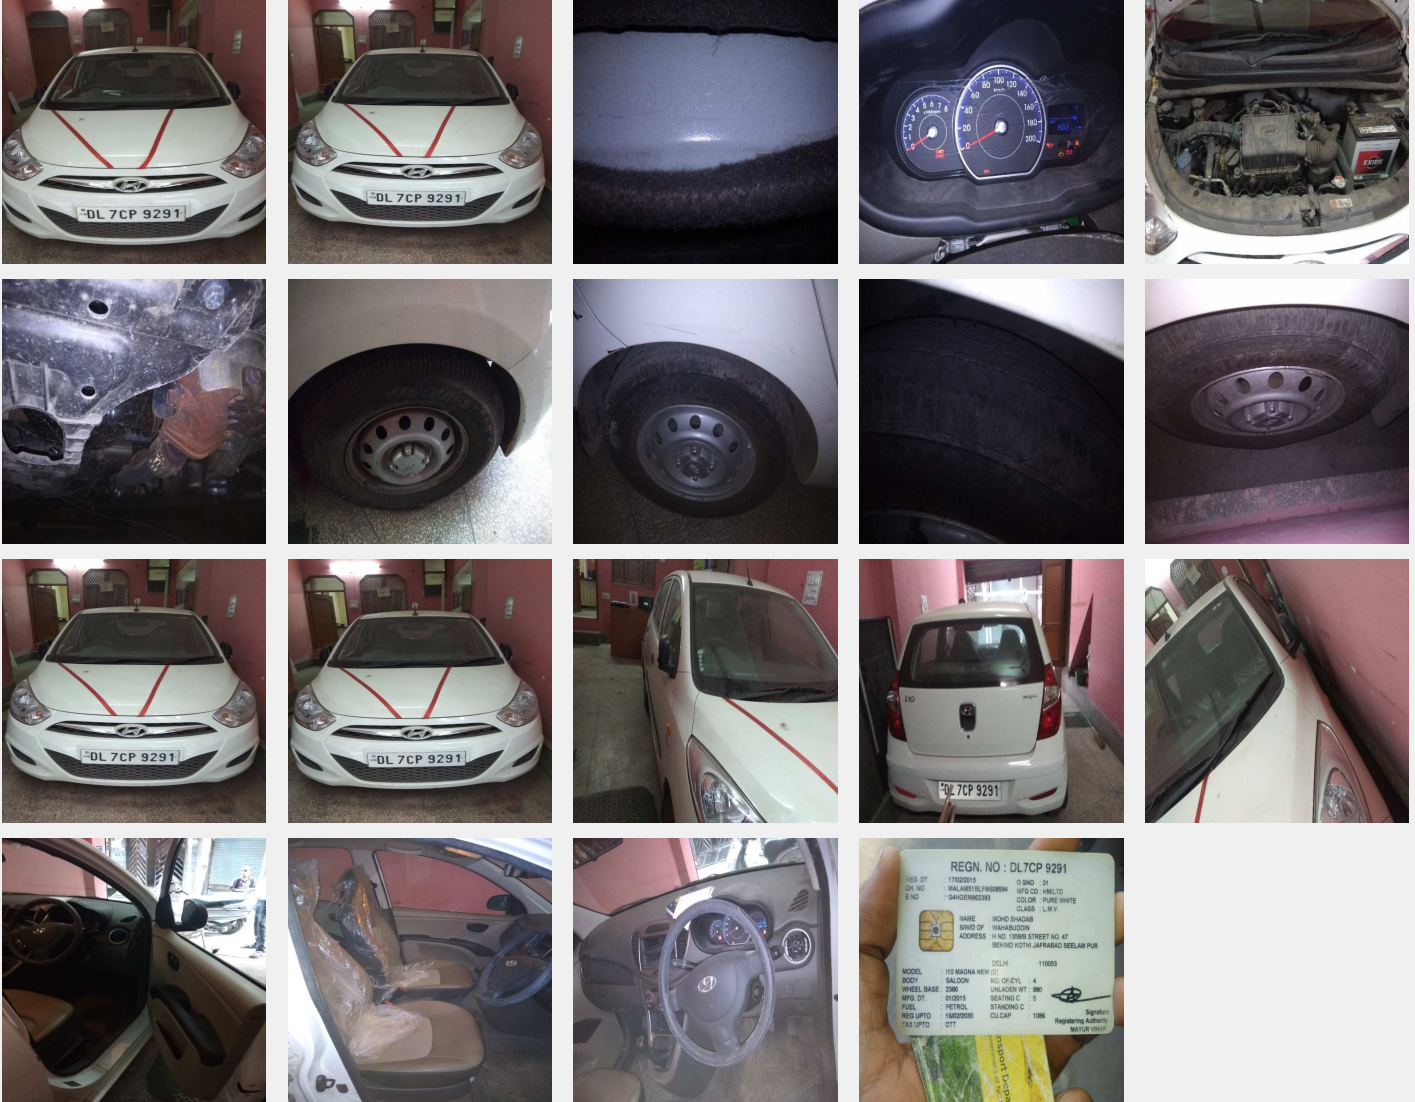
IMAGES

during the inspection time vehicle condition is good some minor scratches on a all body frame and
