ECO INSPECTION CERTIFICATE

Order ID : 30159

121 Points Vehicle Inspection Certificate

Jaguar F-Pace PRESTIGE, 2018

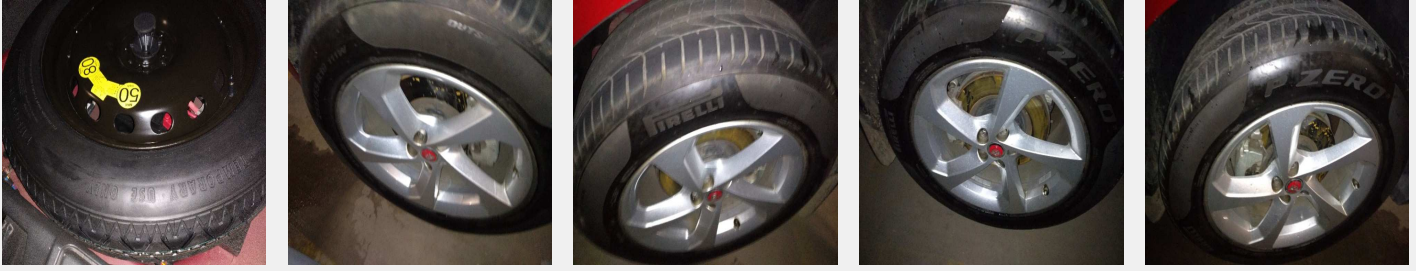
IMAGES

INSPECTION CHECKPOINTS	SCORE(X/10)	REMARKS/COMMENTS	OPTIONAL SPEND EST. (RS)
TYRES	8	GOOD	0

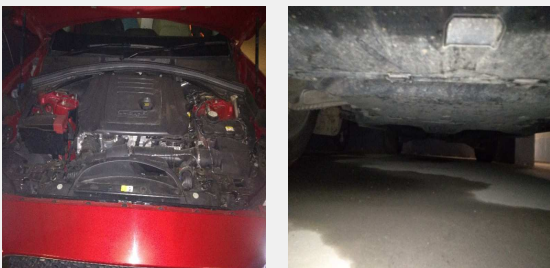
IMAGES

INSPECTION CHECKPOINTS	SCORE(X/10)	REMARKS/COMMENTS	OPTIONAL SPEND EST. (RS)
LH APRON	9	GOOD	0
RH APRON	9	GOOD	0
RADIATOR	9	GOOD	0
WIRING	9	GOOD	0
BATTERY	9	GOOD	0
BRAKE FLUID LEVEL	9	GOOD	0
ENGINE OIL	9	GOOD	0
COOLANT LEVEL	9	GOOD	0
BRAKE & COOLANT HOSE PIPES	9	GOOD	0
UNDERCARRIAGE	9	GOOD	0
EXHAUST SYSTEM	9	GOOD	0
