ECO INSPECTION CERTIFICATE

Order ID : 31321

121 Points Vehicle Inspection Certificate

Tata Indica V2 LS, 2014

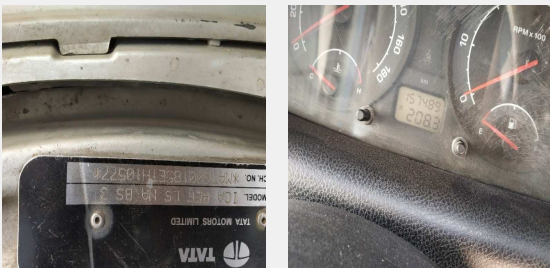
IMAGES

INSPECTION CHECKPOINTS	SCORE(X/10)	REMARKS/COMMENTS	OPTIONAL SPEND EST. (RS)
STEERING PERFORMANCE	7		0
BRAKE PERFORMANCE	8		0
CLUTCH PERFORMANCE	8		0
ENGINE NOISE	8		0
IGNITION SYSTEM	8		0
SUSPENSION PERFORMANCE	8		0
SUSPENSION FRONT SHOCKS	8		0
SUSPENSION REAR SHOCKS	8		0
TRANSMISSION ENGAGE	7		0

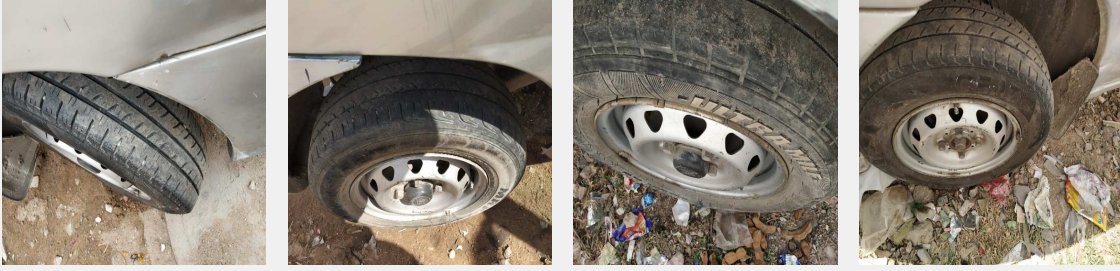
IMAGES

INSPECTION CHECKPOINTS	SCORE(X/10)	REMARKS/COMMENTS	OPTIONAL SPEND EST. (RS)
TYRES	7		0

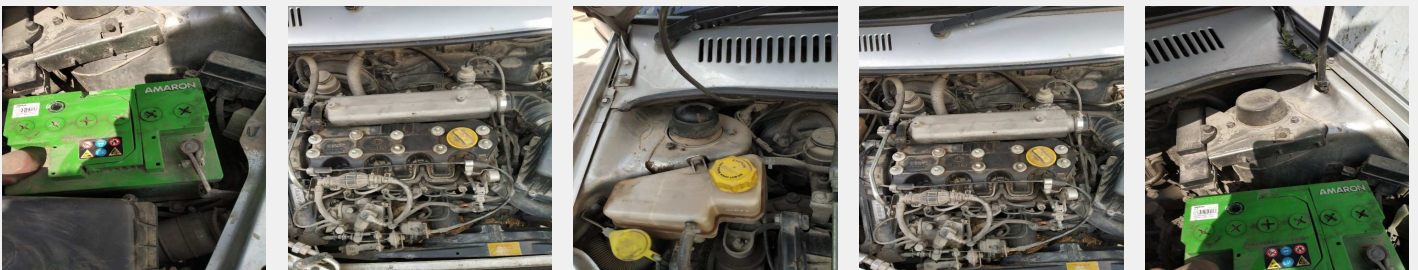
IMAGES

INSPECTION CHECKPOINTS	SCORE(X/10)	REMARKS/COMMENTS	OPTIONAL SPEND EST. (RS)
LH APRON	9		0
RH APRON	9		0
RADIATOR	8		0
WIRING	7		0
BATTERY	8		0
BRAKE FLUID LEVEL	8		0
ENGINE OIL	8		0
COOLANT LEVEL	8		0
BRAKE & COOLANT HOSE PIPES	8		0
UNDERCARRIAGE	8		0
EXHAUST SYSTEM	8		0

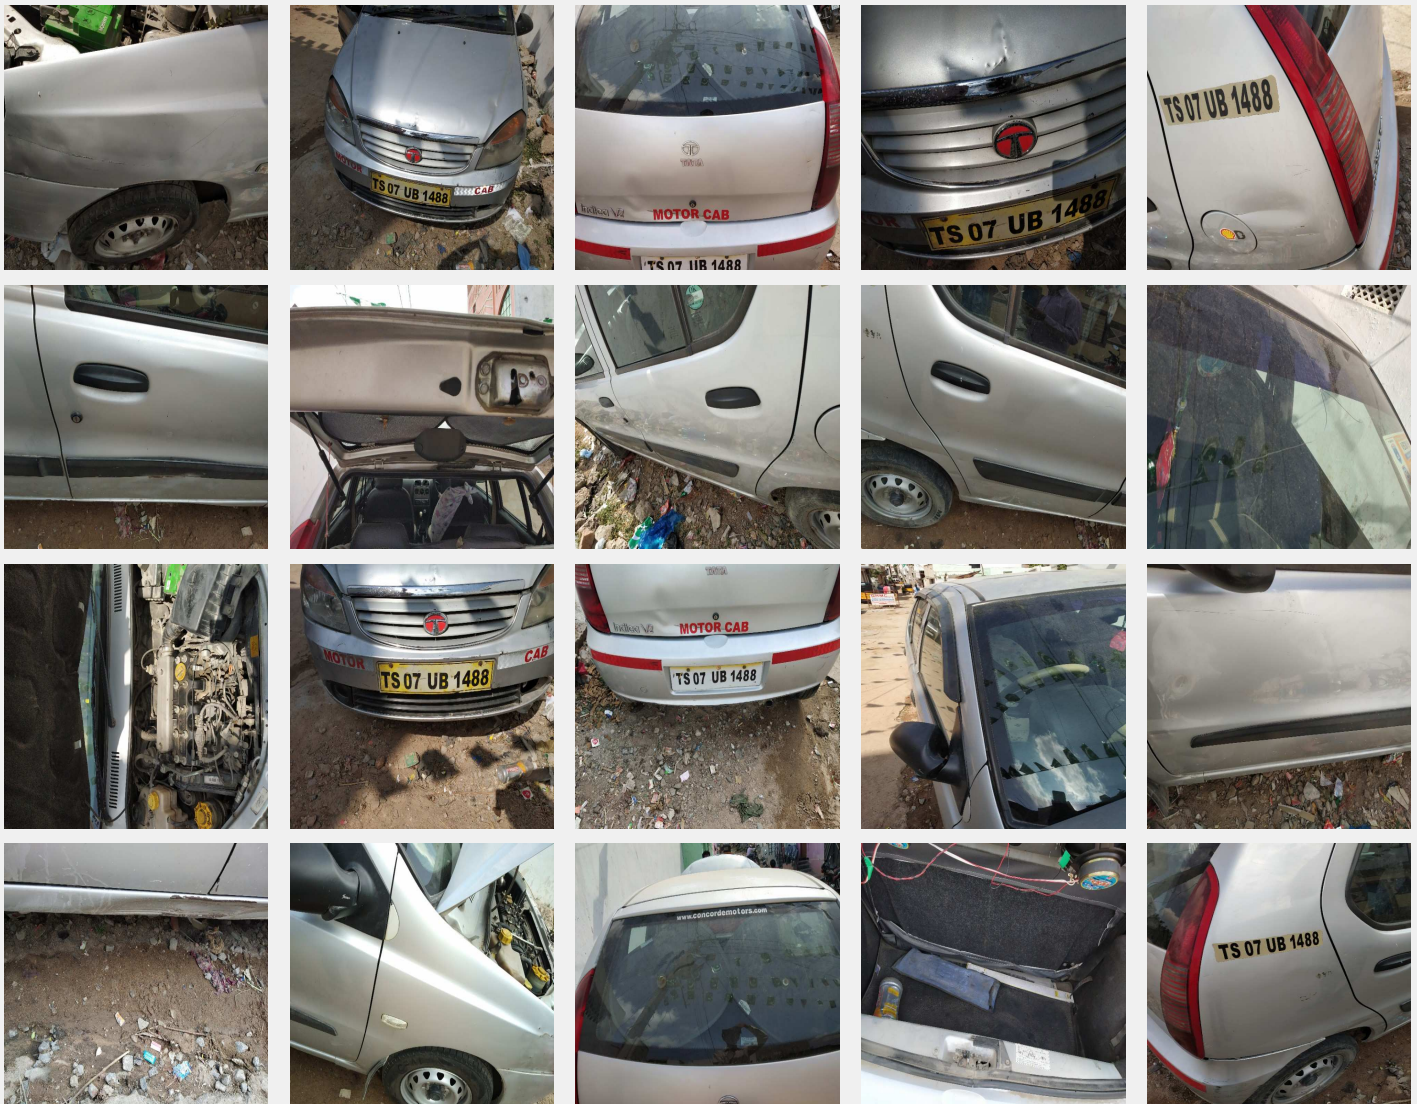
IMAGES

INSPECTION CHECKPOINTS	SCORE(X/10)	REMARKS/COMMENTS	OPTIONAL SPEND EST. (RS)
LICENSE PLATE	6	FADED	0
FRONT BUMPER	6		0
HEAD LIGHTS	7	LEFT DULL	0
GRILLE	8		0
TURN SIGNAL	7		0
FOG LAMPS	7	NOT AVAILABLE - LEFT COVER BROKEN	0
HOOD	6		0
PILLAR	7		0
SIDE VIEW MIRRORS	8		0
LH FENDER	6		0
LH FRONT DOOR	7		0
LH REAR DOOR	7		0
LH RUNNING BOARD	7		0
LH QUARTER PANEL	6		0
FUEL LID	7		0
REAR WINDSHIELD	8		0
REAR BUMPER	7		0
TAIL LIGHT	6		0
TRUNK LID/TAIL GATE	6		0
LUGGAGE COMPARTMENT LIGHT	8		0
RH QUARTER PANEL	8		0
RH RUNNING BOARD	6		0
RH REAR DOOR	7		0
RH FRONT DOOR	6		0

INSPECTION CHECKPOINTS	SCORE(X/10)	REMARKS/COMMENTS	OPTIONAL SPEND EST. (RS)
RH FENDER	6		0
BODY RUST	8		0
PAINT CONDITION	7		0
FRONT WINDSHIELD	5	DAMAGED	4000
