ECO INSPECTION CERTIFICATE

Order ID : 31449

121 Points Vehicle Inspection Certificate

Fiat Linea EMOTION 1.3, 2009

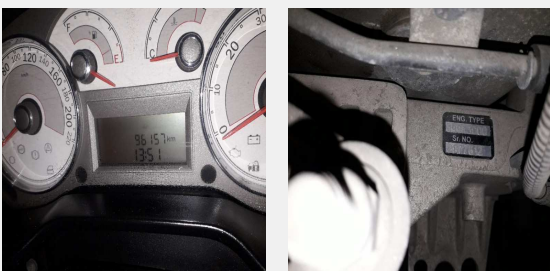
IMAGES

INSPECTION CHECKPOINTS	SCORE(X/10)	REMARKS/COMMENTS	OPTIONAL SPEND EST. (RS)
STEERING PERFORMANCE	6	GOOD	0
BRAKE PERFORMANCE	6	GOOD	0
CLUTCH PERFORMANCE	6	GOOD	0
IGNITION SYSTEM	6	GOOD	0
SUSPENSION FRONT SHOCKS	6	GOOD	0
SUSPENSION REAR SHOCKS	6	GOOD	0
TRANSMISSION ENGAGE	6	GOOD	0
CRUISE CONTROL (NO)	10		0
REAR PARKING SENSORS (NO)	10		0
REAR VIEW CAMERA (YES)	6	GOOD	0
ENGINE NOISE	5	MINOR NOISE	0
SUSPENSION PERFORMANCE	4	MINOR SOUND	6000

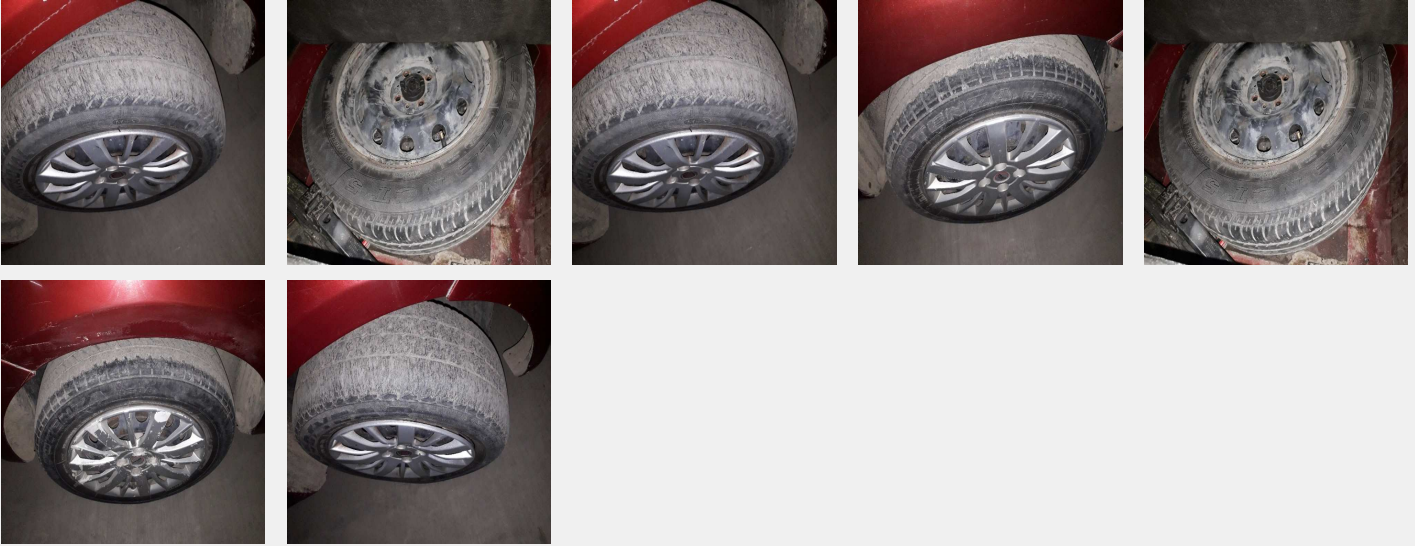
IMAGES

INSPECTION CHECKPOINTS	SCORE(X/10)	REMARKS/COMMENTS	OPTIONAL SPEND EST. (RS)
WHEEL ASSEMBLY (STEEL RIM)	6	GOOD	0
TYRES	3	BAD CONDITION	16000
SPARE TYRE (YES)	3	BAD CONDITION	4000

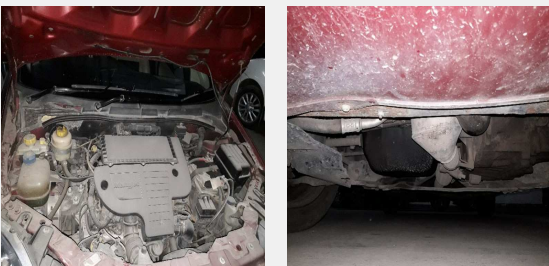
IMAGES

INSPECTION CHECKPOINTS	SCORE(X/10)	REMARKS/COMMENTS	OPTIONAL SPEND EST. (RS)
LH APRON	6	GOOD	0
RH APRON	6	GOOD	0
RADIATOR	6	GOOD	0
WIRING	6	GOOD	0
BATTERY	6	GOOD	0
BRAKE FLUID LEVEL	6	GOOD	0
BRAKE & COOLANT HOSE PIPES	6	GOOD	0
UNDERCARRIAGE	6	GOOD	0
ENGINE OIL	3	BAD	3000
COOLANT LEVEL	3	BAD	500
EXHAUST SYSTEM	5	MINOR BLACK SMOKE	5000

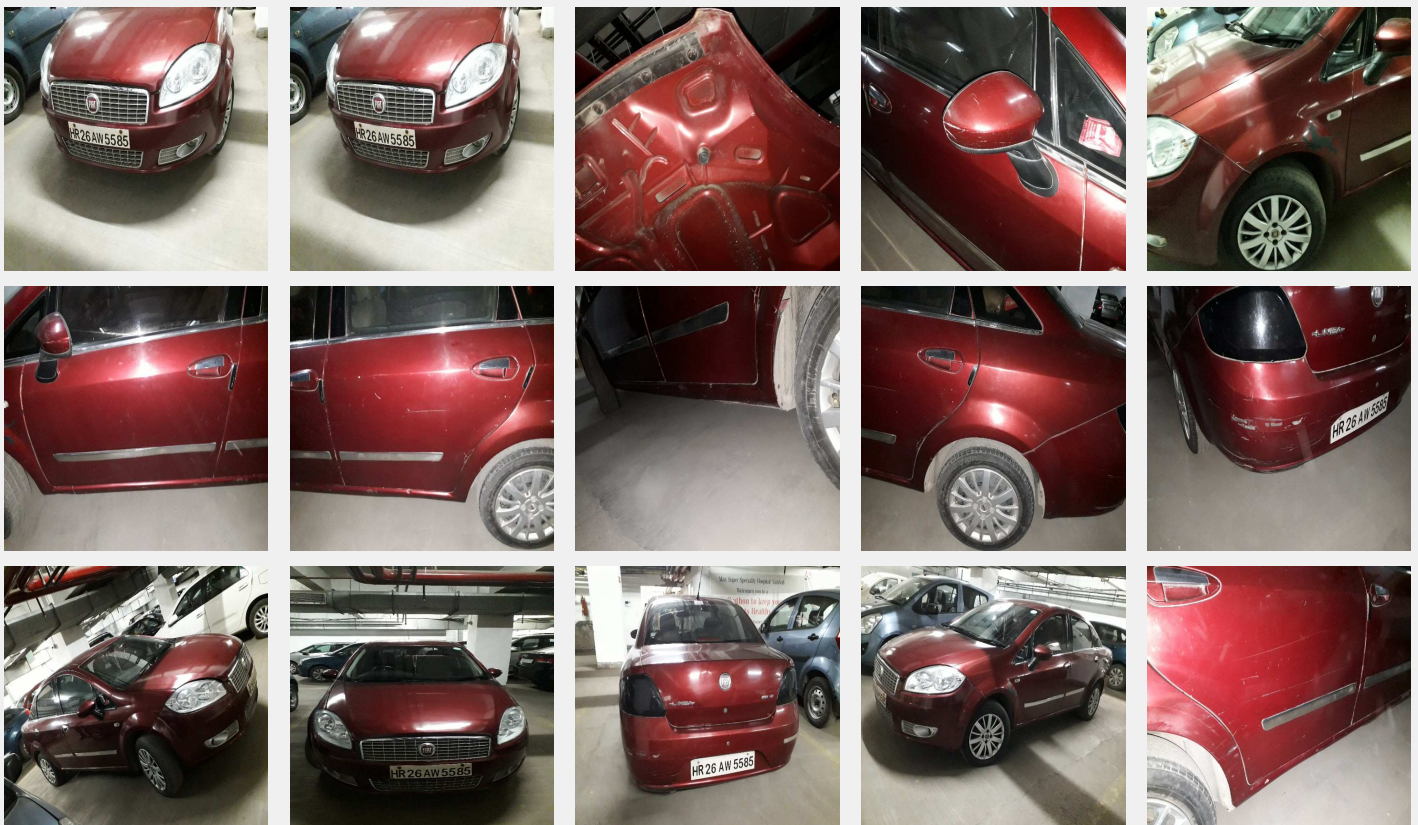
IMAGES

INSPECTION CHECKPOINTS	SCORE(X/10)	REMARKS/COMMENTS	OPTIONAL SPEND EST. (RS)
RH QUARTER PANEL	5	PAINTED	0
RH RUNNING BOARD	3	PAINTED AND DENT	3000
RH REAR DOOR	5	MINOR PAINTED AND SCRATCH	2500
RH FENDER	5	PAINTED	0
PAINT CONDITION	5	FULL CAR IS PAINTED WITHOUT ROOF	0

full car is painted without roof and dukey frant side accident tyres are bad suspension is bad
