# ECO INSPECTION CERTIFICATE

Order ID : 31636

121 Points Vehicle Inspection Certificate

## Maruti Suzuki Alto LXI CNG, 2011

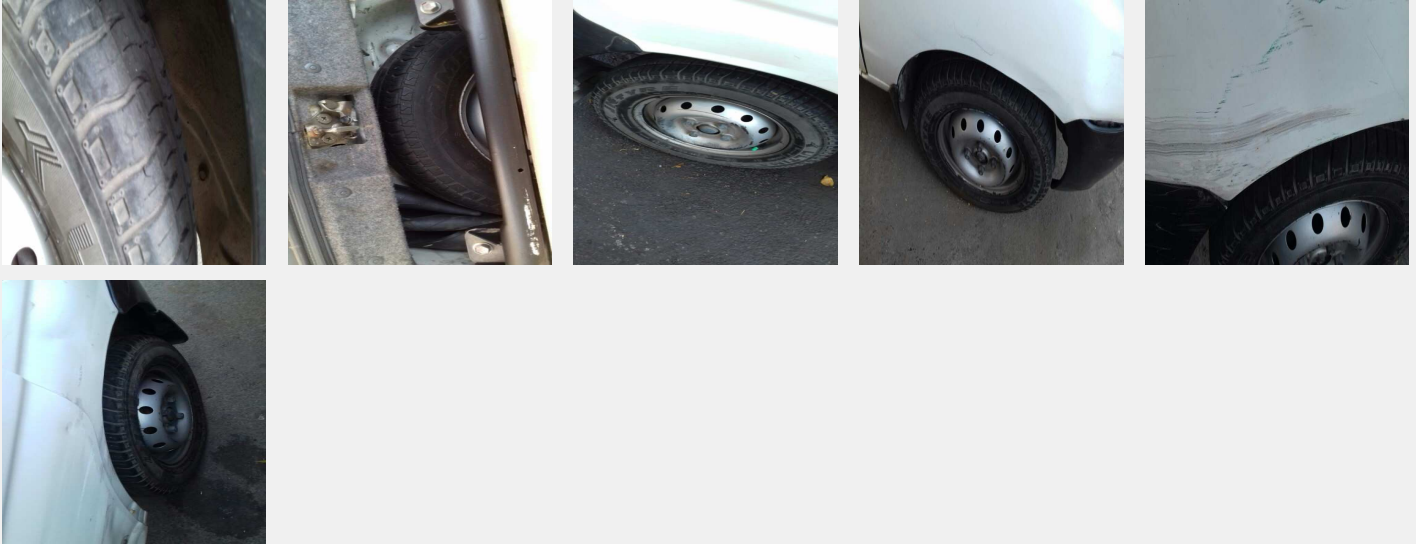
IMAGES

INSPECTION CHECKPOINTS	SCORE(X/10)	REMARKS/COMMENTS	OPTIONAL SPEND EST. (RS)
TYRES	6	GOOD	0
SPARE TYRE (YES)	7	GOOD	0
WHEEL ASSEMBLY (STEEL RIM)	6	GOOD	0

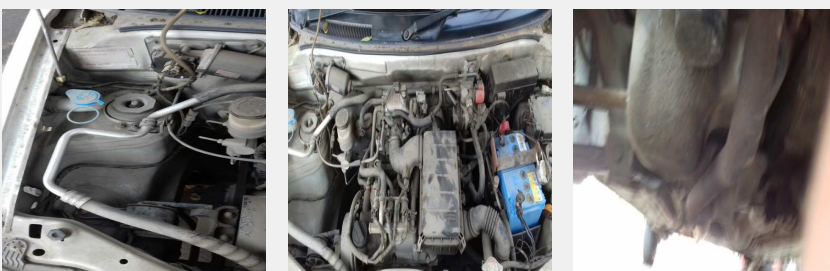
IMAGES

INSPECTION CHECKPOINTS	SCORE(X/10)	REMARKS/COMMENTS	OPTIONAL SPEND EST. (RS)
LH APRON	6	GOOD	0
RH APRON	6	GOOD	0
RADIATOR	6	GOOD	0
WIRING	6	GOOD	0
BATTERY	6	GOOD	0
BRAKE FLUID LEVEL	7	GOOD	0
ENGINE OIL	6	GOOD	0
COOLANT LEVEL	6	GOOD	0
BRAKE & COOLANT HOSE PIPES	7	GOOD	0
UNDERCARRIAGE	6	GOOD	0
EXHAUST SYSTEM	6	GOOD	0

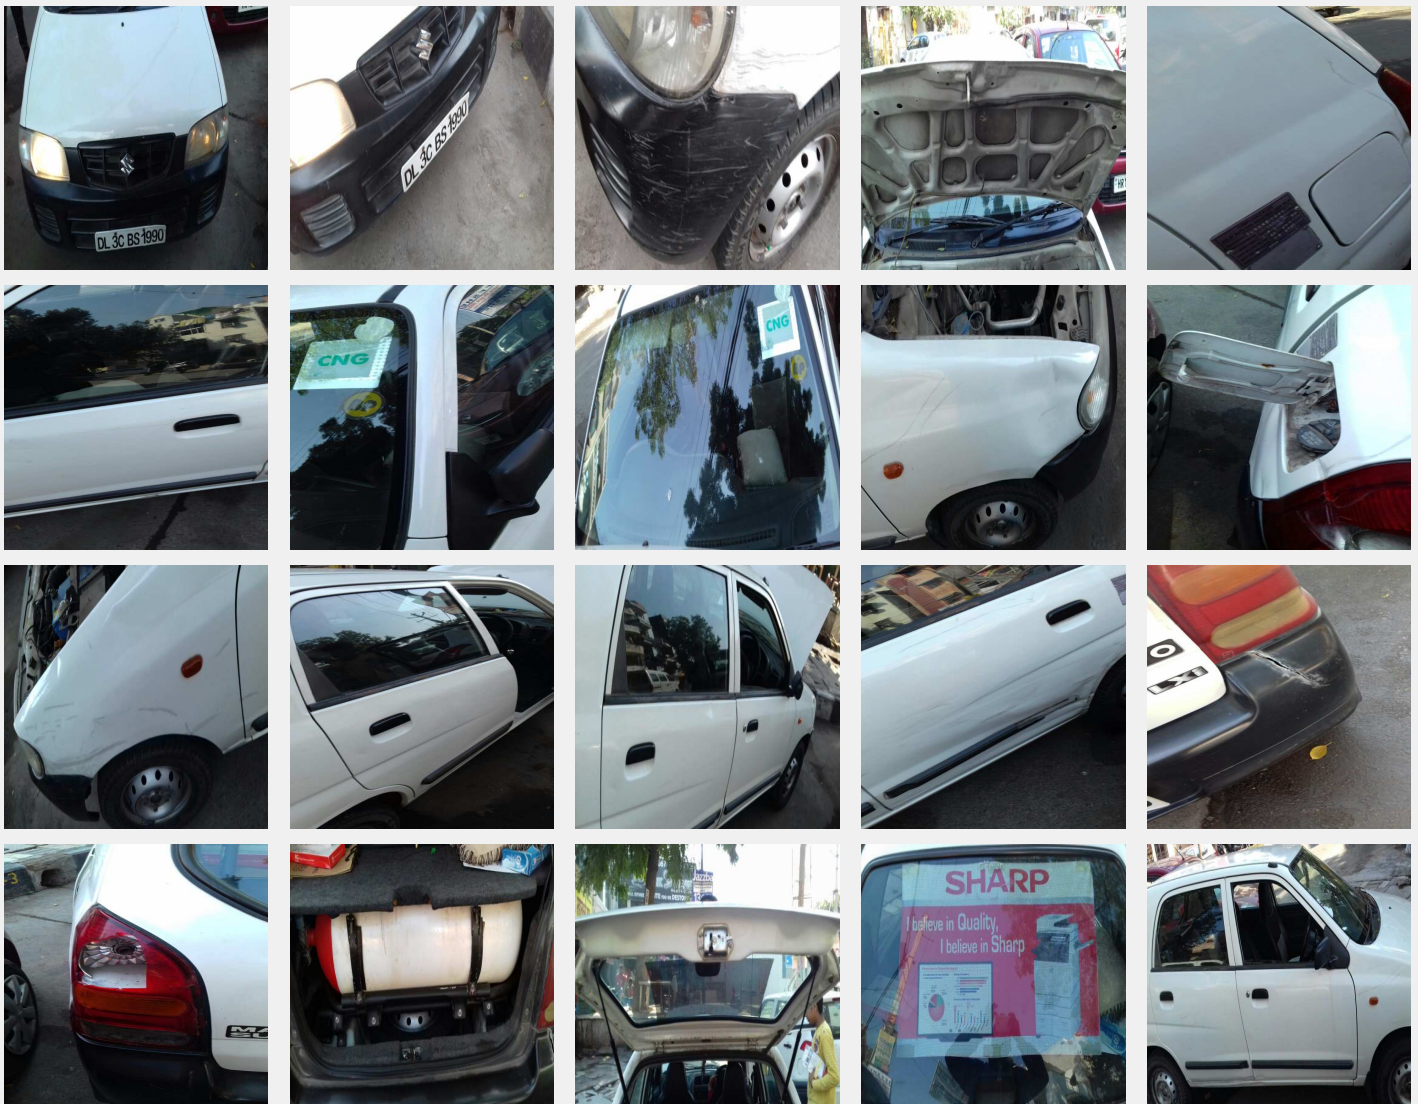
## IMAGES

INSPECTION CHECKPOINTS	SCORE(X/10)	REMARKS/COMMENTS	OPTIONAL SPEND EST. (RS)
LH REAR DOOR	0	DENT AND SCRATCHES	5000
LH QUARTER PANEL	3	SCRATCHES	2000
REAR BUMPER	0	BROKEN NEED TO CHANGE	5000
TAIL LIGHT	0	BROKEN NEED TO CHANGE	2000
PAINT CONDITION	3	ALL BODY SCRATCHES NEED TO PAINT	7000

all body dented need to repair tail light broken L.S. rear bumper need to change all body scratch
