ECO INSPECTION CERTIFICATE

Order ID : 31697

121 Points Vehicle Inspection Certificate

Maruti Suzuki Swift VDI, 2012

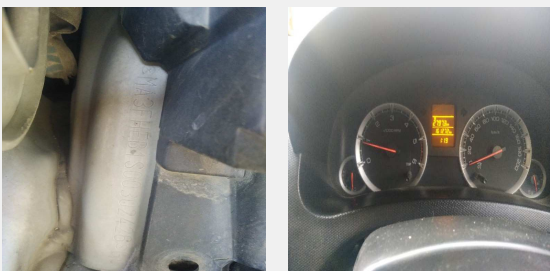
IMAGES

INSPECTION CHECKPOINTS	SCORE(X/10)	REMARKS/COMMENTS	OPTIONAL SPEND EST. (RS)
STEERING PERFORMANCE	10		0
BRAKE PERFORMANCE	10		0
CLUTCH PERFORMANCE	10		0
ENGINE NOISE	10		0
IGNITION SYSTEM	10		0
SUSPENSION PERFORMANCE	10		0
SUSPENSION FRONT SHOCKS	10		0
SUSPENSION REAR SHOCKS	10		0
TRANSMISSION ENGAGE	10		0
CRUISE CONTROL (NO)	10		0
REAR PARKING SENSORS (NO)	10		0
REAR VIEW CAMERA (NO)	10		0

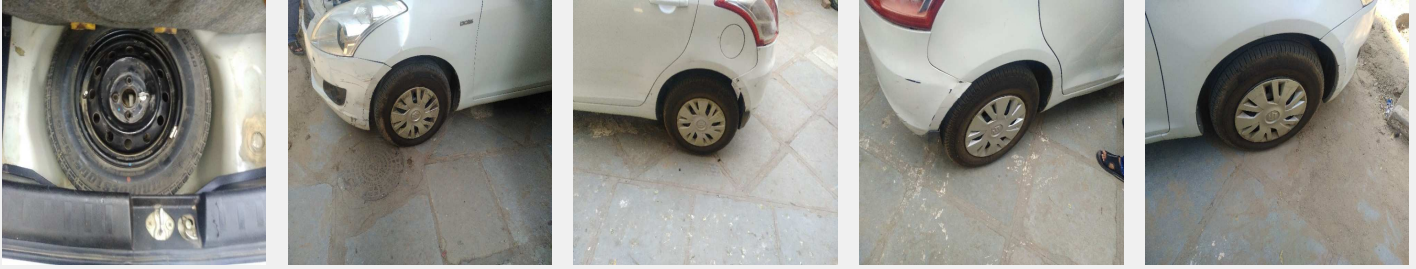
IMAGES

INSPECTION CHECKPOINTS	SCORE(X/10)	REMARKS/COMMENTS	OPTIONAL SPEND EST. (RS)
TYRES	10	BRAND NEW TIRES	0
SPARE TYRE (YES)	10		0
WHEEL ASSEMBLY (STEEL RIM)	10		0

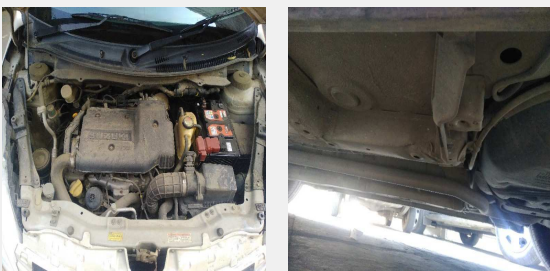
IMAGES

INSPECTION CHECKPOINTS	SCORE(X/10)	REMARKS/COMMENTS	OPTIONAL SPEND EST. (RS)
LH APRON	10		0
RH APRON	10		0
RADIATOR	10		0
WIRING	10		0
BATTERY	10	NEW BATTERY DATE OF INSTALLATION 31/07/2018	0
BRAKE FLUID LEVEL	10		0
ENGINE OIL	10		0
COOLANT LEVEL	10		0
BRAKE & COOLANT HOSE PIPES	10		0
UNDERCARRIAGE	10		0
EXHAUST SYSTEM	10		0

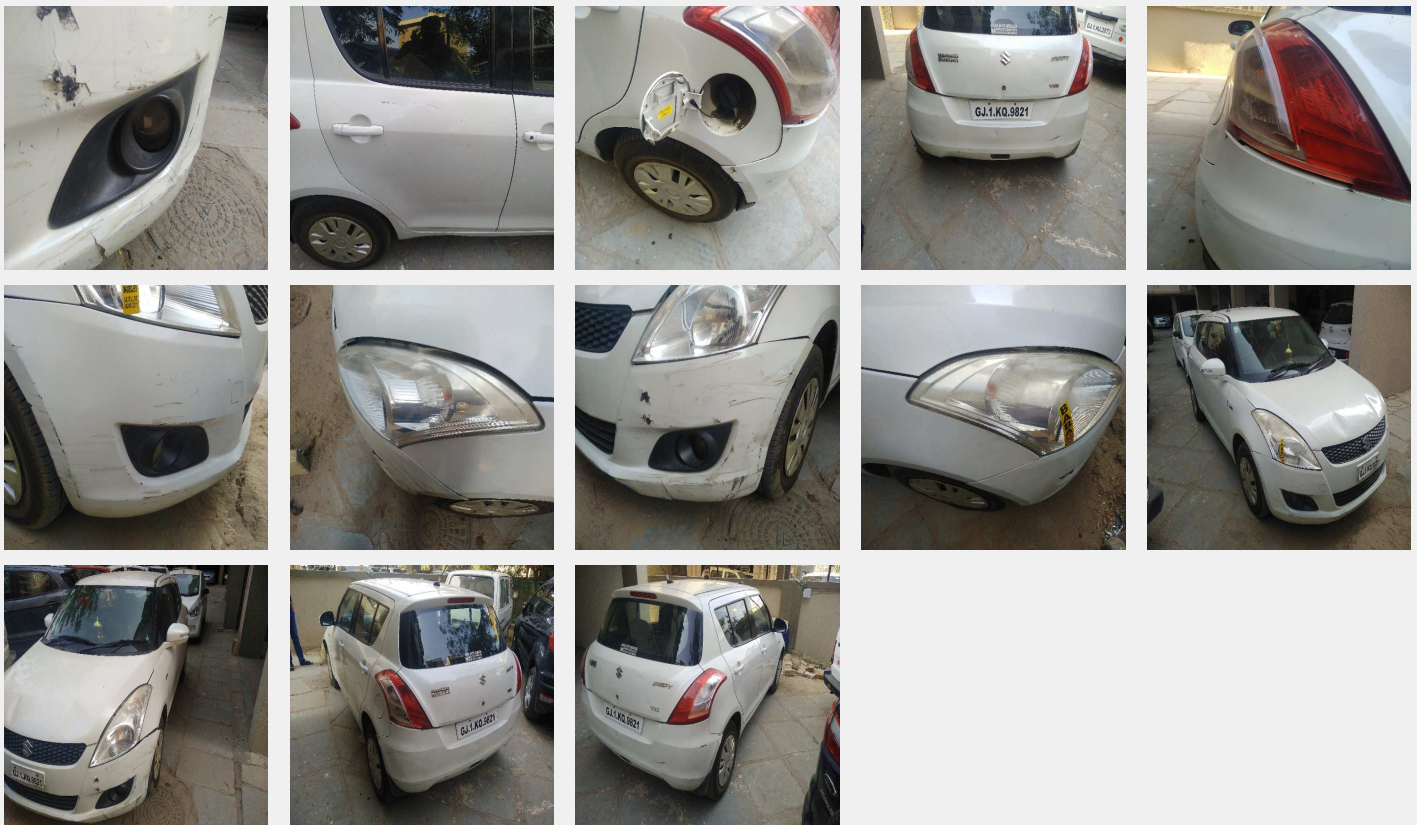
IMAGES

INSPECTION CHECKPOINTS	SCORE(X/10)	REMARKS/COMMENTS	OPTIONAL SPEND EST. (RS)
LICENSE PLATE	10		0
GRILLE	10		0
TURN SIGNAL	10		0
HOOD	7		0
PILLAR	10		0
FRONT WINDSHIELD	10		0
SIDE VIEW MIRRORS	10		0
LH FENDER	7		0
LH FRONT DOOR	7	NEEDS HAMMARY	500
LH REAR DOOR	7	NEEDS REPAIR AND PAINT	1500
LH RUNNING BOARD	10		0
LH QUARTER PANEL	10		0
FUEL LID	10		0
REAR WINDSHIELD	10		0
TRUNK LID/TAIL GATE	10		0
LUGGAGE COMPARTMENT LIGHT	10	DOES NOT EXIST	0
RH QUARTER PANEL	10		0
RH RUNNING BOARD	10		0
RH FRONT DOOR	10		0
RH FENDER	10		0
BODY RUST	10		0
ROOF (REGULAR)	10		0
PAINT CONDITION	10		0
FRONT BUMPER	3	BUMPER REPAIR AND PAINT REQUIRED	2500

INSPECTION CHECKPOINTS	SCORE(X/10)	REMARKS/COMMENTS	OPTIONAL SPEND EST. (RS)
HEAD LIGHTS	5	HEADLIGHT NEEDS TO BE REPLACED	5200
FOG LAMPS	5	NEEDS PROPER FITTING	100
REAR BUMPER	5	NEEDS REPAIR AND PAINT	1500
TAIL LIGHT	0	LH TAILLIGHT BROKEN	1750
RH REAR DOOR	5	NEEDS PAINT	1500
