ECO INSPECTION CERTIFICATE

Order ID : 32086

121 Points Vehicle Inspection Certificate

Audi A6 2.0 TDI Premium Plus, 2012

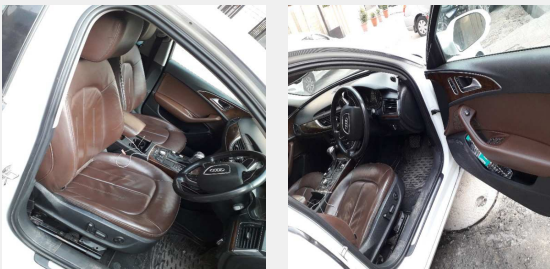
IMAGES

INSPECTION CHECKPOINTS	SCORE(X/10)	REMARKS/COMMENTS	OPTIONAL SPEND EST. (RS)
DOOR PANEL	6	GOOD	0
DOOR HINGES	6	GOOD	0
CARPET & FLOOR MAT	6	GOOD	0
SEAT & SEAT BELT	6	GOOD	0
DASHBOARD & INSTRUMENT PANEL	6	GOOD	0
HORN	6	GOOD	0
SPEAKERS & MUSIC SYSTEM	6	GOOD	0
HANDBRAKE	6	GOOD	0
STEERING-MOUNTED CONTROLS	6	GOOD	0
PEDALS	6	GOOD	0
CENTRAL LOCK	6	GOOD	0
A/C VENTS & HEATER	6	GOOD	0
CUP HOLDERS	6	GOOD	0
NAVIGATION (YES)	7	GOOD	0
ODOMETER	6	GOOD	0
POWER WINDOWS (YES)	6	GOOD	0
HAZARD LIGHT	6	GOOD	0

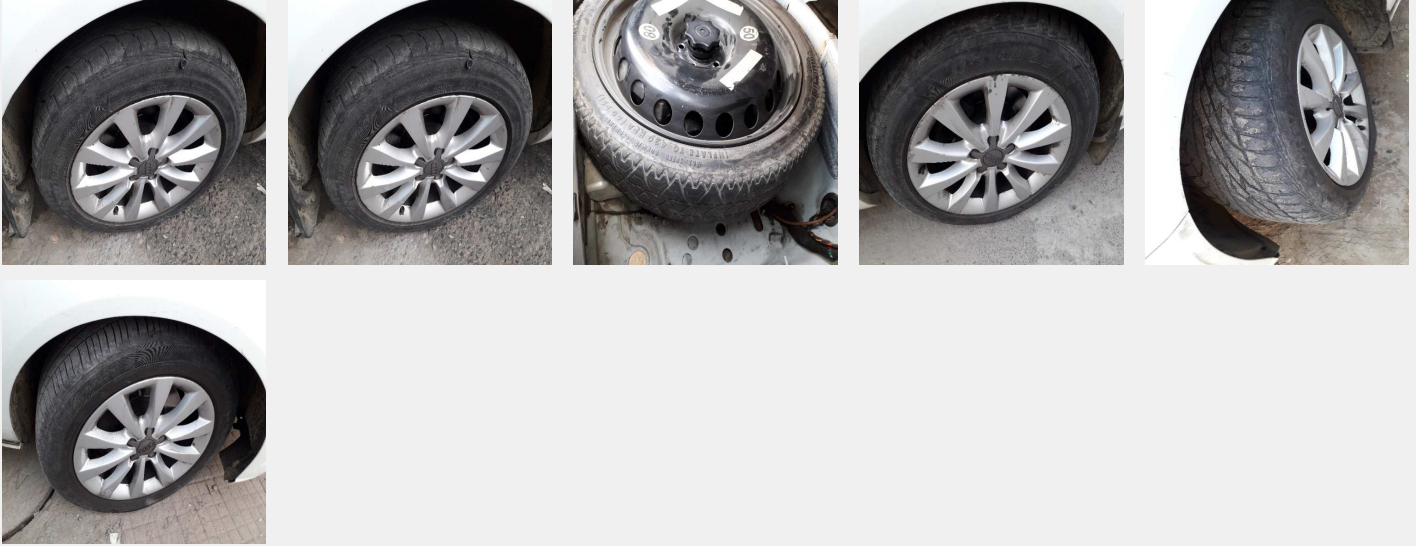
IMAGES

INSPECTION CHECKPOINTS	SCORE(X/10)	REMARKS/COMMENTS	OPTIONAL SPEND EST. (RS)
SPARE TYRE (YES)	6	GOOD	0
WHEEL ASSEMBLY (ALLOY RIM)	7	GOOD	0
TYRES	5	GOOD	0

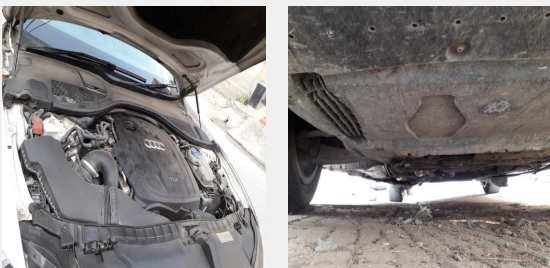
IMAGES

INSPECTION CHECKPOINTS	SCORE(X/10)	REMARKS/COMMENTS	OPTIONAL SPEND EST. (RS)
LH APRON	6	GOOD	0
RH APRON	6	GOOD	0
RADIATOR	6	GOOD	0
WIRING	6	GOOD	0
BATTERY	6	GOOD	0
BRAKE FLUID LEVEL	6	GOOD	0
COOLANT LEVEL	6	GOOD	0
BRAKE & COOLANT HOSE PIPES	6	GOOD	0
UNDERCARRIAGE	6	GOOD	0
EXHAUST SYSTEM	6	GOOD	0
ENGINE OIL	5	AVERAGE CONDITION	0

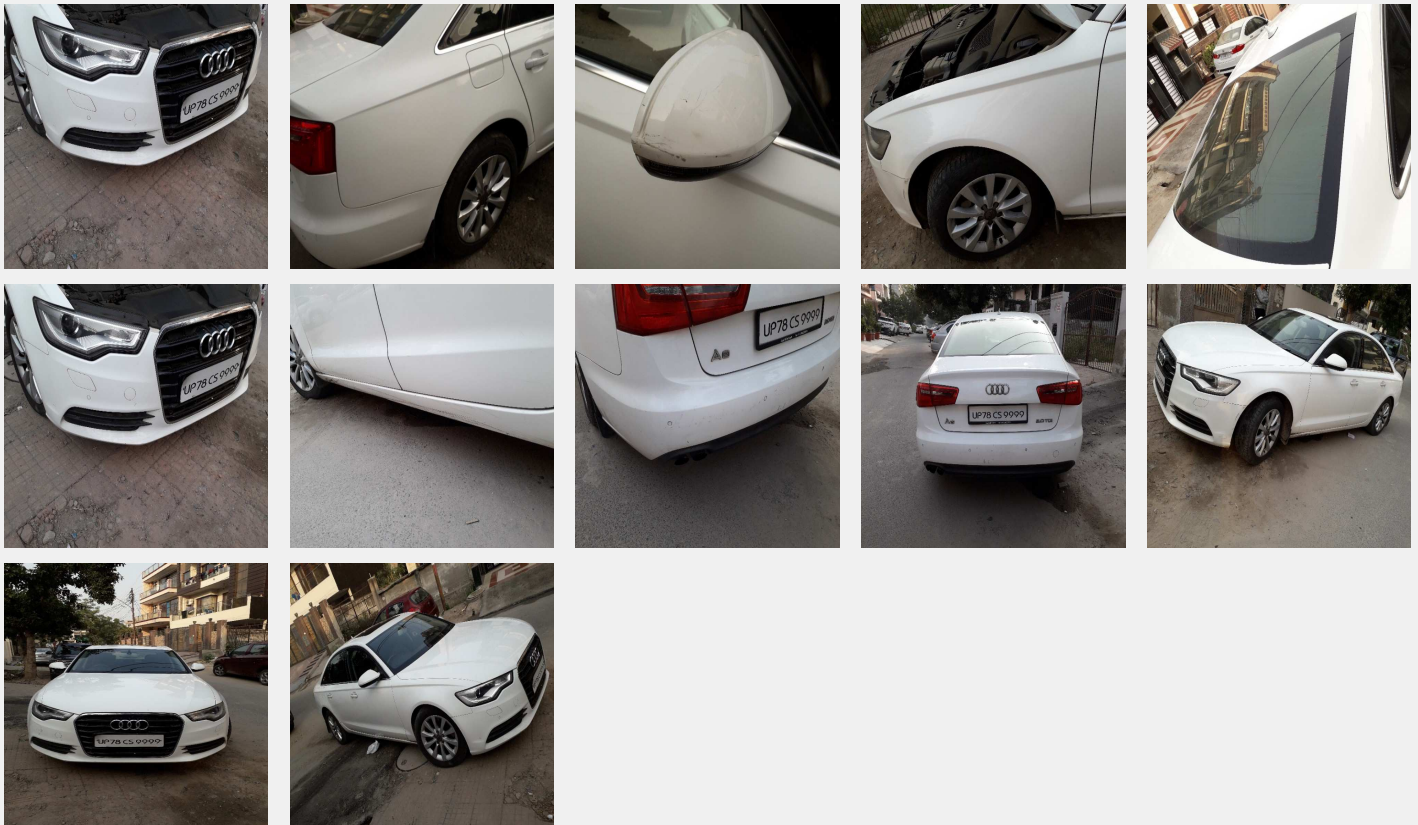
IMAGES

INSPECTION CHECKPOINTS	SCORE(X/10)	REMARKS/COMMENTS	OPTIONAL SPEND EST. (RS)
LICENSE PLATE	6	GOOD	0
HEAD LIGHTS	6	GOOD	0
GRILLE	6	GOOD	0
TURN SIGNAL	6	GOOD	0
HOOD	6	GOOD	0
PILLAR	6	GOOD	0
FRONT WINDSHIELD	6	GOOD	0
LH FRONT DOOR	6	MINOR PAINTED	0
LH REAR DOOR	6	MINOR PAINTED	0
LH QUARTER PANEL	6	MINOR PAINTED	0
FUEL LID	6	GOOD	0
TAIL LIGHT	6	GOOD	0
TRUNK LID/TAIL GATE	6	GOOD	0
LUGGAGE COMPARTMENT LIGHT	7	GOOD	0
RH RUNNING BOARD	6	GOOD	0
RH REAR DOOR	6	GOOD	0
RH FRONT DOOR	6	GOOD	0
RH FENDER	6	GOOD	0
BODY RUST	6	GOOD	0
ROOF (SUN ROOF)	6	GOOD	0
PAINT CONDITION	6	GOOD	0
FRONT BUMPER	5	PAINTED	0
FOG LAMPS	0	NO	0
SIDE VIEW MIRRORS	5	SCRATCH	1500

INSPECTION CHECKPOINTS	SCORE(X/10)	REMARKS/COMMENTS	OPTIONAL SPEND EST. (RS)
LH FENDER	5	PAINTED	0
LH RUNNING BOARD	5	PAINTED AND SCRATCH	3000
REAR WINDSHIELD	5	ALREADY CHANGED	0
REAR BUMPER	5	PAINTED	0
RH QUARTER PANEL	5	PAINTED	0
