ECO INSPECTION CERTIFICATE

Order ID : 32429

121 Points Vehicle Inspection Certificate

Fiat Linea 1.3 MULTIJET DYNAMIC, 2010

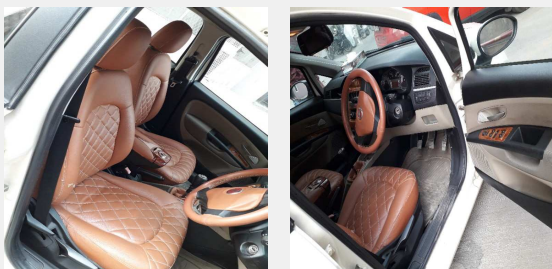
IMAGES

INSPECTION CHECKPOINTS	SCORE(X/10)	REMARKS/COMMENTS	OPTIONAL SPEND EST. (RS)
DOOR PANEL	6	GOOD	0
DOOR HINGES	6	GOOD	0
CARPET & FLOOR MAT	6	GOOD	0
SEAT & SEAT BELT	6	GOOD	0
DASHBOARD & INSTRUMENT PANEL	6	GOOD	0
HORN	6	GOOD	0
SPEAKERS & MUSIC SYSTEM	6	GOOD	0
HANDBRAKE	6	GOOD	0
STEERING-MOUNTED CONTROLS	6	GOOD	0
PEDALS	6	GOOD	0
CENTRAL LOCK	6	GOOD	0
A/C VENTS & HEATER	6	GOOD	0
CUP HOLDERS	6	GOOD	0
NAVIGATION (NO)	10		0
ODOMETER	6	GOOD	0
POWER WINDOWS (YES)	6	GOOD	0
HAZARD LIGHT	6	GOOD	0

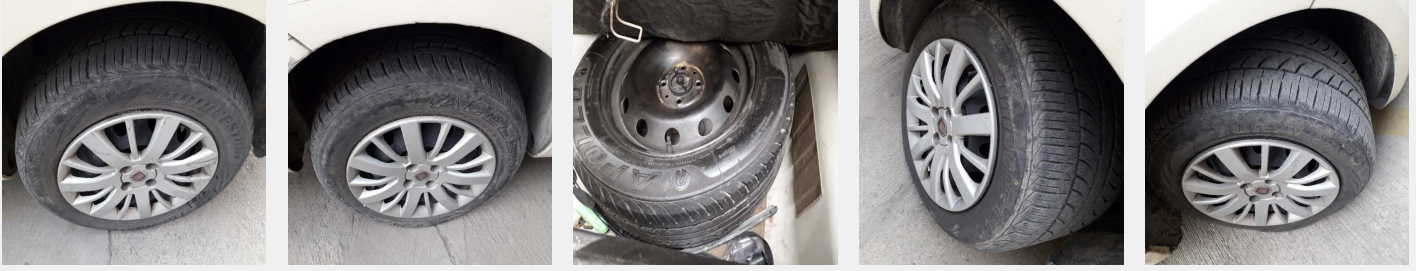
IMAGES

INSPECTION CHECKPOINTS	SCORE(X/10)	REMARKS/COMMENTS	OPTIONAL SPEND EST. (RS)
TYRES	7	GOOD	0
SPARE TYRE (YES)	6	GOOD	0
WHEEL ASSEMBLY (STEEL RIM)	6	GOOD	0

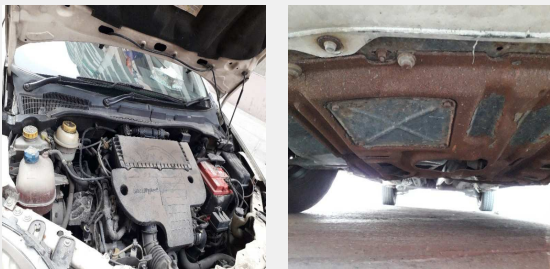
IMAGES

INSPECTION CHECKPOINTS	SCORE(X/10)	REMARKS/COMMENTS	OPTIONAL SPEND EST. (RS)
LH APRON	6	GOOD	0
RH APRON	6	GOOD	0
RADIATOR	6	GOOD	0
WIRING	6	GOOD	0
BATTERY	6	GOOD	0
BRAKE FLUID LEVEL	6	GOOD	0
BRAKE & COOLANT HOSE PIPES	6	GOOD	0
UNDERCARRIAGE	6	GOOD	0
EXHAUST SYSTEM	6	GOOD	0
ENGINE OIL	3	BAD	2500
COOLANT LEVEL	4	BAD	750

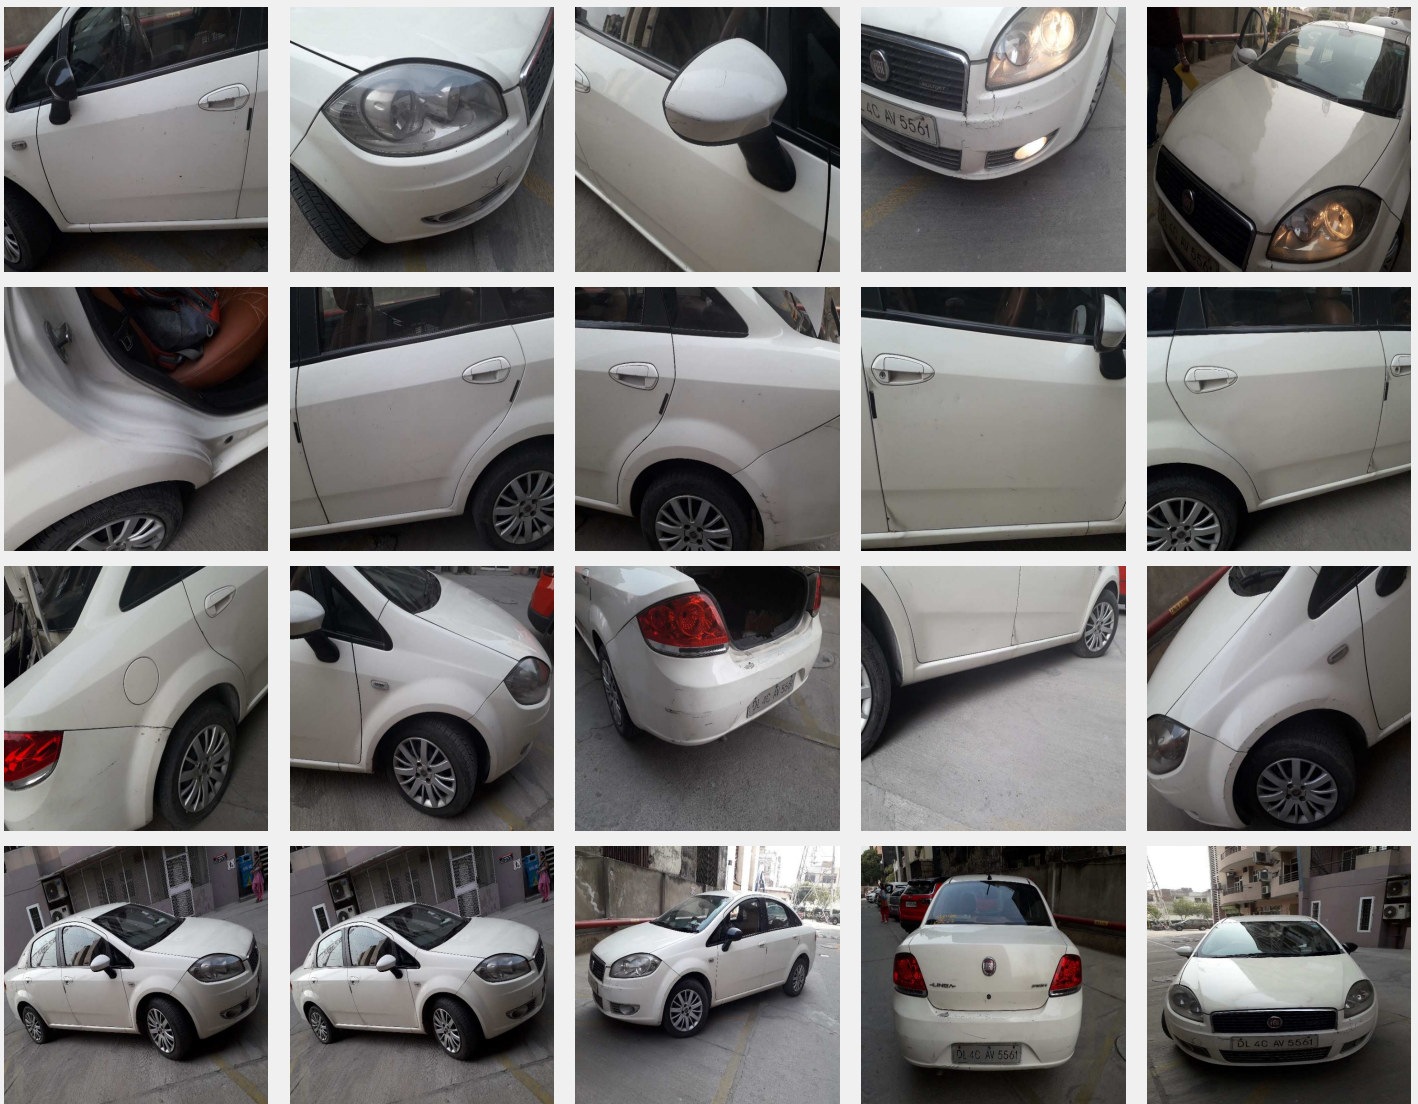
IMAGES

INSPECTION CHECKPOINTS	SCORE(X/10)	REMARKS/COMMENTS	OPTIONAL SPEND EST. (RS)
LICENSE PLATE	6	GOOD	0
GRILLE	6	GOOD	0
TURN SIGNAL	6	GOOD	0
FOG LAMPS	6	GOOD	0
FRONT WINDSHIELD	6	GOOD	0
LH RUNNING BOARD	6	MINOR PAINTED	0
FUEL LID	6	GOOD	0
REAR WINDSHIELD	6	GOOD	0
TAIL LIGHT	6	GOOD	0
TRUNK LID/TAIL GATE	6	GOOD	0
LUGGAGE COMPARTMENT LIGHT	6	GOOD	0
BODY RUST	6	GOOD	0
ROOF (REGULAR)	6	GOOD	0
FRONT BUMPER	5	PAINTED AND SCRATCH	3000
HEAD LIGHTS	3	RIGHT SIDE HED LIGHT IS BAD CONDITION	1800
HOOD	5	PAINTED	0
PILLAR	5	RIGHT QUTAR PAINAL ACCIDENT	0
SIDE VIEW MIRRORS	5	PAINTED AND SCRATCH	1000
LH FENDER	5	PAINTED AND MINOR SCRATCH	0
LH FRONT DOOR	5	PAINTED	0
LH REAR DOOR	5	PAINTED	0
LH QUARTER PANEL	5	PAINTED	0
REAR BUMPER	5	PAINTED AND SCRATCH	3000
BH QUARTER PANEL	5	PAINTED	0

INSPECTION CHECKPOINTS	SCORE(X/10)	REMARKS/COMMENTS	OPTIONAL SPEND EST. (RS)
RH RUNNING BOARD	5	PAINTED	0
RH REAR DOOR	5	PAINTED	0
RH FRONT DOOR	5	DENT	2500
RH FENDER	5	PAINTED	0
PAINT CONDITION	5	PAINTED	0

car is average condition need to be service car is 80% painted
