# ECO INSPECTION CERTIFICATE

Order ID : 32619

121 Points Vehicle Inspection Certificate

## Nissan Micra XV PREMIUM DIESEL, 2012

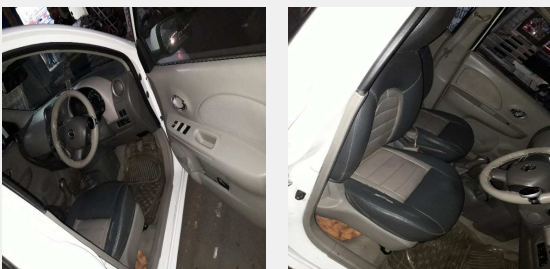
## IMAGES

INSPECTION CHECKPOINTS	SCORE(X/10)	REMARKS/COMMENTS	OPTIONAL SPEND EST. (RS)
DOOR HINGES	6	GOOD	0
DASHBOARD & INSTRUMENT PANEL	6	GOOD	0
HORN	6	GOOD	0
SPEAKERS & MUSIC SYSTEM	6	GOOD	0
HANDBRAKE	6	GOOD	0
STEERING-MOUNTED CONTROLS	6	GOOD	0
PEDALS	6	GOOD	0
CENTRAL LOCK	6	GOOD	0
A/C VENTS & HEATER	6	GOOD	0
CUP HOLDERS	6	GOOD	0
NAVIGATION (NO)	10		0
ODOMETER	6	GOOD	0
POWER WINDOWS (YES)	6	GOOD	0
HAZARD LIGHT	6	GOOD	0
DOOR PANEL	5	NEED DRYCLINIG	2000
CARPET & FLOOR MAT	5	NEED DRYCLINIG	0
SEAT & SEAT BELT	4	BAD CONDITION	5000

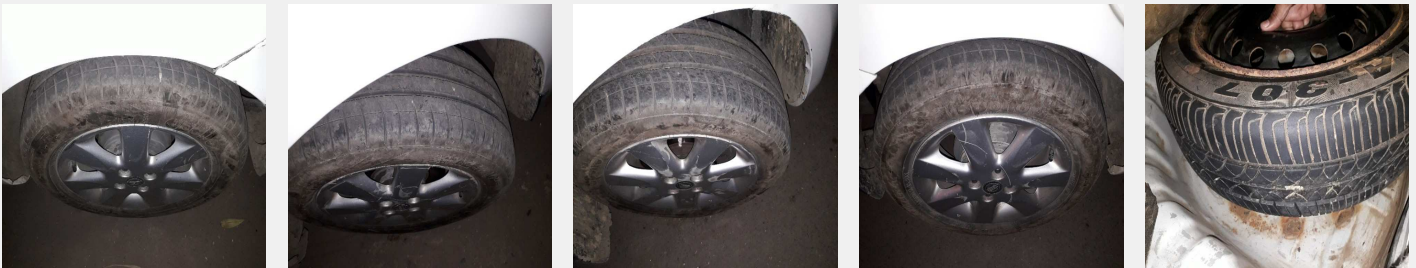
## IMAGES

INSPECTION CHECKPOINTS	SCORE(X/10)	REMARKS/COMMENTS	OPTIONAL SPEND EST. (RS)
TYRES	7	GOOD	0
SPARE TYRE (YES)	6	MINOR HARD	0
WHEEL ASSEMBLY (ALLOY RIM)	6	GOOD	0

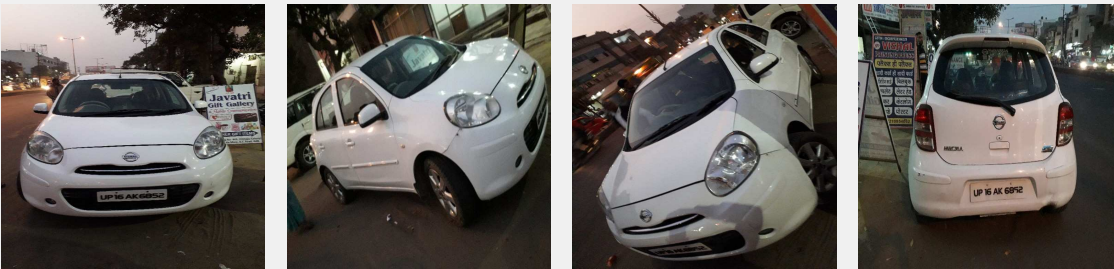
IMAGES

INSPECTION CHECKPOINTS	SCORE(X/10)	REMARKS/COMMENTS	OPTIONAL SPEND EST. (RS)
LICENSE PLATE	6	GOOD	0
HEAD LIGHTS	6	GOOD	0
GRILLE	6	GOOD	0
TURN SIGNAL	6	GOOD	0
FOG LAMPS	6	GOOD	0
HOOD	6	GOOD	0
PILLAR	6	GOOD	0
LH FRONT DOOR	6	MINOR PAINTED	0
LH REAR DOOR	6	MINOR PAINTED	0
FUEL LID	6	GOOD	0
REAR WINDSHIELD	6	GOOD	0
TAIL LIGHT	6	GOOD	0
TRUNK LID/TAIL GATE	6	GOOD	0
LUGGAGE COMPARTMENT LIGHT	6	GOOD	0
RH REAR DOOR	6	MINOR PAINTED	0
RH FRONT DOOR	6	MINOR PAINTED	0
BODY RUST	6	GOOD	0
ROOF (REGULAR)	6	GOOD	0
FRONT BUMPER	5	PAINTED AND MINOR SCRATCH	0
FRONT WINDSHIELD	5	ALREADY CHANGED	0
SIDE VIEW MIRRORS	5	PAINTED AND SCRATCH	1000
LH FENDER	5	PAINTED	0
LH RUNNING BOARD	5	PAINTED AND DENT	3000
LH QUARTER PANEL	5	PAINTED	0

INSPECTION CHECKPOINTS	SCORE(X/10)	REMARKS/COMMENTS	OPTIONAL SPEND EST. (RS)
REAR BUMPER	5	PAINTED AND SCRATCH	1000
RH QUARTER PANEL	5	PAINTED	0
RH RUNNING BOARD	5	PAINTED	0
RH FENDER	5	PAINTED	0
PAINT CONDITION	5	40% PAINTED	0
