ECO INSPECTION CERTIFICATE

Order ID : 32715

121 Points Vehicle Inspection Certificate

Ford Endeavour 3.0L THUNDER PLUS 4X4, 2009

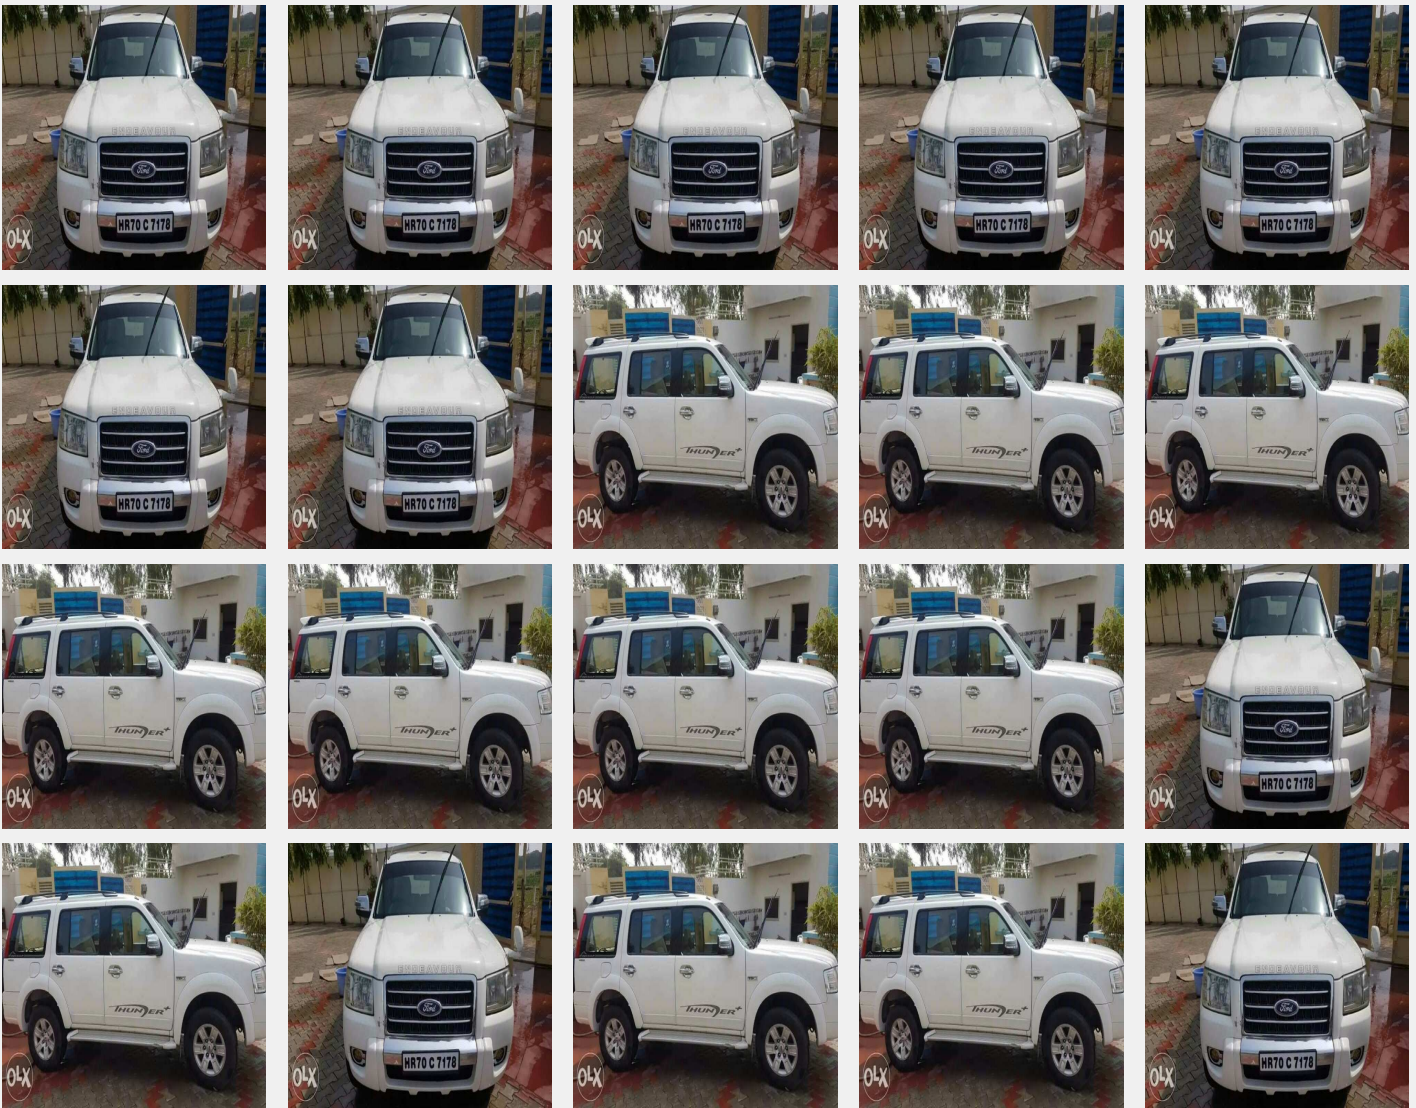
INSPECTION CHECKPOINTS	SCORE(X/10)	REMARKS/COMMENTS	OPTIONAL SPEND EST. (RS)
LH QUARTER PANEL	4	REFUSED	5000
REAR WINDSHIELD	4	REFUSED	6000
REAR BUMPER	4	REFUSED BCZ DAMAGES	6000
TAIL LIGHT	4	REFUSED BCZ DAMAGES	2500
TRUNK LID/TAIL GATE	4	REFUSED BCZ DAMAGES	4000

NEED ATTENTION
