# ECO INSPECTION CERTIFICATE

121 Points Vehicle Inspection Certificate

## Ford Endeavour TITANIUM 3.2 4X4 AT, 2018

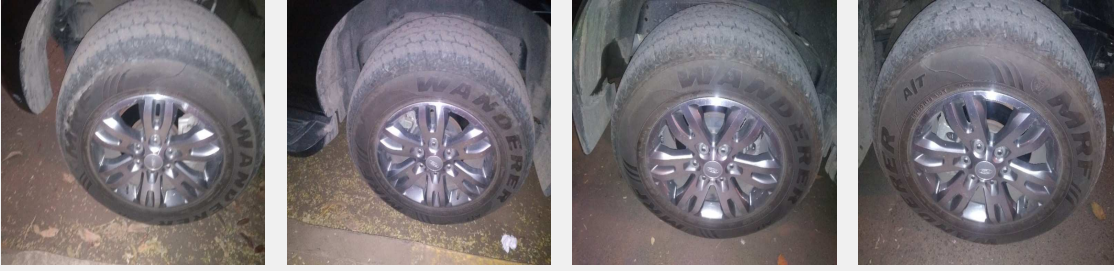
IMAGES

| INSPECTION CHECKPOINTS | SCORE(X/10) | REMARKS/COMMENTS | OPTIONAL SPEND EST. (RS) |
|---|---|---|---|
| TYRES | 10 | OK | 0 |
| SPARE TYRE (YES) | 10 | OK | 0 |
| WHEEL ASSEMBLY (STEEL RIM) | 10 | OK | 0 |

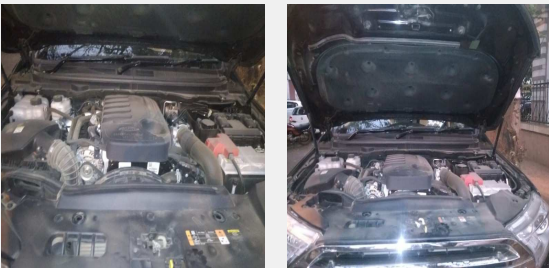
IMAGES

| INSPECTION CHECKPOINTS | SCORE(X/10) | REMARKS/COMMENTS | OPTIONAL SPEND EST. (RS) |
|---|---|---|---|
| LH APRON | 10 | OK | 0 |
| UNDERCARRIAGE | 10 | OK | 0 |
| EXHAUST SYSTEM | 10 | OK | 0 |
