ECO INSPECTION CERTIFICATE

Order ID : 33171

121 Points Vehicle Inspection Certificate

Nissan Terrano XV D THP 110 PS, 2013

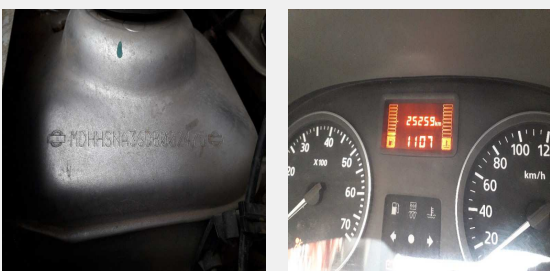
IMAGES

INSPECTION CHECKPOINTS	SCORE(X/10)	REMARKS/COMMENTS	OPTIONAL SPEND EST. (RS)
STEERING PERFORMANCE	7	GOOD	0
BRAKE PERFORMANCE	7	GOOD	0
CLUTCH PERFORMANCE	7	GOOD	0
ENGINE NOISE	7	GOOD	0
IGNITION SYSTEM	7	GOOD	0
SUSPENSION PERFORMANCE	7	GOOD	0
SUSPENSION FRONT SHOCKS	7	GOOD	0
SUSPENSION REAR SHOCKS	7	GOOD	0
TRANSMISSION ENGAGE	7	GOOD	0
CRUISE CONTROL (NO)	10		0
REAR PARKING SENSORS (YES)	7	GOOD	0
REAR VIEW CAMERA (YES)	7	GOOD	0

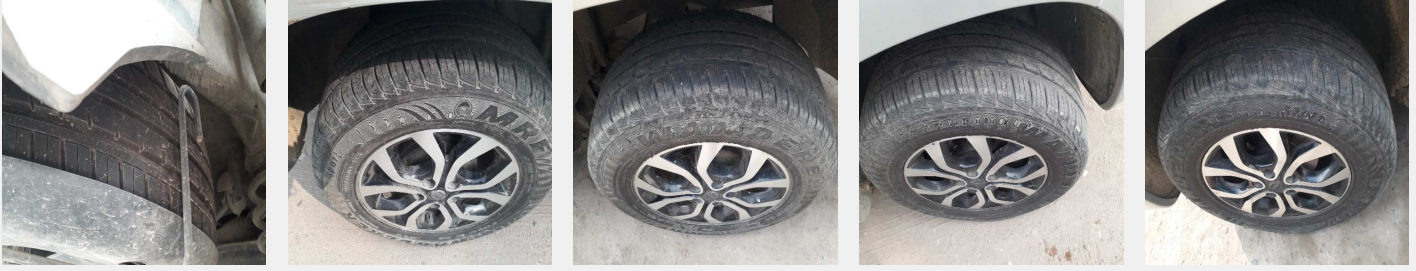
IMAGES

INSPECTION CHECKPOINTS	SCORE(X/10)	REMARKS/COMMENTS	OPTIONAL SPEND EST. (RS)
TYRES	6	GOOD	0
SPARE TYRE (YES)	8	GOOD	0
WHEEL ASSEMBLY (ALLOY RIM)	7	GOOD	0

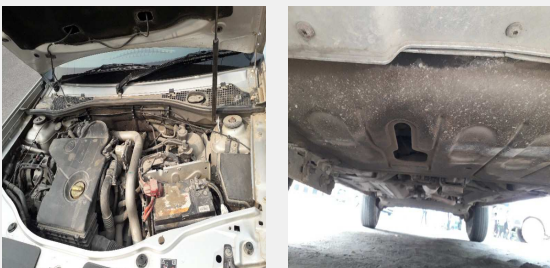
IMAGES

INSPECTION CHECKPOINTS	SCORE(X/10)	REMARKS/COMMENTS	OPTIONAL SPEND EST. (RS)
LH APRON	7	GOOD	0
RH APRON	7	GOOD	0
RADIATOR	6	GOOD	0
WIRING	7	GOOD	0
BATTERY	6	GOOD	0
BRAKE FLUID LEVEL	7	GOOD	0
ENGINE OIL	6	GOOD	0
COOLANT LEVEL	6	GOOD	0
BRAKE & COOLANT HOSE PIPES	7	GOOD	0
UNDERCARRIAGE	7	GOOD	0
EXHAUST SYSTEM	7	GOOD	0

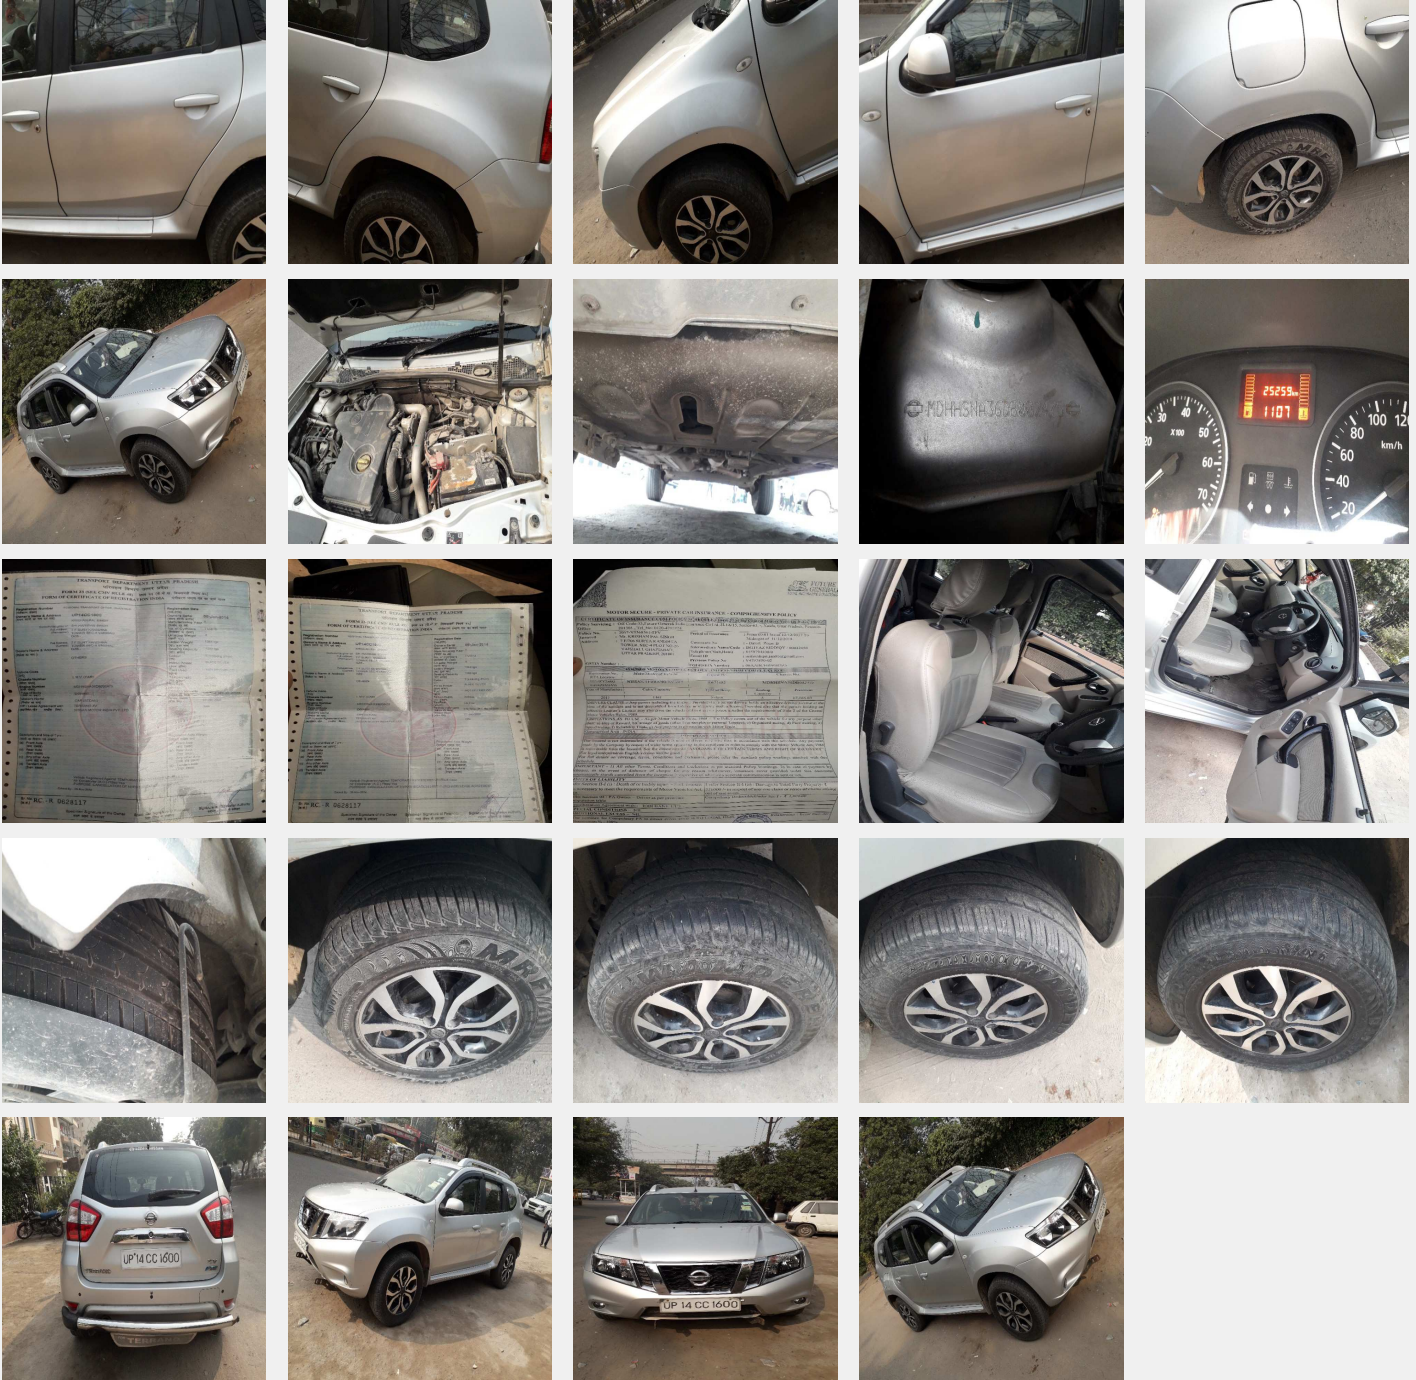
IMAGES

car is better canditon left side both full painted
