# ECO INSPECTION CERTIFICATE

121 Points Vehicle Inspection Certificate

## Tata Tiago REVOTORQ XZ, 2017

VEHICLE INFORMATION			
MAKE	TATA	TRANSMISSION TYPE	MANUAL
MODEL	TIAGO	REGISTRATION NO.	WB24AM3276
YEAR	2017	VIN/CHASIS NUMBER	NA
TRIM	REVOTORQ XZ	KMS RUN	20506
COLOR	OTHER	INSURANCE EXPIRY	2018-12-6
BODY TYPE	SEDAN	LOCATION	SODEPUR
FUEL TYPE	PETROL	ENGINE SOUND LINK	NIL

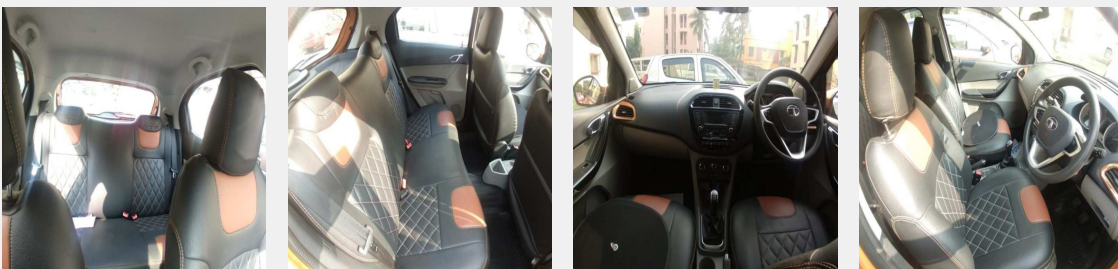
INSPECTION CHECKPOINTS	SCORE(X/10)	REMARKS/COMMENTS	OPTIONAL SPEND EST. (RS)
DOOR PANEL	7	OK	0
DOOR HINGES	8	OK	0
CARPET & FLOOR MAT	7	OK	0
SEAT & SEAT BELT	8	OK	0
DASHBOARD & INSTRUMENT PANEL	8	OK	0
HORN	7	OK	0
SPEAKERS & MUSIC SYSTEM	8	OK	0
HANDBRAKE	8	OK	0
STEERING-MOUNTED CONTROLS	8	OK	0
PEDALS	8	OK	0
CENTRAL LOCK	7	OK	0
A/C VENTS & HEATER	7	OK	0
CUP HOLDERS	7	OK	0
NAVIGATION (NO)	10		0
ODOMETER	7	OK	0
POWER WINDOWS (YES)	7	OK	0
HAZARD LIGHT	7	OK	0

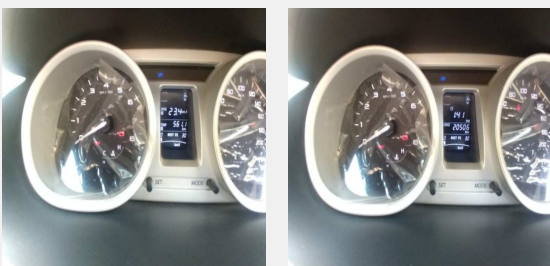
INSPECTION CHECKPOINTS	SCORE(X/10)	REMARKS/COMMENTS	OPTIONAL SPEND EST. (RS)
STEERING PERFORMANCE	7	OK	0
BRAKE PERFORMANCE	8	OK	0
CLUTCH PERFORMANCE	7	OK	0
ENGINE NOISE	7	OK	0
IGNITION SYSTEM	7	OK	0
SUSPENSION PERFORMANCE	8	OK	0
SUSPENSION FRONT SHOCKS	8	OK.	0
SUSPENSION REAR SHOCKS	7	OK	0
TRANSMISSION ENGAGE	7	OK	0
CRUISE CONTROL (YES)	7	OK	0
REAR PARKING SENSORS (NO)	10		0
REAR VIEW CAMERA (NO)	10		0

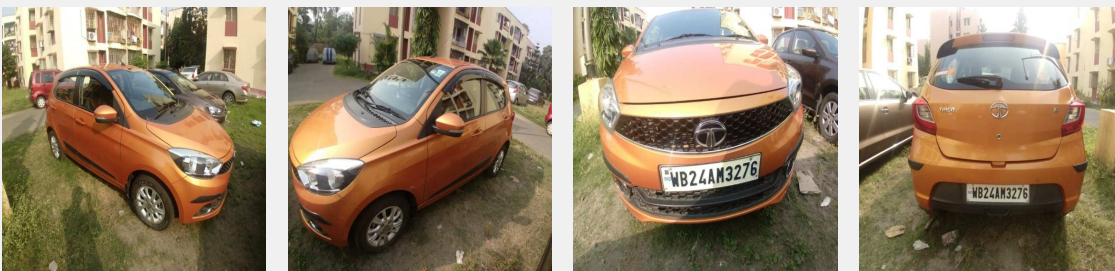
INSPECTION CHECKPOINTS	SCORE(X/10)	REMARKS/COMMENTS	OPTIONAL SPEND EST. (RS)
RH FRONT DOOR	7	OK	0
RH FENDER	7	OK	0
BODY RUST	7	OK	0
ROOF (REGULAR)	7	OK	0
PAINT CONDITION	8	OK	0

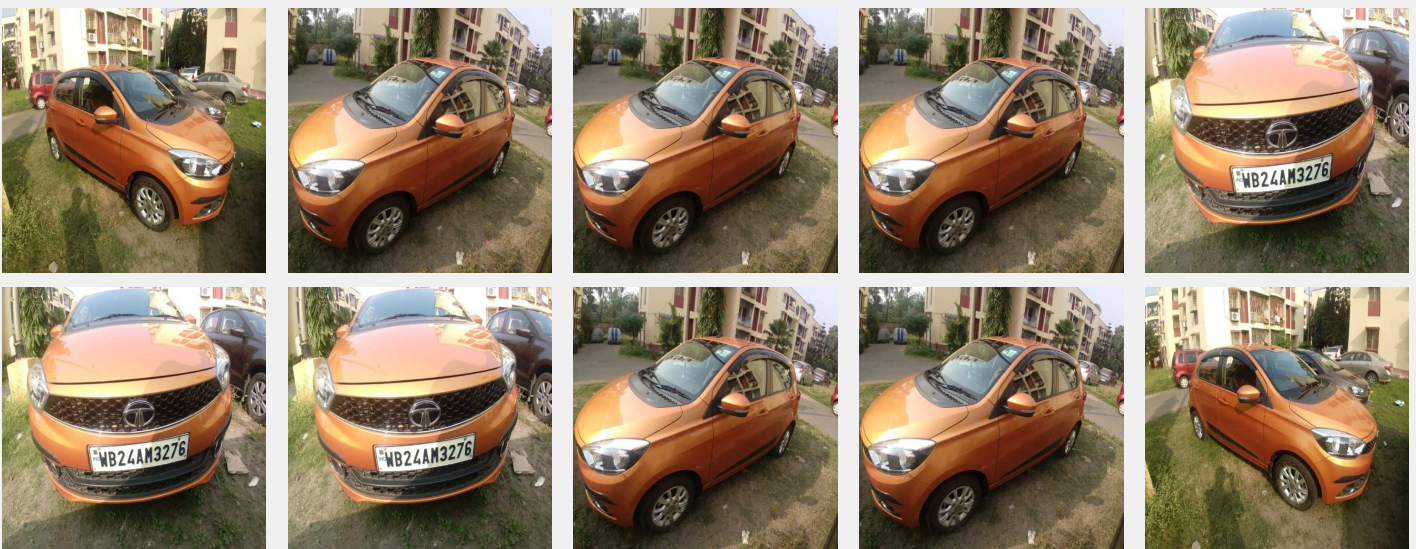
Good condition
