# ECO INSPECTION CERTIFICATE

Order ID : 33596

121 Points Vehicle Inspection Certificate

## Nissan Micra XE DIESEL, 2014

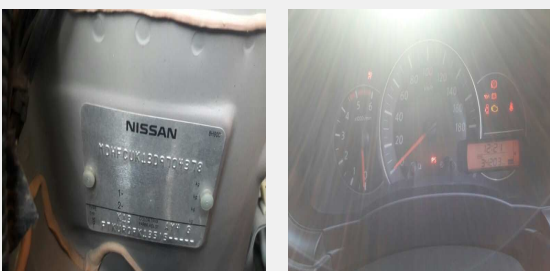
## IMAGES

INSPECTION CHECKPOINTS	SCORE(X/10)	REMARKS/COMMENTS	OPTIONAL SPEND EST. (RS)
STEERING PERFORMANCE	7		0
BRAKE PERFORMANCE	7		0
CLUTCH PERFORMANCE	7		0
ENGINE NOISE	7		0
IGNITION SYSTEM	7		0
SUSPENSION PERFORMANCE	8		0
SUSPENSION FRONT SHOCKS	8		0
SUSPENSION REAR SHOCKS	8		0
TRANSMISSION ENGAGE	8		0
CRUISE CONTROL (NO)	10		0
REAR PARKING SENSORS (NO)	10		0
REAR VIEW CAMERA (NO)	10		0

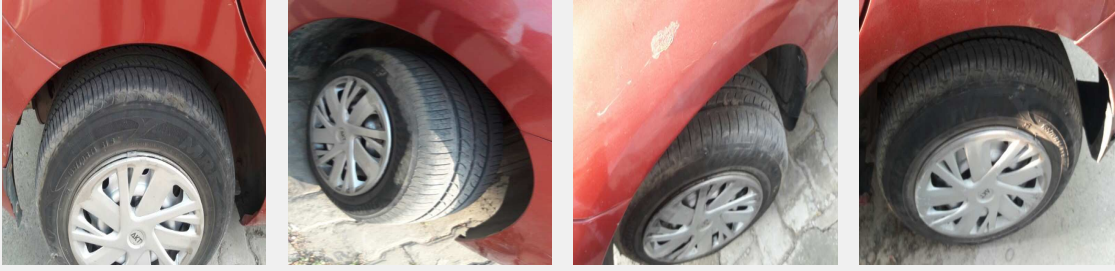
IMAGES

INSPECTION CHECKPOINTS	SCORE(X/10)	REMARKS/COMMENTS	OPTIONAL SPEND EST. (RS)
TYRES	7		0
SPARE TYRE (YES)	7		0
WHEEL ASSEMBLY (ALLOY RIM)	7		0

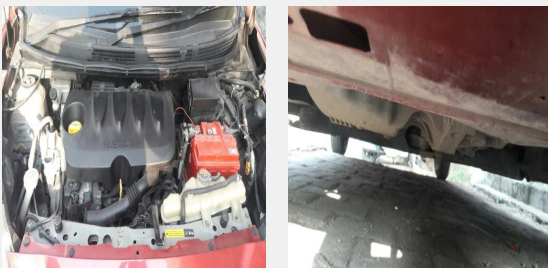
IMAGES

INSPECTION CHECKPOINTS	SCORE(X/10)	REMARKS/COMMENTS	OPTIONAL SPEND EST. (RS)
LH APRON	7		0
RH APRON	7		0
RADIATOR	7		0
WIRING	7		0
BATTERY	7		0
BRAKE FLUID LEVEL	7		0
ENGINE OIL	7		0
COOLANT LEVEL	7		0
BRAKE & COOLANT HOSE PIPES	7		0
UNDERCARRIAGE	6		0
EXHAUST SYSTEM	7		0
