ECO INSPECTION CERTIFICATE

Order ID : 34100

121 Points Vehicle Inspection Certificate

Tata Indica Ev2 LX, 2013

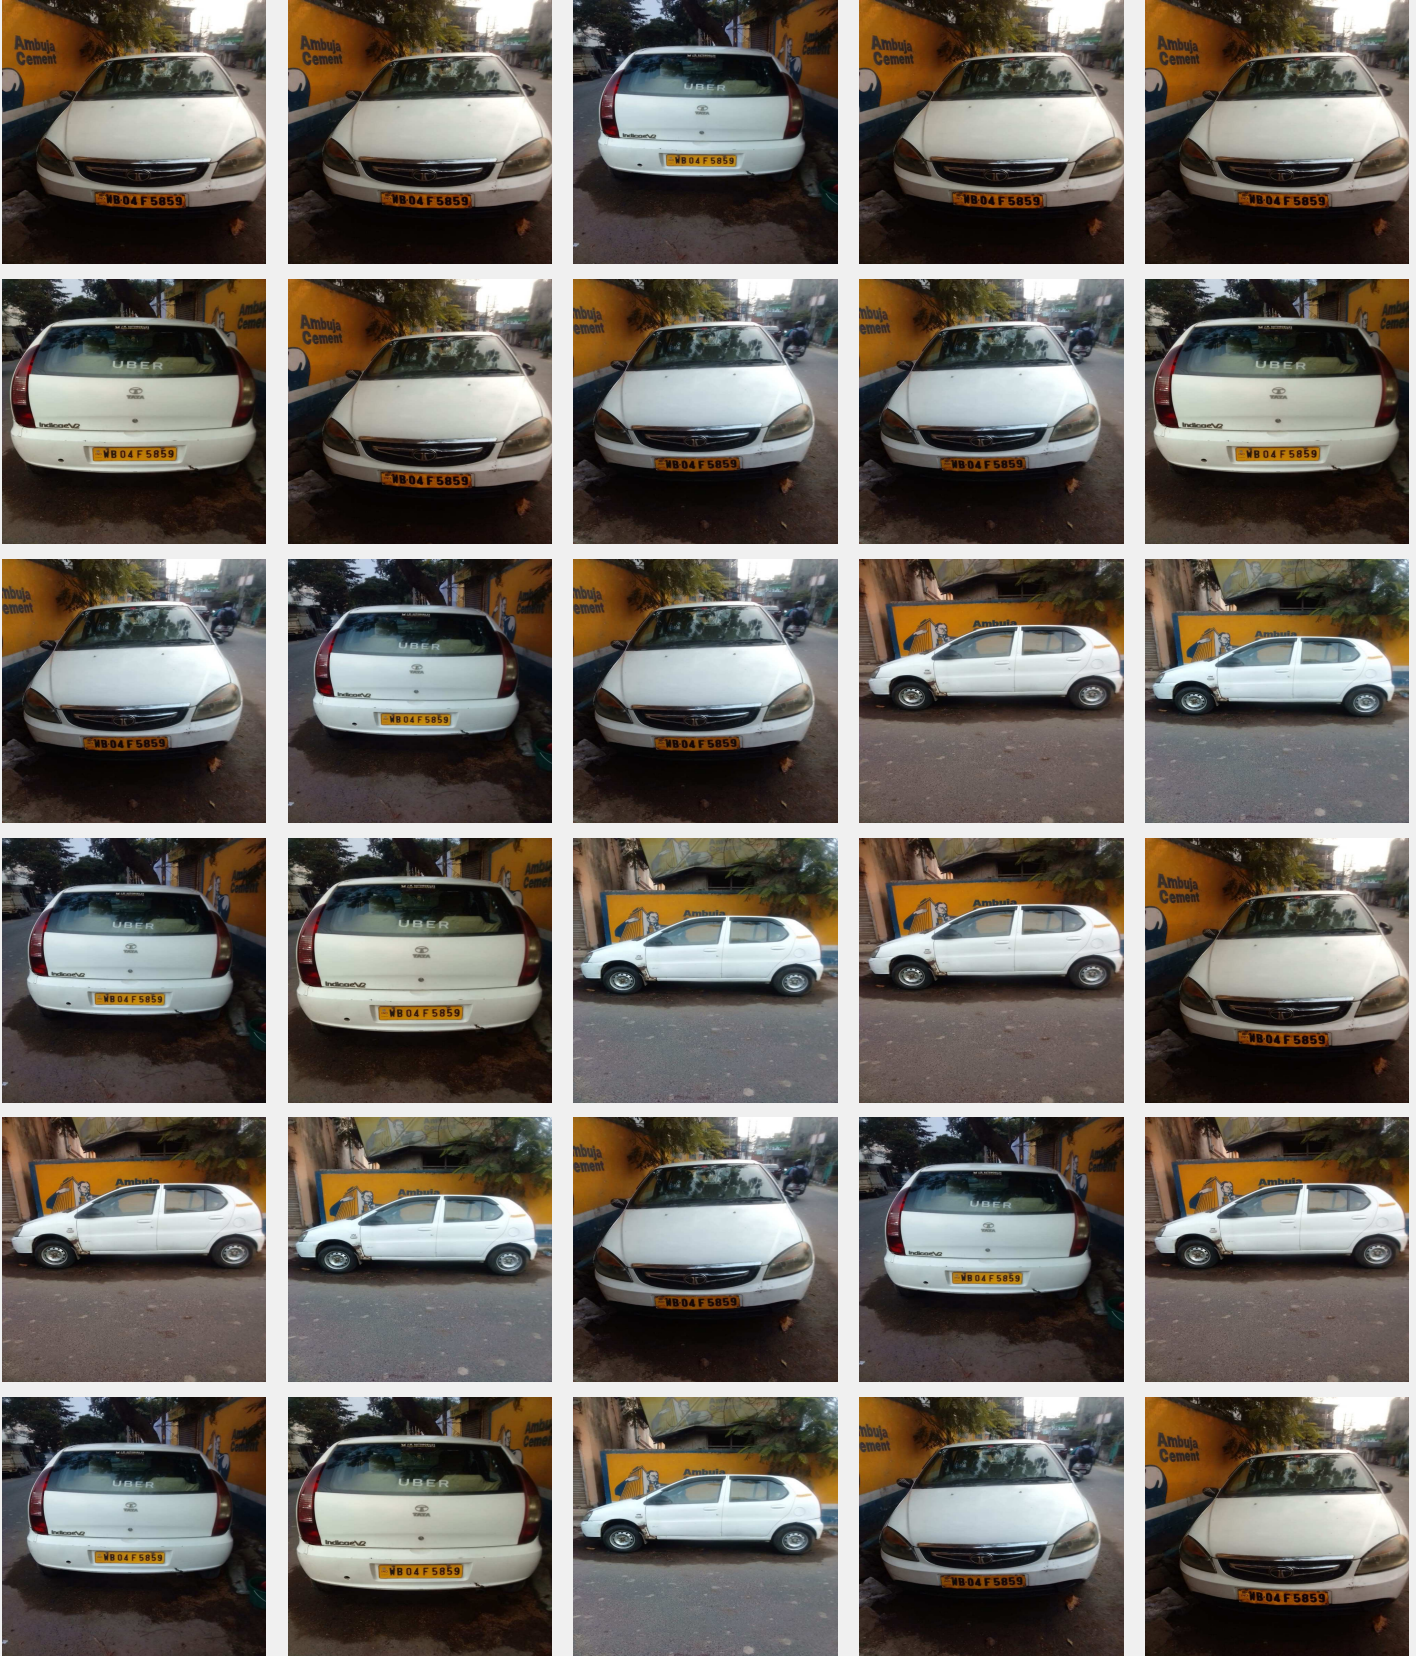
INSPECTION CHECKPOINTS	SCORE(X/10)	REMARKS/COMMENTS	OPTIONAL SPEND EST. (RS)
FRONT BUMPER	5	NEED TO REPAIR	3000
LH FENDER	4	DENT	3000
LH FRONT DOOR	5	DENT	4000
LH QUARTER PANEL	5	DENT	1000
PAINT CONDITION	5	REQUIRED	30000

NEED ATTENTION ⚠

Average
