ECO INSPECTION CERTIFICATE

Order ID : 34511

121 Points Vehicle Inspection Certificate

Mahindra Kuv100 Nxt K8 D 6 STR DUAL TONE, 2017

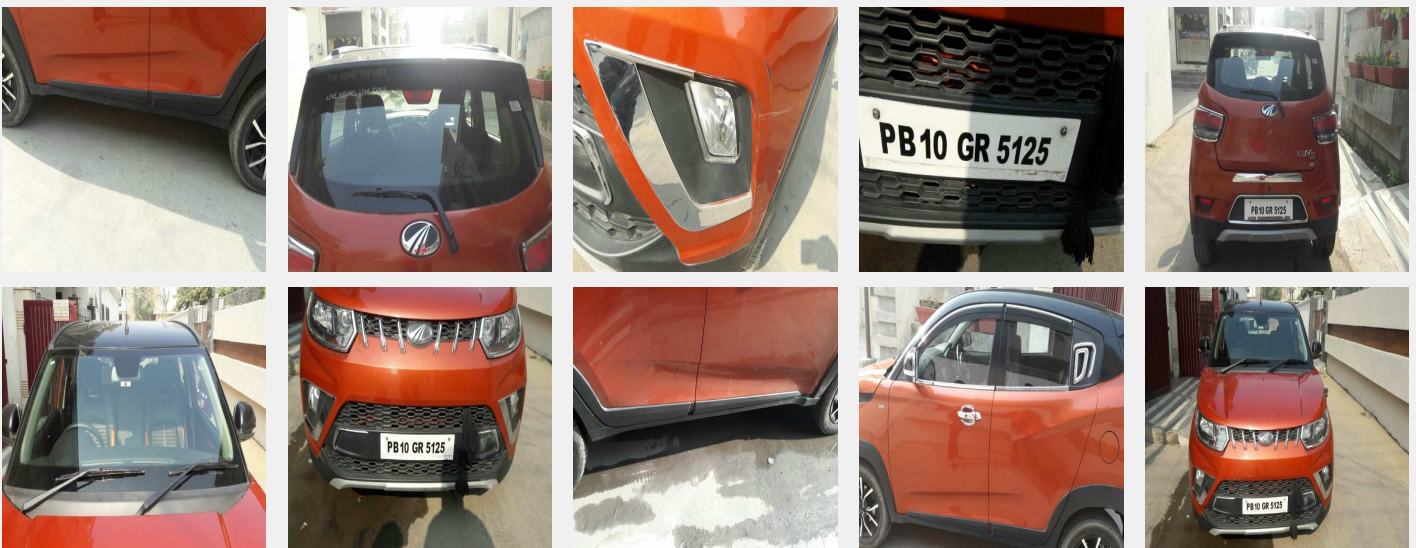
NEED ATTENTION ⚠️

INSPECTION CHECKPOINTS	SCORE(X/10)	REMARKS/COMMENTS	OPTIONAL SPEND EST. (RS)
RH FENDER	7		0
BODY RUST	7		0
ROOF (REGULAR)	8		0
PAINT CONDITION	8		0
FRONT WINDSHIELD	5	SCAR	8000
