ECO INSPECTION CERTIFICATE

Order ID : 34998

121 Points Vehicle Inspection Certificate

Tata Indigo GLS, 2005

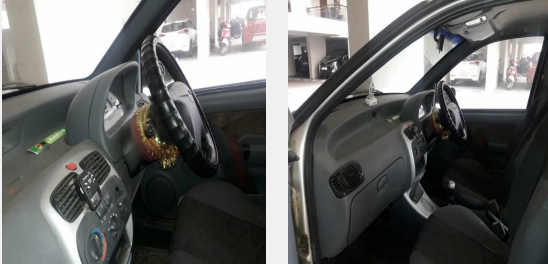
NEED ATTENTION

INSPECTION CHECKPOINTS	SCORE(X/10)	REMARKS/COMMENTS	OPTIONAL SPEND EST. (RS)
DOOR PANEL	7	OK	0
DOOR HINGES	7	OK	0
CARPET & FLOOR MAT	7	OK	0
SEAT & SEAT BELT	6	OK	0
DASHBOARD & INSTRUMENT PANEL	7	OK	0
HORN	6	OK	0
SPEAKERS & MUSIC SYSTEM	6	OK	0
HANDBRAKE	6	AVERAGE	0
STEERING-MOUNTED CONTROLS	7	OK	0
PEDALS	6	AVERAGE	0
CENTRAL LOCK	6	NOT AVAILABLE	0
A/C VENTS & HEATER	6	OK	0
CUP HOLDERS	6	AVAILABLE	0
NAVIGATION (NO)	10		0
ODOMETER	6	OK	0
POWER WINDOWS (YES - FRONT ONLY)	6	OK	0
HAZARD LIGHT	6	AVERAGE	0

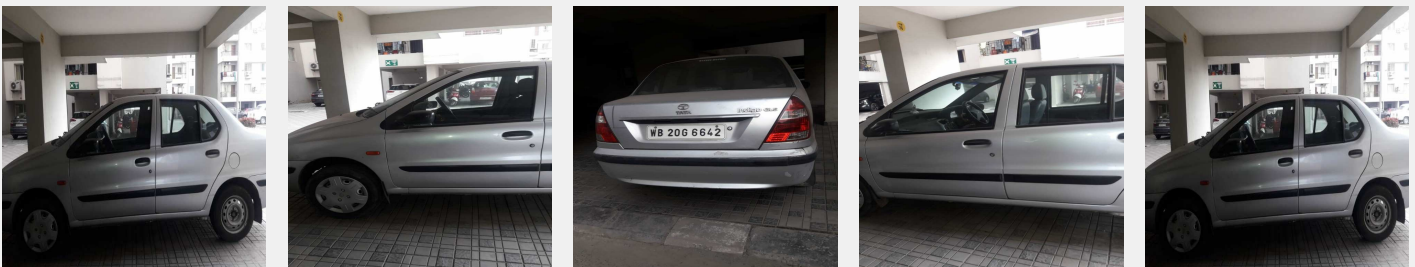
NEED ATTENTION

INSPECTION CHECKPOINTS	SCORE(X/10)	REMARKS/COMMENTS	OPTIONAL SPEND EST. (RS)
RH FENDER	6	OK	0
BODY RUST	6	AVERAGE	0
ROOF (REGULAR)	6	AVERAGE	0
PAINT CONDITION	6	OK	0
REAR BUMPER	5	DENT	2000
