# ECO INSPECTION CERTIFICATE

Order ID : 35019

121 Points Vehicle Inspection Certificate

## Datsun Redi-Go T (O), 2017

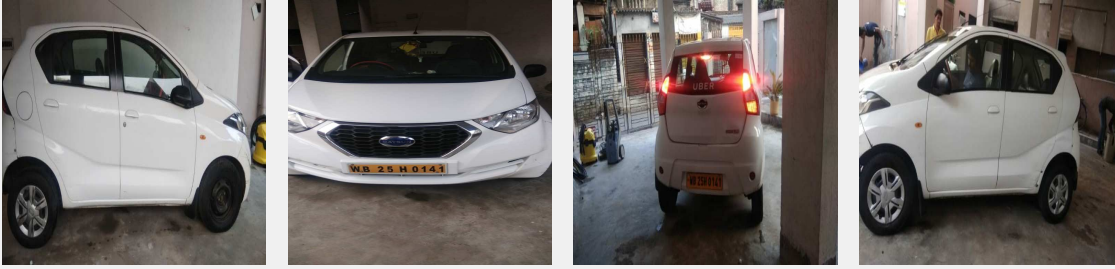
INSPECTION CHECKPOINTS	SCORE(X/10)	REMARKS/COMMENTS	OPTIONAL SPEND EST. (RS)
TYRES	6	OK	0
SPARE TYRE (YES)	6	AVERAGE	0
WHEEL ASSEMBLY (STEEL RIM)	6	OK	0
