# ECO INSPECTION CERTIFICATE

Order ID : 35376

121 Points Vehicle Inspection Certificate

## Volvo Xc90 D5 AWD, 2013

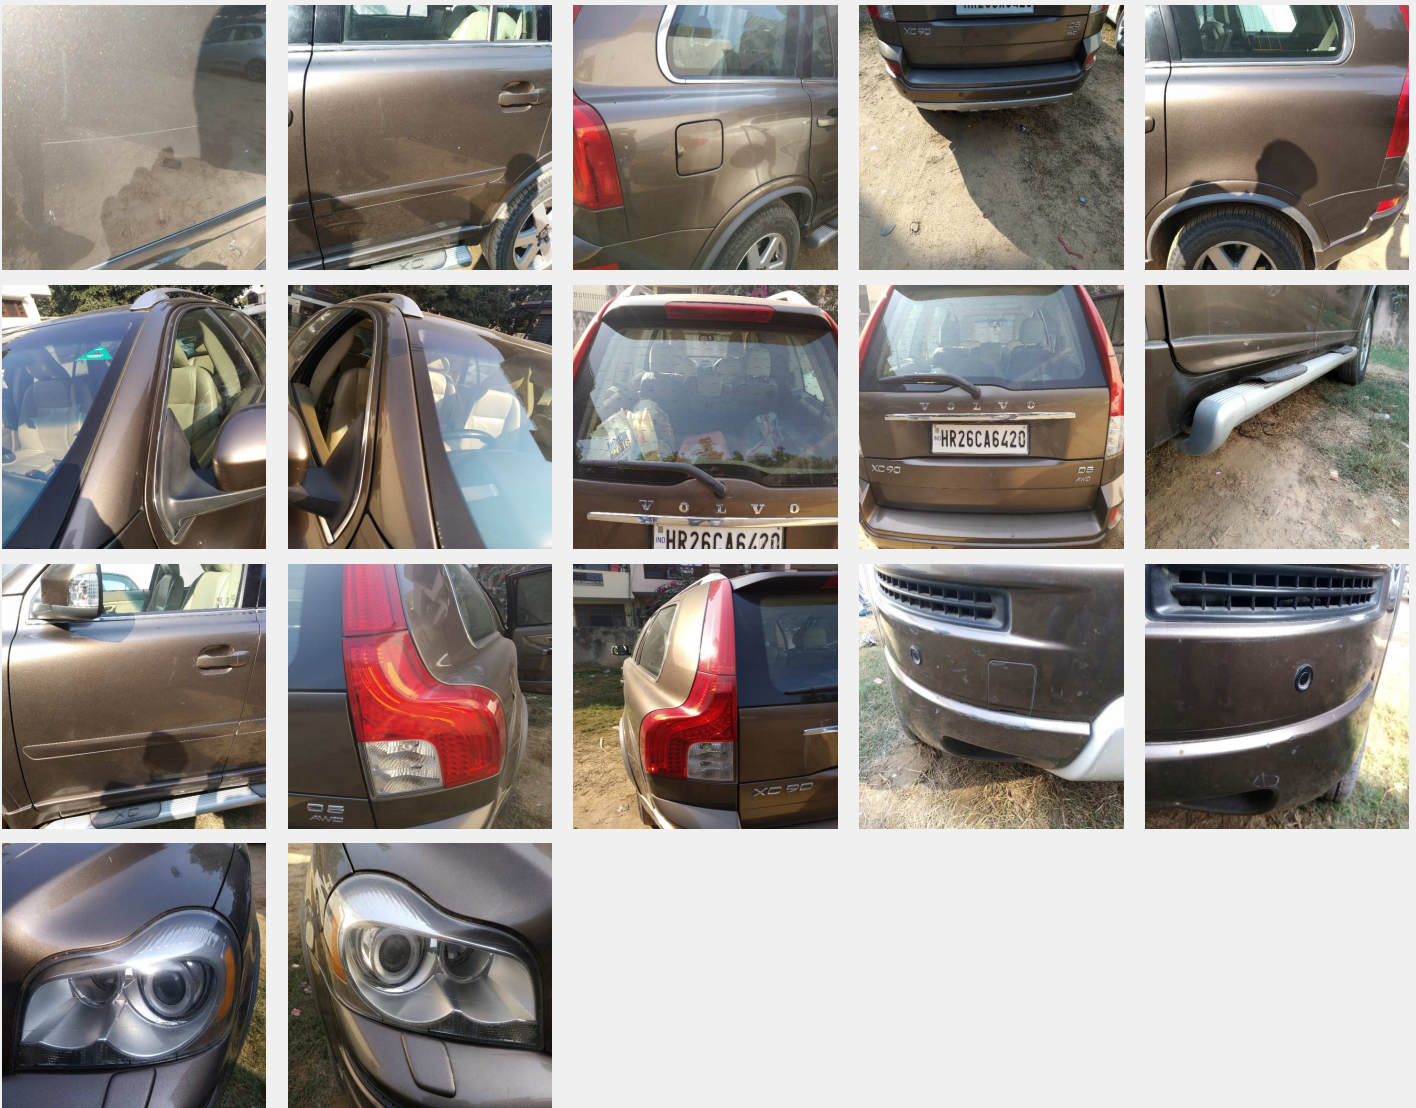
## NEED ATTENTION

minor scratches and minor dent all tyres already changed
