ECO INSPECTION CERTIFICATE

Order ID : 35966

121 Points Vehicle Inspection Certificate

Tata Safari 4X2 EX DICOR 2.2 VTT, 2009

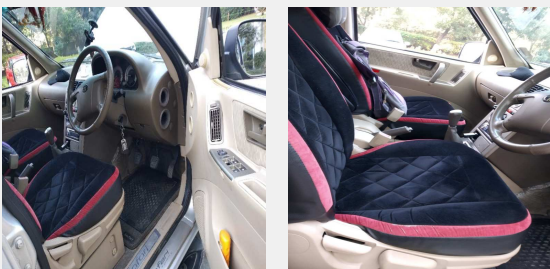
INSPECTION CHECKPOINTS	SCORE(X/10)	REMARKS/COMMENTS	OPTIONAL SPEND EST. (RS)
DOOR PANEL	7	GOOD	0
DOOR HINGES	7	GOOD	0
CARPET & FLOOR MAT	7	GOOD	0
SEAT & SEAT BELT	7	GOOD	0
DASHBOARD & INSTRUMENT PANEL	7	GOOD	0
HORN	7	GOOD	0
SPEAKERS & MUSIC SYSTEM	7	GOOD	0
HANDBRAKE	7	GOOD	0
PEDALS	7	GOOD	0
CENTRAL LOCK	7	GOOD	0
A/C VENTS & HEATER	7	GOOD	0
CUP HOLDERS	7	GOOD	0
NAVIGATION (NO)	10		0
ODOMETER	7	GOOD	0
POWER WINDOWS (YES)	7	GOOD	0
HAZARD LIGHT	7	GOOD	0
STEERING-MOUNTED CONTROLS	0	NA	0

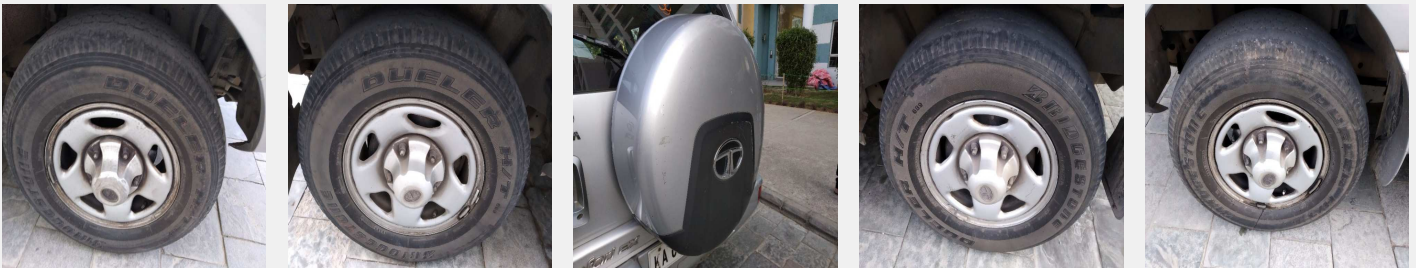
INSPECTION CHECKPOINTS	SCORE(X/10)	REMARKS/COMMENTS	OPTIONAL SPEND EST. (RS)
TYRES	7	GOOD	0
SPARE TYRE (YES)	7	GOOD	0
WHEEL ASSEMBLY (ALLOY RIM)	7	GOOD	0

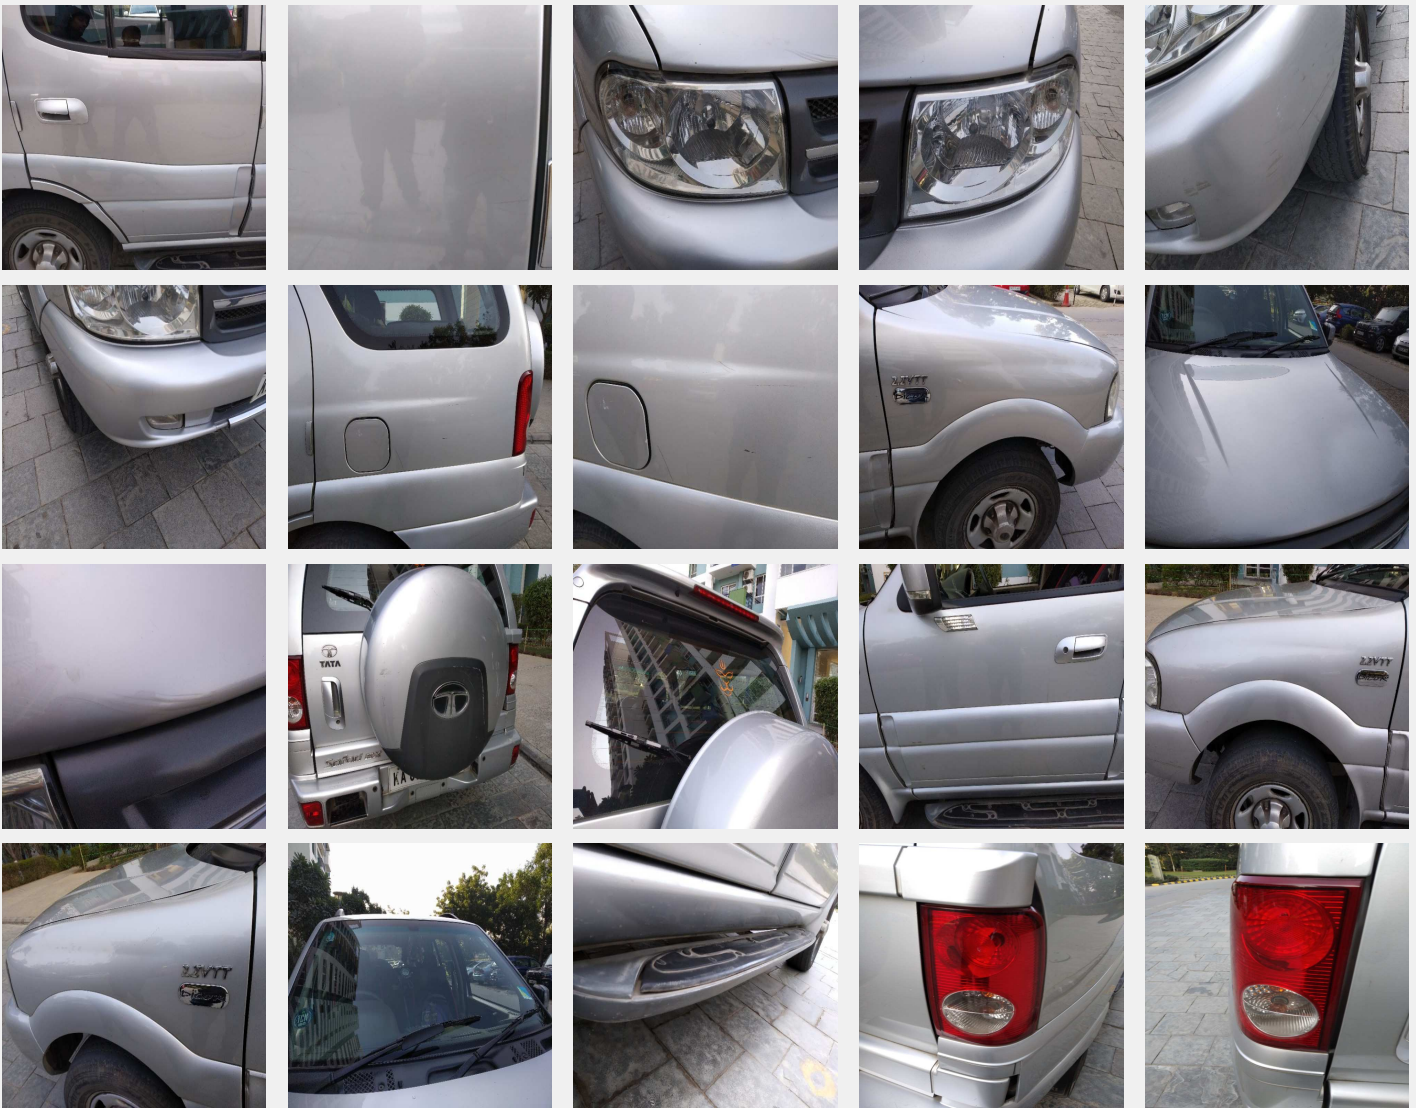
INSPECTION CHECKPOINTS	SCORE(X/10)	REMARKS/COMMENTS	OPTIONAL SPEND EST. (RS)
LICENSE PLATE	7	GOOD	0
FRONT BUMPER	7	GOOD	0
HEAD LIGHTS	7	GOOD	0
GRILLE	7	GOOD	0
TURN SIGNAL	7	GOOD	0
FOG LAMPS	7	GOOD	0
HOOD	6	MINOR SCRATCHES	0
PILLAR	7	GOOD	0
FRONT WINDSHIELD	7	GOOD	0
SIDE VIEW MIRRORS	7	GOOD	0
LH FENDER	6	MINOR SCRATCHES	0
LH FRONT DOOR	7	GOOD	0
LH REAR DOOR	6	MINOR SCRATCHES	0
LH RUNNING BOARD	7	GOOD	0
LH QUARTER PANEL	6	MINOR SCRATCHES	0
FUEL LID	7	GOOD	0
REAR WINDSHIELD	7	GOOD	0
REAR BUMPER	6	MINOR SCTATCHES	0
TAIL LIGHT	7	GOOD	0
TRUNK LID/TAIL GATE	7	GOOD	0
LUGGAGE COMPARTMENT LIGHT	7	GOOD	0
RH QUARTER PANEL	7	GOOD	0
RH RUNNING BOARD	7	GOOD	0
RH REAR DOOR	6	MINOR SCRATCHES	0

INSPECTION CHECKPOINTS	SCORE(X/10)	REMARKS/COMMENTS	OPTIONAL SPEND EST. (RS)
RH FRONT DOOR	7	GOOD	0
RH FENDER	7	GOOD	0
BODY RUST	7	GOOD	0
ROOF (REGULAR)	7	GOOD	0
PAINT CONDITION	7	GOOD	0

minor scratches and minor dent all tyres cracking need to be changed front bumper and Hood already p
