# ECO INSPECTION CERTIFICATE

121 Points Vehicle Inspection Certificate

## Tata Zest QUADRAJET 1.3 75PS XE, 2017

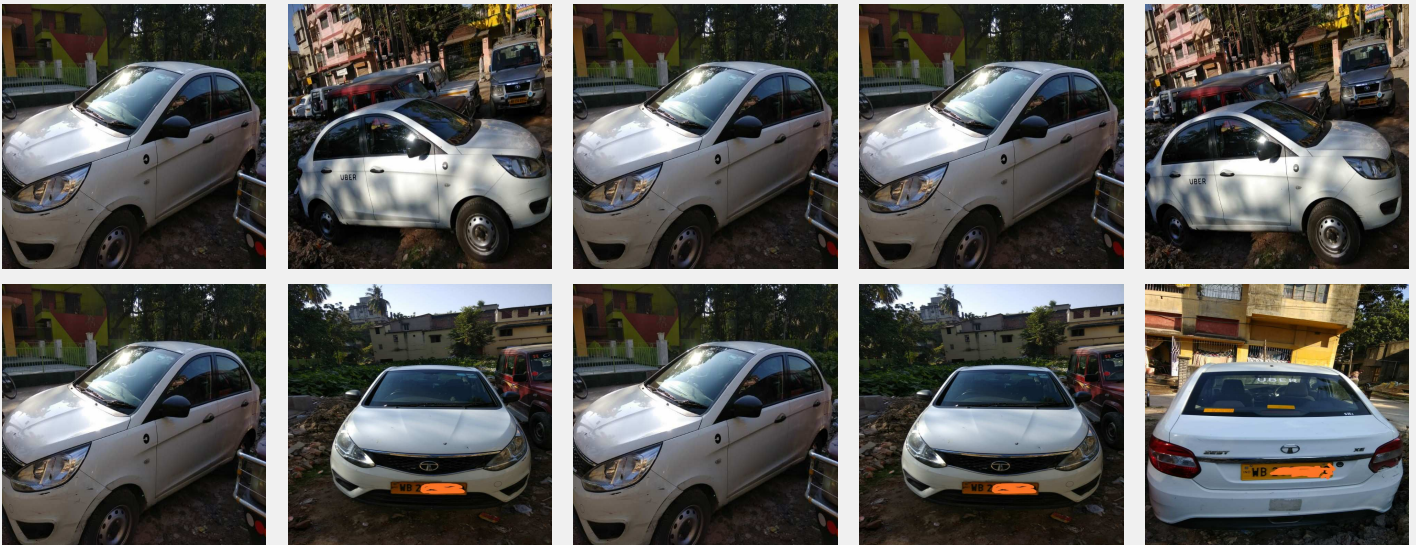
## NEED ATTENTION ⚠️

INSPECTION CHECKPOINTS	SCORE(X/10)	REMARKS/COMMENTS	OPTIONAL SPEND EST. (RS)
BODY RUST	6	AVERAGE	0
ROOF (REGULAR)	6	OK	0
PAINT CONDITION	6	AVERAGE	0
LH FENDER	5	DENT	1200
TAIL LIGHT	5	BROKEN	1500

DESCRIPTION

Average
