ECO INSPECTION CERTIFICATE

Order ID : 38286

121 Points Vehicle Inspection Certificate

Mercedes-Benz C-Class 220 Cdi Avantgarde At, 2014

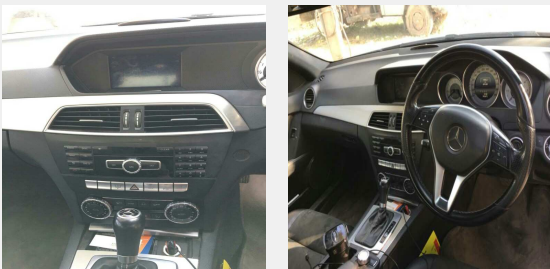
INSPECTION CHECKPOINTS	SCORE(X/10)	REMARKS/COMMENTS	OPTIONAL SPEND EST. (RS)
DOOR PANEL	7	OK	0
DOOR HINGES	7	GOOD	0
CARPET & FLOOR MAT	7	OK	0
SEAT & SEAT BELT	6	OK	0
DASHBOARD & INSTRUMENT PANEL	7	WORKING	0
HORN	7	OK	0
SPEAKERS & MUSIC SYSTEM	7	WORKING	0
HANDBRAKE	7	OK	0
STEERING-MOUNTED CONTROLS	7	OK	0
PEDALS	7	GOOD	0
CENTRAL LOCK	7	OK	0
A/C VENTS & HEATER	7	WORKING	0
CUP HOLDERS	6	GOOD	0
NAVIGATION (YES)	7	OK	0
ODOMETER	7	GOOD	0
POWER WINDOWS (YES)	6	OK	0
HAZARD LIGHT	7	WORKING	0

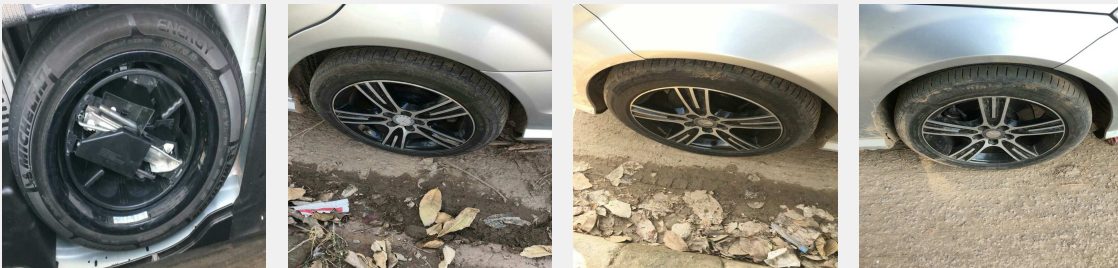
INSPECTION CHECKPOINTS	SCORE(X/10)	REMARKS/COMMENTS	OPTIONAL SPEND EST. (RS)
TYRES	7	GOOD	0
SPARE TYRE (YES)	6	GOOD	0
WHEEL ASSEMBLY (STEEL RIM)	7	GOOD	0

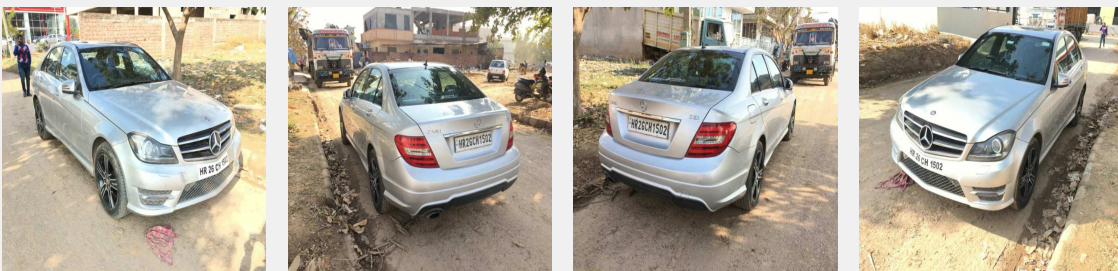
INSPECTION CHECKPOINTS	SCORE(X/10)	REMARKS/COMMENTS	OPTIONAL SPEND EST. (RS)
RH FRONT DOOR	6	GOOD	0
RH FENDER	8	OK	0
BODY RUST	7	NO BODY RUST	0
ROOF (REGULAR)	7	SMOOTH	0
PAINT CONDITION	7	GOOD	0
