ECO INSPECTION CERTIFICATE

Order ID : 38312

121 Points Vehicle Inspection Certificate

Audi A4 35 TDI TECHNOLOGY, 2017

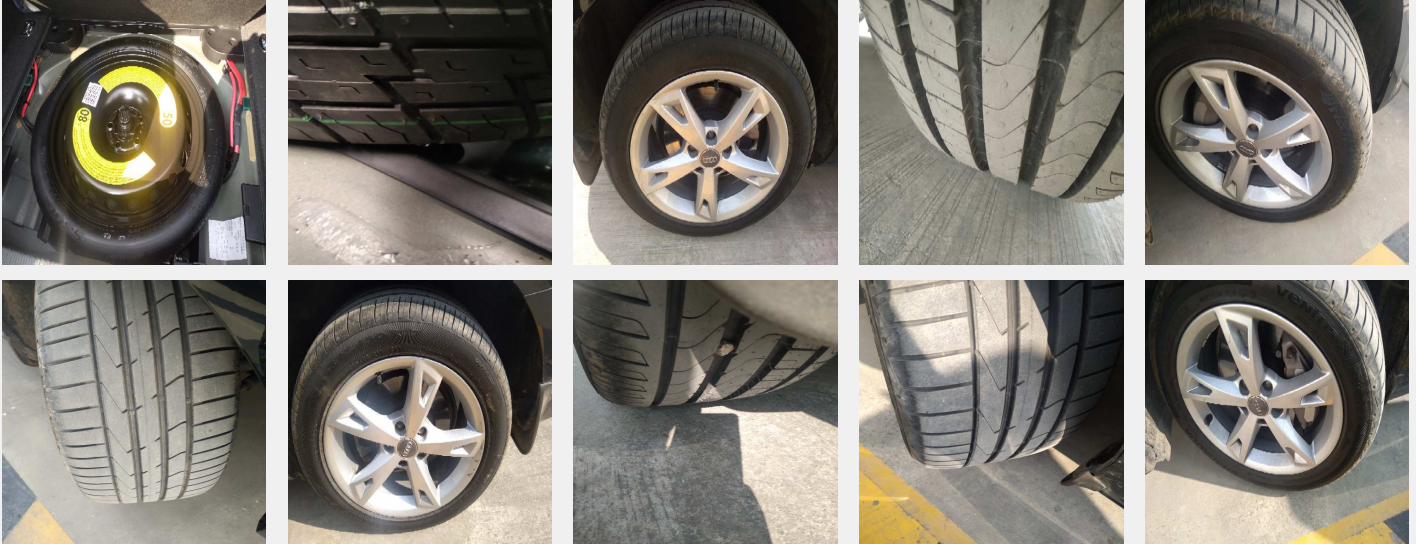
IMAGES

INSPECTION CHECKPOINTS	SCORE(X/10)	REMARKS/COMMENTS	OPTIONAL SPEND EST. (RS)
TYRES	8	GOOD CONDITION AND WORKING PROPERLY	0
SPARE TYRE (YES)	8	GOOD CONDITION AND WORKING PROPERLY	0
WHEEL ASSEMBLY (ALLOY RIM)	8	GOOD CONDITION AND WORKING PROPERLY	0

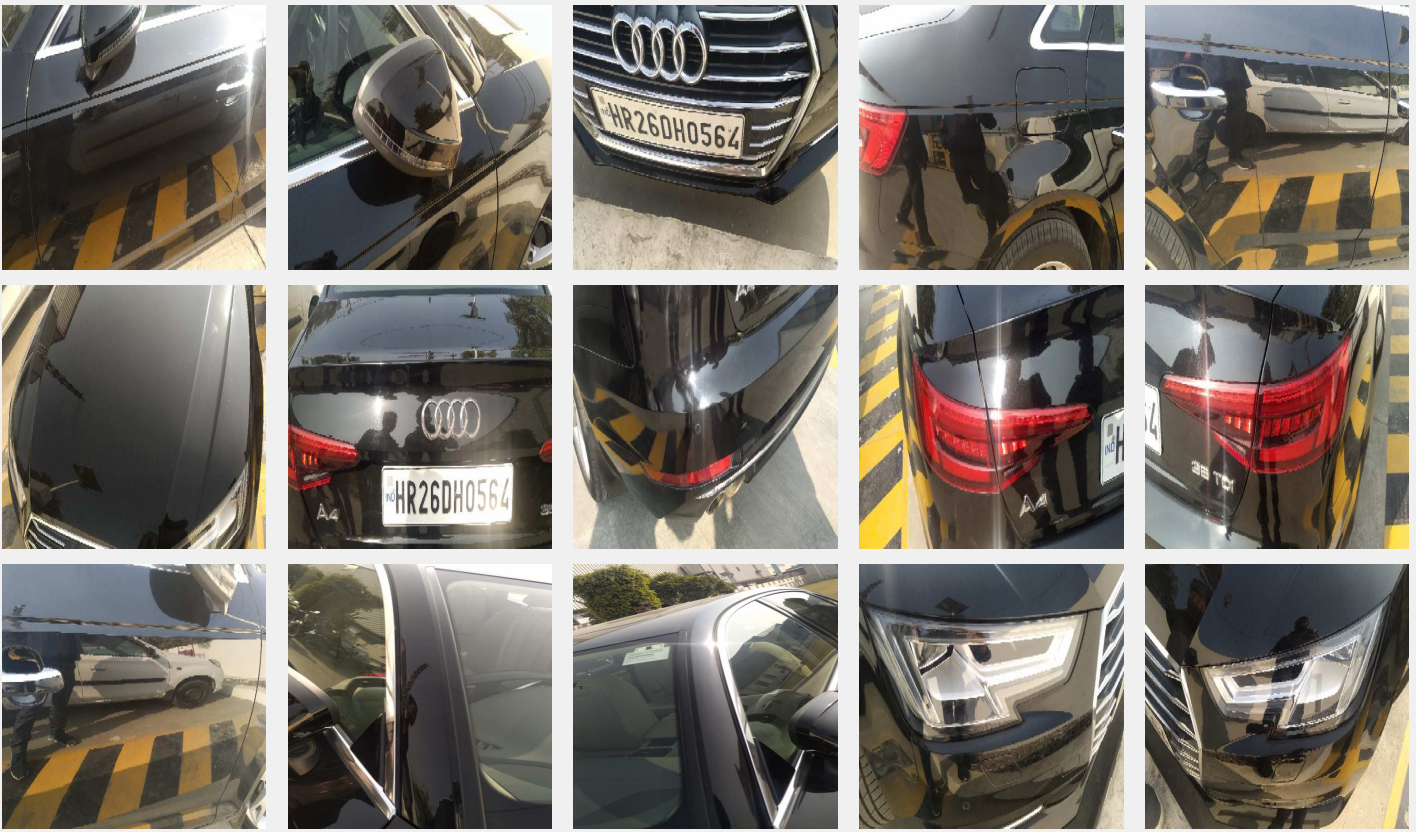
NEED ATTENTION ⚠

INSPECTION CHECKPOINTS	SCORE(X/10)	REMARKS/COMMENTS	OPTIONAL SPEND EST. (RS)
LICENSE PLATE	8	GOOD CONDITION	0
FRONT BUMPER	7	MINOR SCRATCHES	2000
HEAD LIGHTS	8	GOOD CONDITION AND WORKING PROPERLY	0
GRILLE	8	GOOD CONDITION	0
TURN SIGNAL	8	GOOD CONDITION AND WORKING PROPERLY	0
FOG LAMPS	8	GOOD CONDITION AND WORKING PROPERLY	0
HOOD	8	GOOD CONDITION AND WORKING PROPERLY	0
PILLAR	8	GOOD CONDITION	0
FRONT WINDSHIELD	8	GOOD VISIBILITY	0
SIDE VIEW MIRRORS	8	GOOD CONDITION AND WORKING PROPERLY	0
LH FENDER	8	GOOD CONDITION	0
LH FRONT DOOR	8	GOOD CONDITION	0
LH REAR DOOR	8	GOOD CONDITION	0
LH RUNNING BOARD	8	GOOD CONDITION	0
LH QUARTER PANEL	8	GOOD CONDITION	0
FUEL LID	8	GOOD CONDITION AND WORKING PROPERLY	0
REAR WINDSHIELD	8	GOOD VISIBILITY	0
REAR BUMPER	7	MINOR SCRATCHES	2000
TAIL LIGHT	8	GOOD CONDITION AND WORKING PROPERLY	0
TRUNK LID/TAIL GATE	8	GOOD CONDITION AND WORKING PROPERLY	0
LUGGAGE COMPARTMENT LIGHT	8	GOOD CONDITION	0

minor scratches both rear tyres are already changed
