ECO INSPECTION CERTIFICATE

Order ID : 38495

121 Points Vehicle Inspection Certificate

Volkswagen Polo GT TSI, 2016

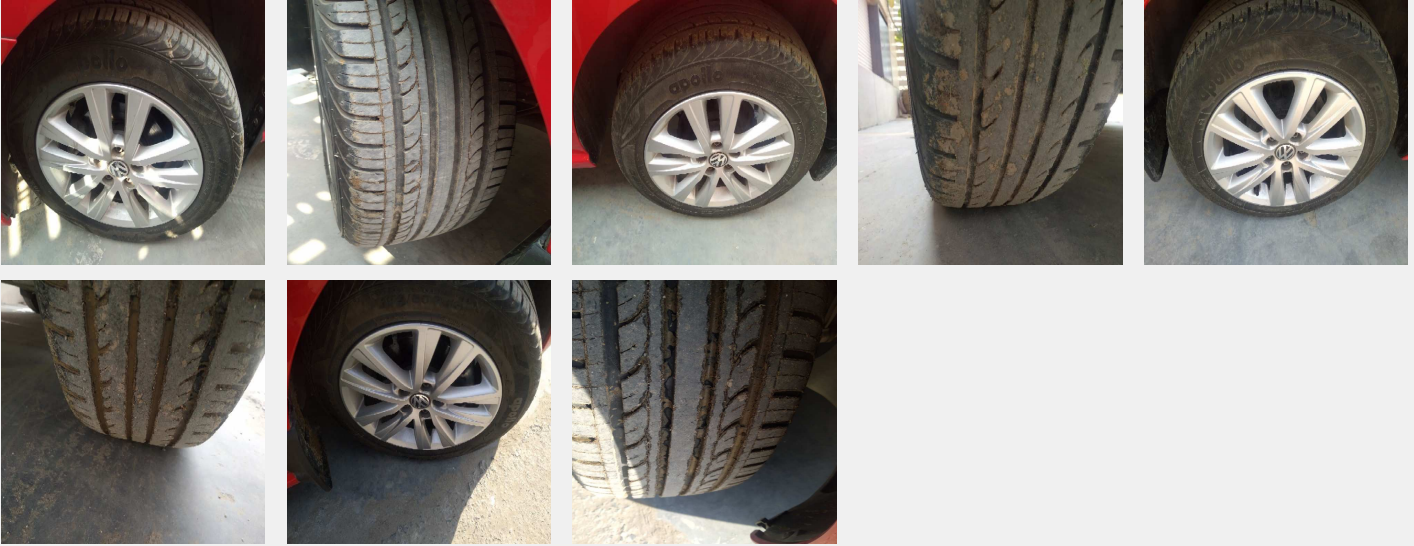
INSPECTION CHECKPOINTS	SCORE(X/10)	REMARKS/COMMENTS	(RS)
TYRES	7	GOOD CONDITION AND WORKING PROPERLY	0
SPARE TYRE (YES)	7	GOOD CONDITION AND WORKING PROPERLY	0
WHEEL ASSEMBLY (ALLOY RIM)	7	GOOD CONDITION AND WORKING PROPERLY	0

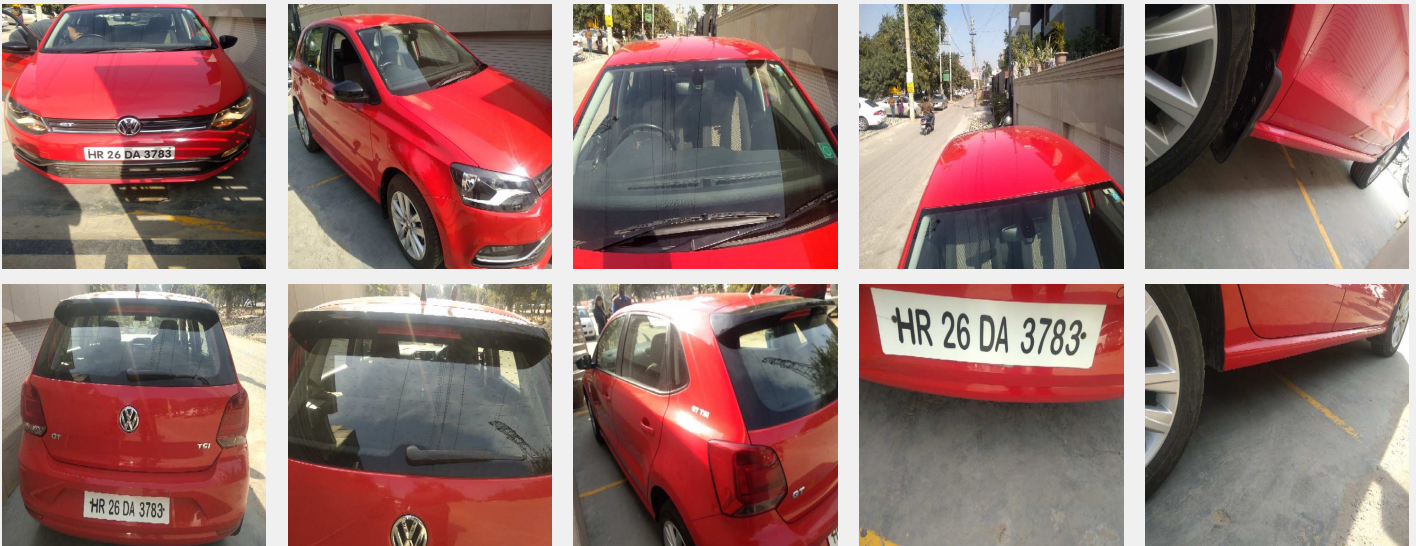
INSPECTION CHECKPOINTS	SCORE(X/10)	REMARKS/COMMENTS	OPTIONAL SPEND EST. (RS)
RH FRONT DOOR	7	GOOD CONDITION	0
RH FENDER	7	GOOD CONDITION	0
BODY RUST	7	GOOD CONDITION	0
ROOF (REGULAR)	7	GOOD CONDITION	0
PAINT CONDITION	8	GOOD CONDITION	0

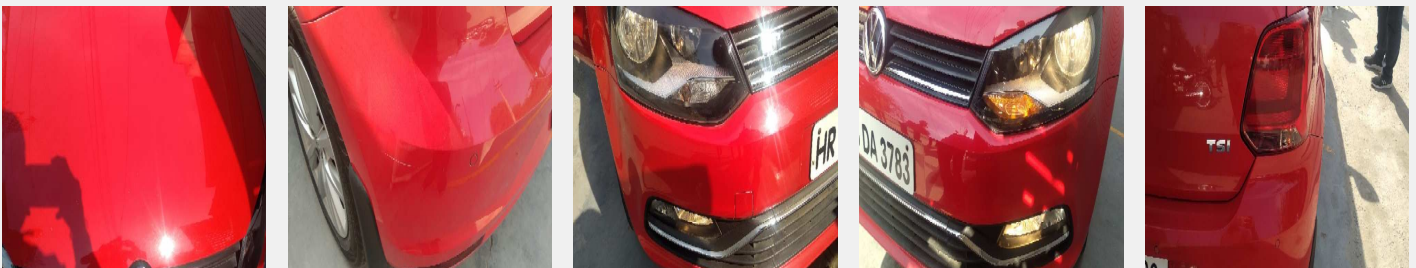
NEED ATTENTION ⚠

minor scratches
