ECO INSPECTION CERTIFICATE

Order ID : 38562

121 Points Vehicle Inspection Certificate

Um Renegade Commando 280CC, 2017

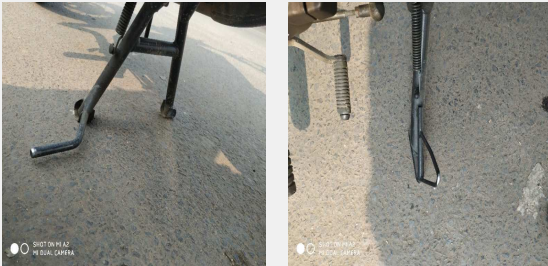
IMAGES

INSPECTION CHECKPOINTS	SCORE(X/10)	REMARKS/COMMENTS	OPTIONAL SPEND EST. (RS)
CENTRE STAND CONDITION	8		0
CENTRE STAND RETENTION	8		0
SIDE STAND CONDITION	8		0
SIDE STAND RETENTION	8		0
