ECO INSPECTION CERTIFICATE

Order ID : 38862

121 Points Vehicle Inspection Certificate

Fiat Punto EMOTION PACK 1.4, 2011

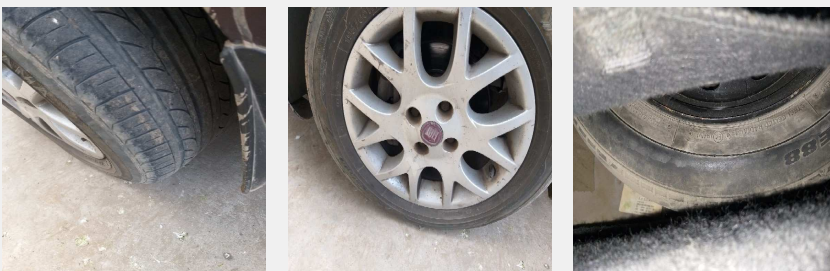
NEED ATTENTION

INSPECTION CHECKPOINTS	SCORE(X/10)	REMARKS/COMMENTS	OPTIONAL SPEND EST. (RS)
TYRES	6	GOOD CONDITION AND WORKING PROPERLY	0
SPARE TYRE (YES)	6	NORMAL CONDITION	0
WHEEL ASSEMBLY (ALLOY RIM)	6	GOOD CONDITION AND WORKING PROPERLY	0

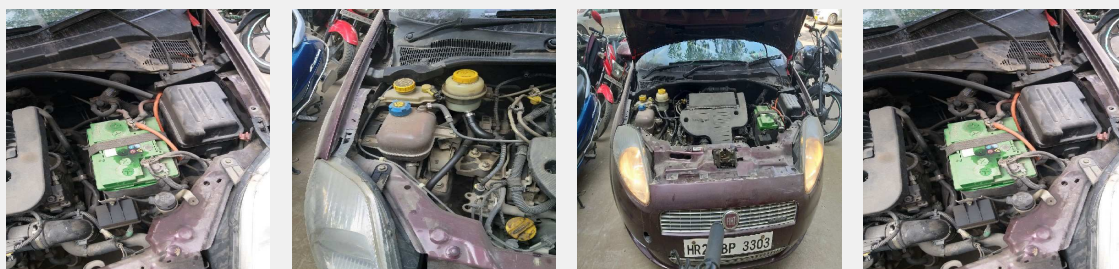
NEED ATTENTION

INSPECTION CHECKPOINTS	SCORE(X/10)	REMARKS/COMMENTS	OPTIONAL SPEND EST. (RS)
LH APRON	6	GOOD CONDITION	0
RH APRON	6	GOOD CONDITION	0
RADIATOR	6	GOOD CONDITION AND WORKING PROPERLY	0
WIRING	6	GOOD CONDITION AND WORKING PROPERLY	0

BATTERY	6	GOOD CONDITION AND WORKING PROPERLY	0
BRAKE FLUID LEVEL	6	MAXIMUM LAVAL	0
ENGINE OIL	7	MAXIMUM LAVAL	0
COOLANT LEVEL	7	MAXIMUM LAVAL	0
BRAKE & COOLANT HOSE PIPES	7	GOOD CONDITION AND WORKING PROPERLY	0
UNDERCARRIAGE	6	GOOD	0
EXHAUST SYSTEM	6	GOOD	0

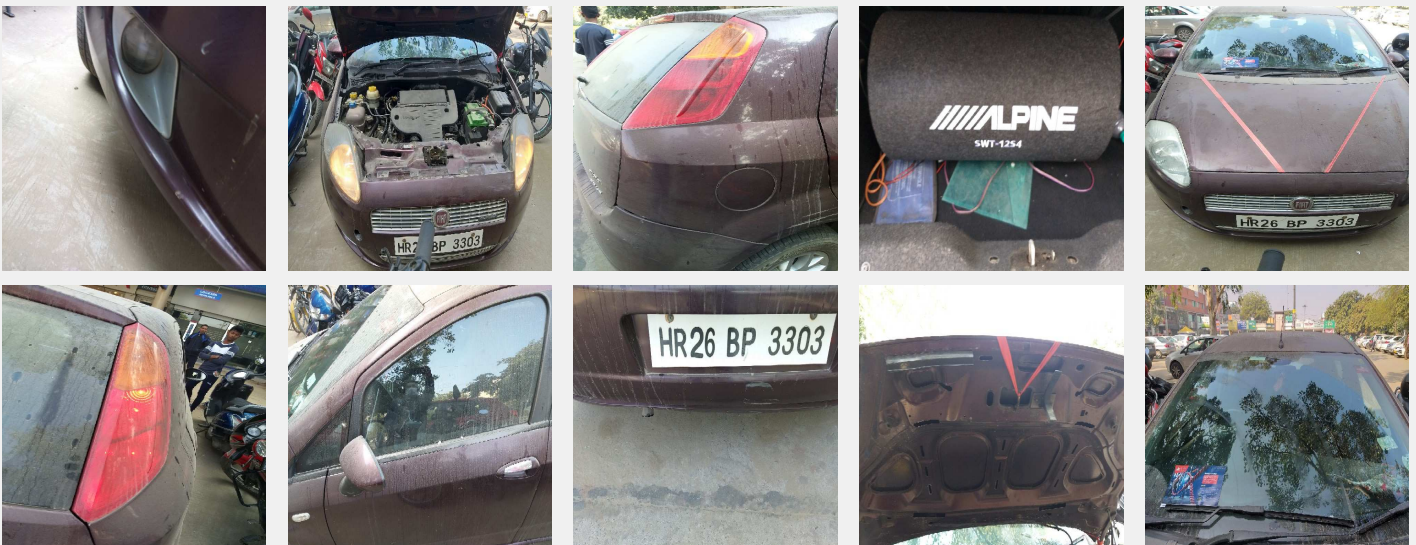
NEED ATTENTION ⚠️

INSPECTION CHECKPOINTS	SCORE(X/10)	REMARKS/COMMENTS	OPTIONAL SPEND EST. (RS)
LICENSE PLATE	7	GOOD CONDITION AND WORKING PROPERLY	0
FRONT BUMPER	6	MINORS SCRATCHES NEED TO BE REAPING	3000
HEAD LIGHTS	7	GOOD CONDITION AND WORKING PROPERLY	0
GRILLE	7	GOOD	0
TURN SIGNAL	6	GOOD CONDITION AND WORKING PROPERLY	0
FOG LAMPS	6	NOT PROPERLY WORKING NEED TO BE REAPING	500
HOOD	6	GOOD	0
PILLAR	6	GOOD CONDITION	0
FRONT WINDSHIELD	6	GOOD VISIBILITY	0
SIDE VIEW MIRRORS	6	GOOD CONDITION AND WORKING PROPERLY	0
LH FENDER	6	GOOD CONDITION	0
LH FRONT DOOR	6	GOOD CONDITION AND WORKING PROPERLY	0
LH REAR DOOR	6	GOOD CONDITION AND WORKING PROPERLY	0
LH RUNNING BOARD	6	NEED TO BE REAPING	4000
LH QUARTER PANEL	6	GOOD CONDITION	0
FUEL LID	6	GOOD CONDITION AND WORKING PROPERLY	0
REAR WINDSHIELD	6	GOOD VISIBILITY AND REAR WIPER CHANG	500
REAR BUMPER	6	NEED TO BE REAPING MINOR SCRATCHES	0
TAIL LIGHT	6	GOOD CONDITION AND WORKING PROPERLY IN AND	0

TRUNK LID/TAIL GATE	6	GOOD CONDITION AND WORKING PROPERLY	0
LUGGAGE COMPARTMENT LIGHT	6	GOOD CONDITION	0
RH QUARTER PANEL	6	MINORS SCRATCHES NEED TO BE REAPING	5000
RH RUNNING BOARD	6	GOOD CONDITION	0
RH REAR DOOR	6	GOOD CONDITION AND WORKING PROPERLY	0

INSPECTION CHECKPOINTS	SCORE(X/10)	REMARKS/COMMENTS	OPTIONAL SPEND EST. (RS)
RH FRONT DOOR	6	MINORS SCRATCHES	3500
RH FENDER	6	GOOD CONDITION	0
BODY RUST	6	NEED TO BE REAPING	5000
ROOF (REGULAR)	6	GOOD CONDITION	0
PAINT CONDITION	6	GOOD	0
