ECO INSPECTION CERTIFICATE

Order ID : 39301

121 Points Vehicle Inspection Certificate

Audi Q3 35 TDI QUATTRO, 2017

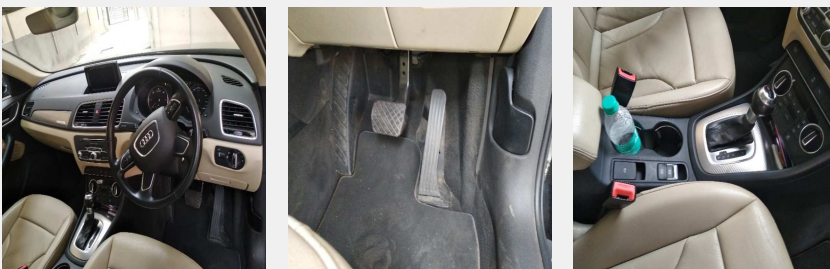
INTERIOR

INSPECTION CHECKPOINTS	SCORE(X/10)	REMARKS/COMMENTS	OPTIONAL SPEND EST. (RS)
DOOR PANEL	9		0
DOOR HINGES	10		0
CARPET & FLOOR MAT	10		0
SEAT & SEAT BELT	9		0
DASHBOARD & INSTRUMENT PANEL	10		0
HORN	10		0
SPEAKERS & MUSIC SYSTEM	9		0
HANDBRAKE	10		0
STEERING-MOUNTED CONTROLS	10		0
PEDALS	9		0
CENTRAL LOCK	10		0
A/C VENTS & HEATER	9		0
CUP HOLDERS	9		0
NAVIGATION (YES)	10		0
ODOMETER	10		0
POWER WINDOWS (YES)	9		0
HAZARD LIGHT	10		0

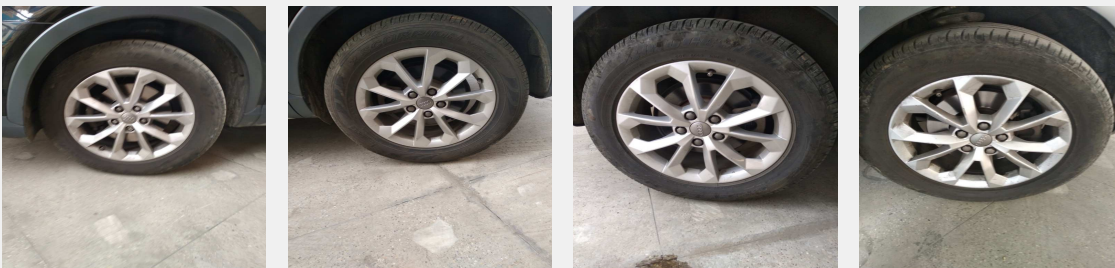
INSPECTION CHECKPOINTS	SCORE(X/10)	REMARKS/COMMENTS	OPTIONAL SPEND EST. (RS)
TYRES	9		0
SPARE TYRE (YES)	9		0
WHEEL ASSEMBLY (STEEL RIM)	10		0

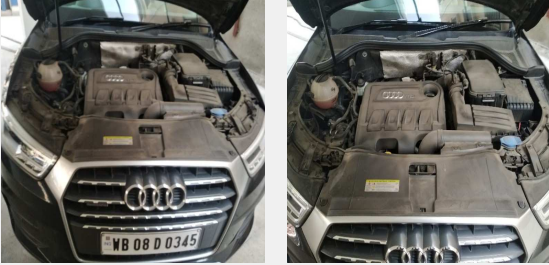
HOOD

INSPECTION CHECKPOINTS	SCORE(X/10)	REMARKS/COMMENTS	OPTIONAL SPEND EST. (RS)
LH APRON	10		0
RH APRON	9		0
RADIATOR	10		0
WIRING	10		0
BATTERY	9		0
BRAKE FLUID LEVEL	9		0

ENGINE OIL	9		0
COOLANT LEVEL	9		0
BRAKE & COOLANT HOSE PIPES	10		0
UNDERCARRIAGE	9		0
EXHAUST SYSTEM	10		0

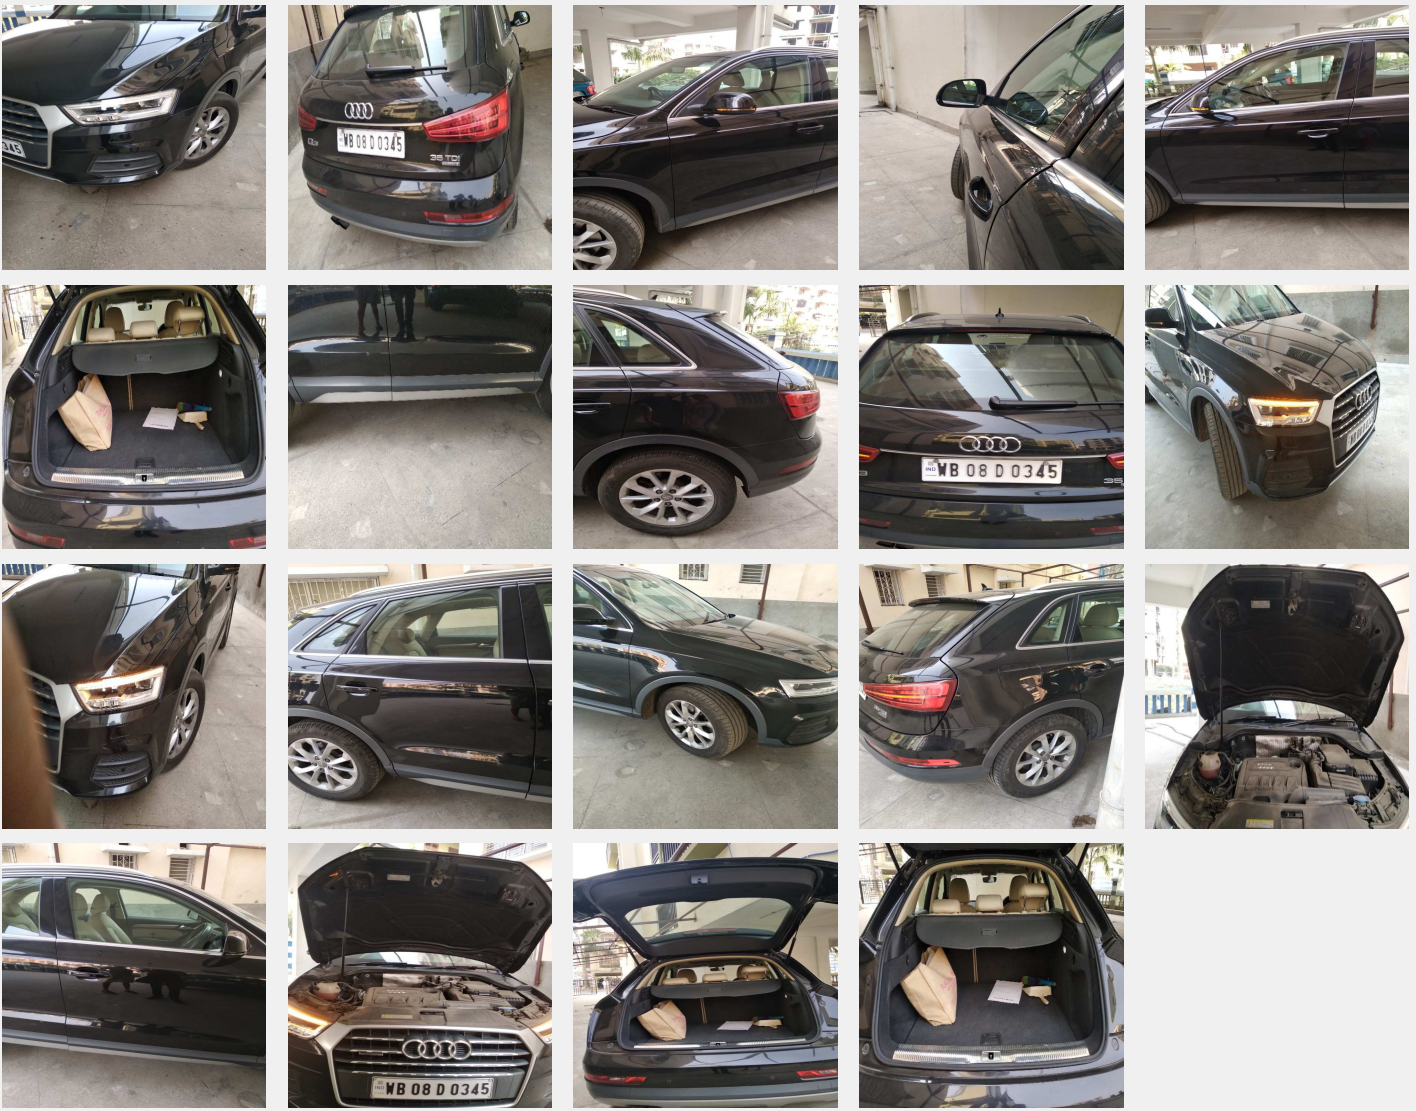
EXTERIOR (CONTINUED)

INSPECTION CHECKPOINTS	SCORE(X/10)	REMARKS/COMMENTS	OPTIONAL SPEND EST. (RS)
RH FRONT DOOR	9		0
RH FENDER	9		0
BODY RUST	9	NO DUST	0
ROOF (REGULAR)	10		0
PAINT CONDITION	9	GOOD	0
