# ECO INSPECTION CERTIFICATE

121 Points Vehicle Inspection Certificate

## Volkswagen Vento 1.5 TDI HIGHLINE AT, 2015

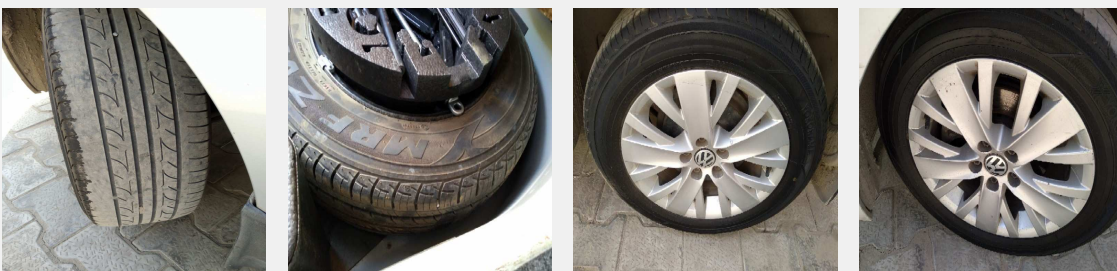
## NEED ATTENTION

INSPECTION CHECKPOINTS	SCORE(X/10)	REMARKS/COMMENTS	OPTIONAL SPEND EST. (RS)
SPARE TYRE (YES)	6	TIRE WEAR NEED TO BE CHANGE	5000
WHEEL ASSEMBLY (ALLOY RIM)	7	GOOD CONDITION	0
<b>TYRES</b>	<b>5</b>	<b>FRONT ALL TIRE WEAR NEED TO BE CHANGE</b>	<b>10000</b>

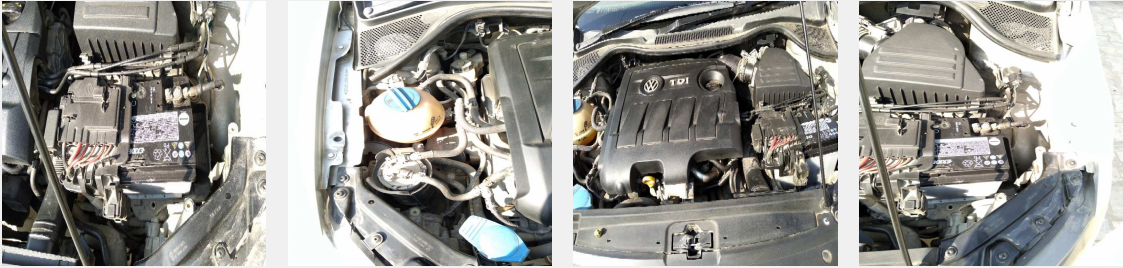
NEED ATTENTION

INSPECTION CHECKPOINTS	SCORE(X/10)	REMARKS/COMMENTS	OPTIONAL SPEND EST. (RS)
LH APRON	7	GOOD CONDITION	0
RH APRON	7	GOOD CONDITION	0
RADIATOR	7	GOOD CONDITION	0
WIRING	7	GOOD CONDITION	0
<b>BATTERY</b>	<b>6</b>	<b>BATTERY WEEK NEED TO CHARGE</b>	<b>0</b>

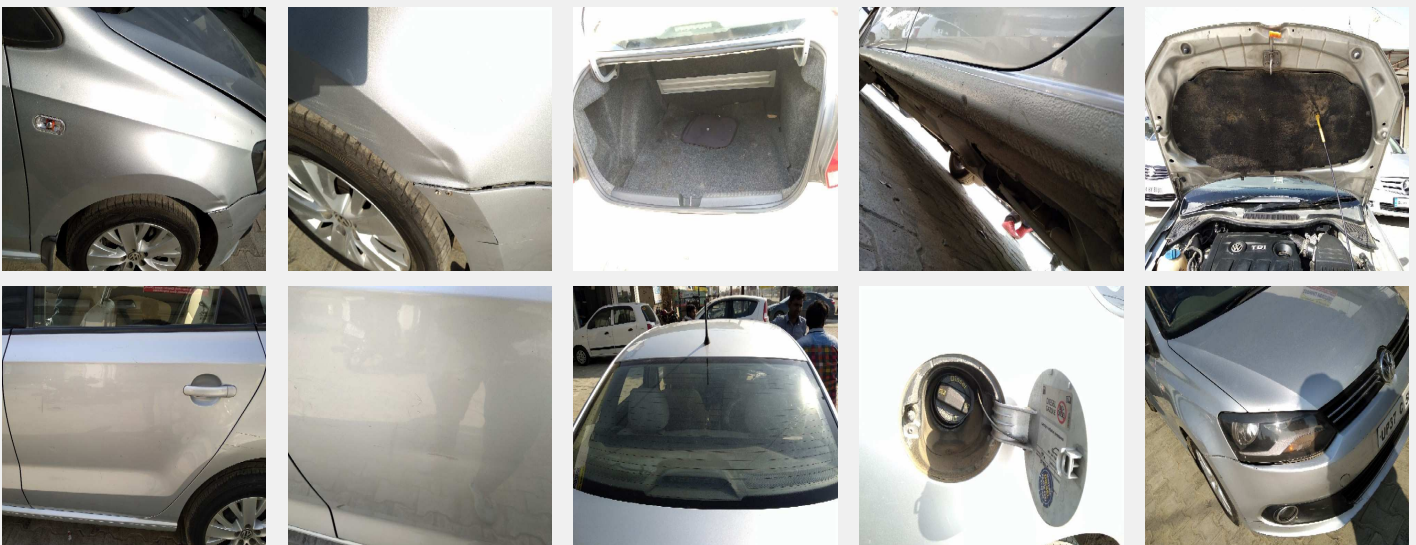
## NEED ATTENTION

RH FENDER	6	MINOR DENT NEEDVTO BE REPAIR	1000
-----------	---	------------------------------	------

INSPECTION CHECKPOINTS	SCORE(X/10)	REMARKS/COMMENTS	OPTIONAL SPEND EST. (RS)
BODY RUST	7	GOOD CONDITION	0
ROOF (REGULAR)	7	GOOD CONDITION	0
PAINT CONDITION	7	GOOD CONDITION	0
FRONT BUMPER	5	MINOR SCRATCH NEED TO BE REPAIR	1500
GRILLE	4	DEMAGE NEED TO BE CHANGE	1500
