# ECO INSPECTION CERTIFICATE

121 Points Vehicle Inspection Certificate

Inspection Date :  
2019-01-30

## Yamaha Ybr 125CC, 2012

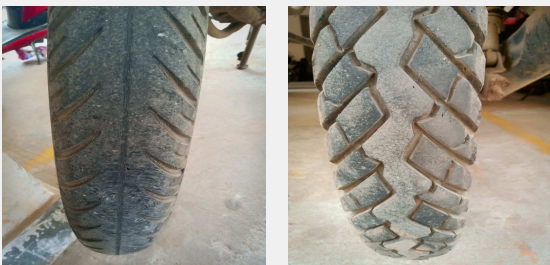
INSPECTION CHECKPOINTS	SCORE(X/10)	REMARKS/COMMENTS	OPTIONAL SPEND EST. (RS)
REAR TYRE CONDITION & AIR PRESSURE	6	GOOD CONDITION	0
WHEEL SPOKES FRONT	6	GOOD CONDITION	0
WHEEL SPOKES REAR	6	GOOD CONDITION	0
WHEEL RIM FRONT	6	GOOD CONDITION	0
WHEEL RIM REAR	6	GOOD CONDITION	0
WHEEL BEARINGS FRONT	6	GOOD CONDITION	0
WHEEL BEARINGS REAR	6	GOOD CONDITION	0
WHEEL SEALS FRONT	6	GOOD CONDITION	0
WHEEL SEALS REAR	6	GOOD CONDITION	0
BRAKE FUNCTION FRONT	6	GOOD CONDITION	0
BRAKE FUNCTION REAR	6	GOOD CONDITION	0
BRAKES CONDITION FRONT	6	GOOD CONDITION	0
BRAKES CONDITION REAR	6	GOOD CONDITION	0
FRONT TYRE CONDITION & AIR PRESSURE	4	NEED TO CHANGE	1500

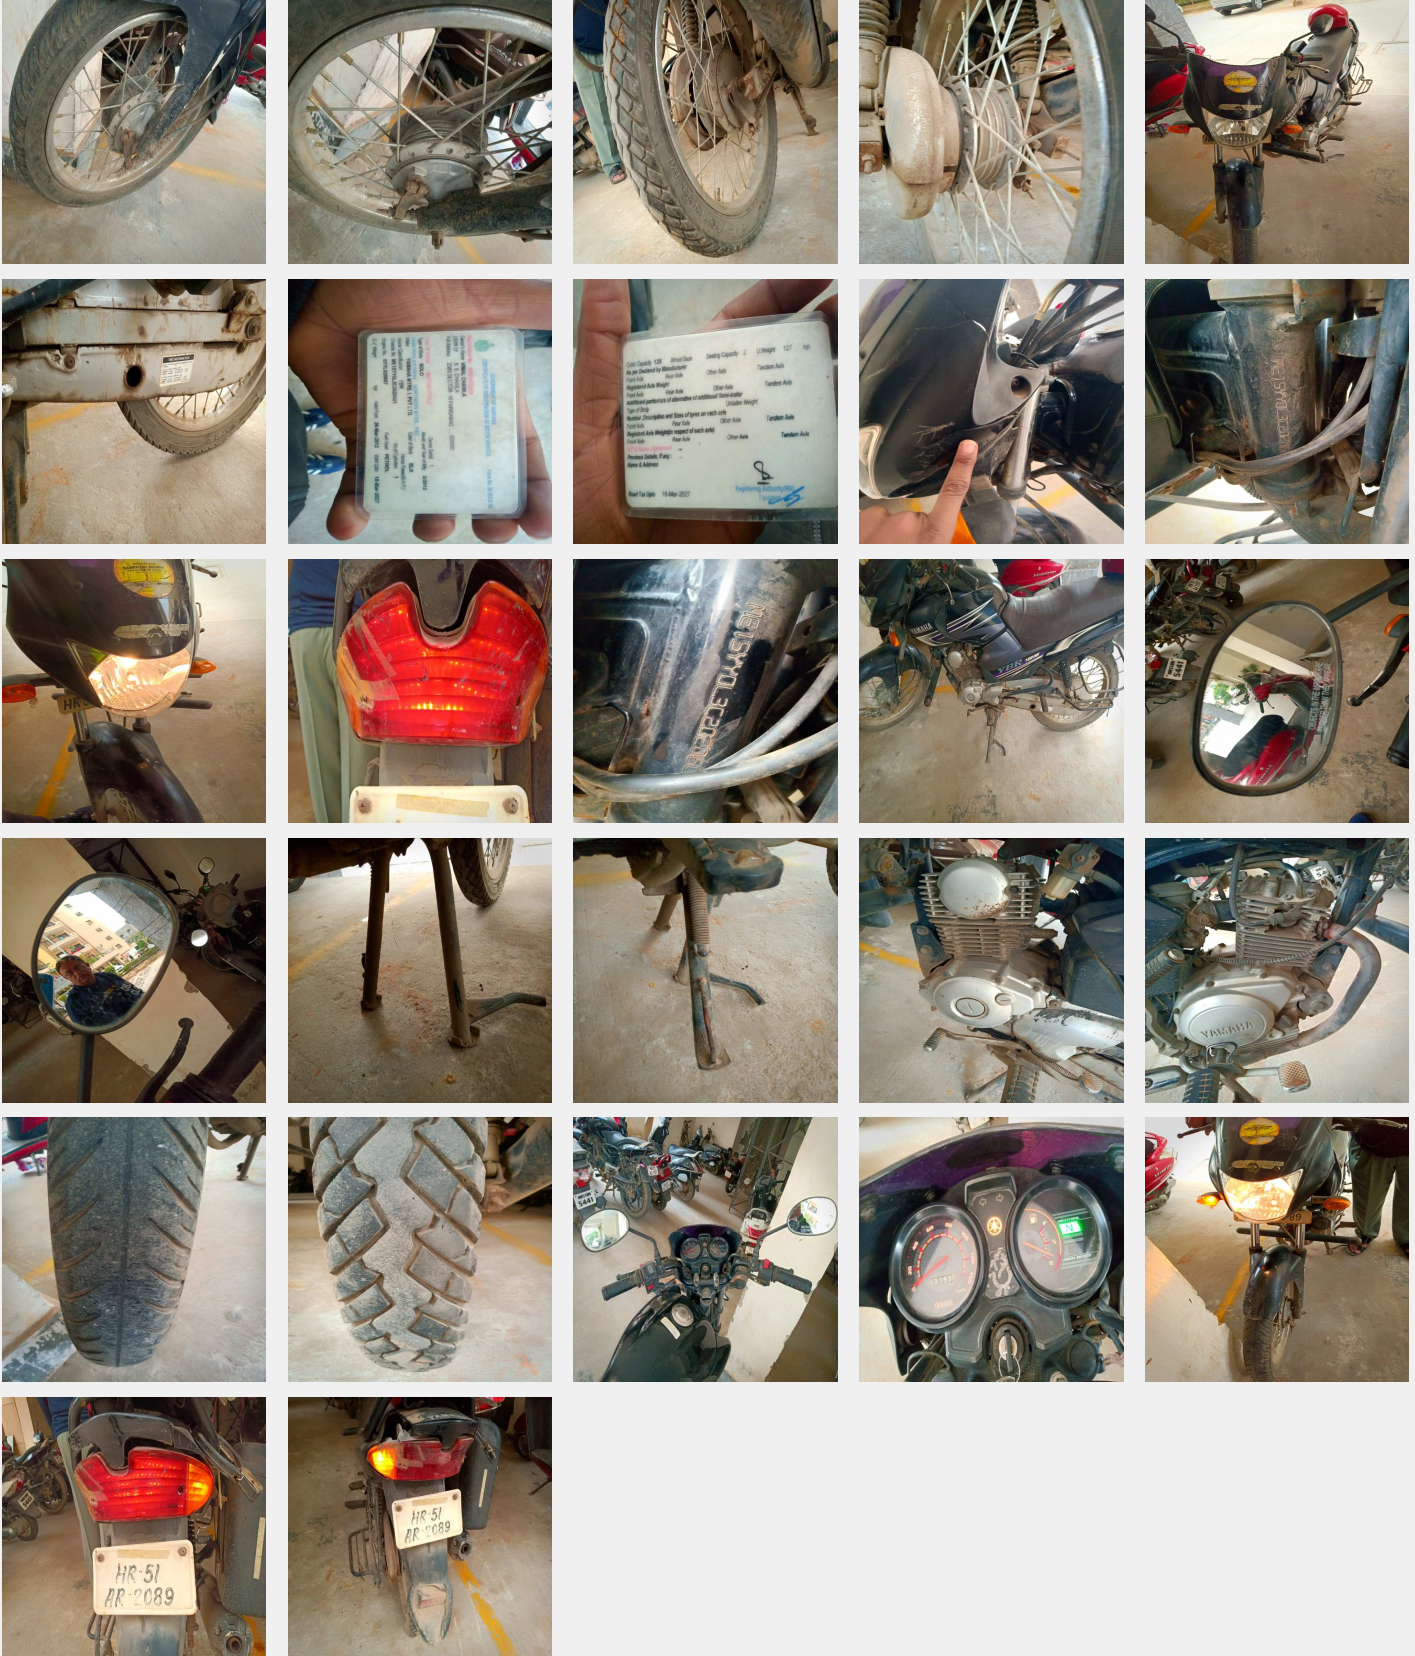
all body normal scratches rear tire already changed normal engine sound chain set need to change fr
