ECO INSPECTION CERTIFICATE

Order ID : 40231

121 Points Vehicle Inspection Certificate

Jaguar Xf 3.0L DIESEL PREMIUM LUXURY, 2012

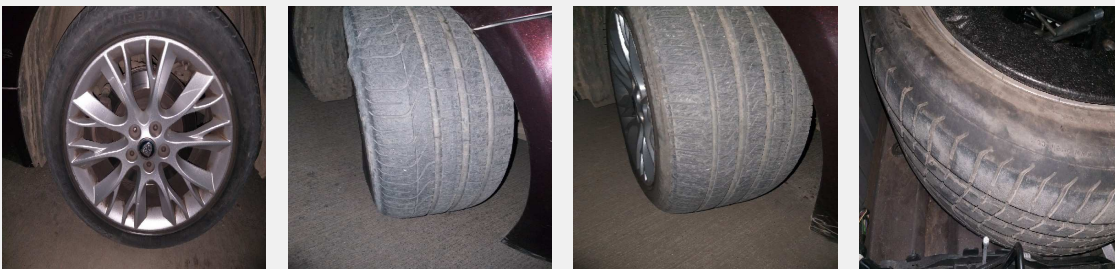
NEED ATTENTION ⚠️

INSPECTION CHECKPOINTS	SCORE(X/10)	REMARKS/COMMENTS	OPTIONAL SPEND EST. (RS)
TYRES	8	FRONT RIGHT HAND SIDE TYRE FULLY CONDITION	0
SPARE TYRE (YES)	8	GOODCONDITION AND WORKING PROPERLY	0
WHEEL ASSEMBLY (ALLOY RIM)	8	GOODCONDITION AND WORKING PROPERLY	0

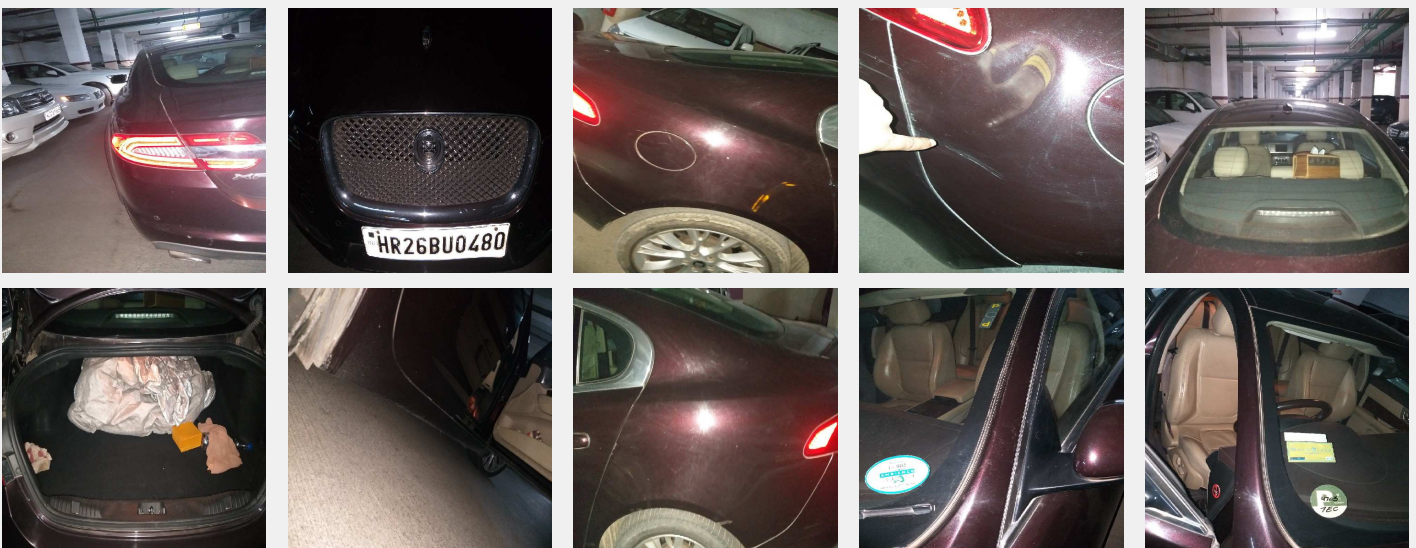
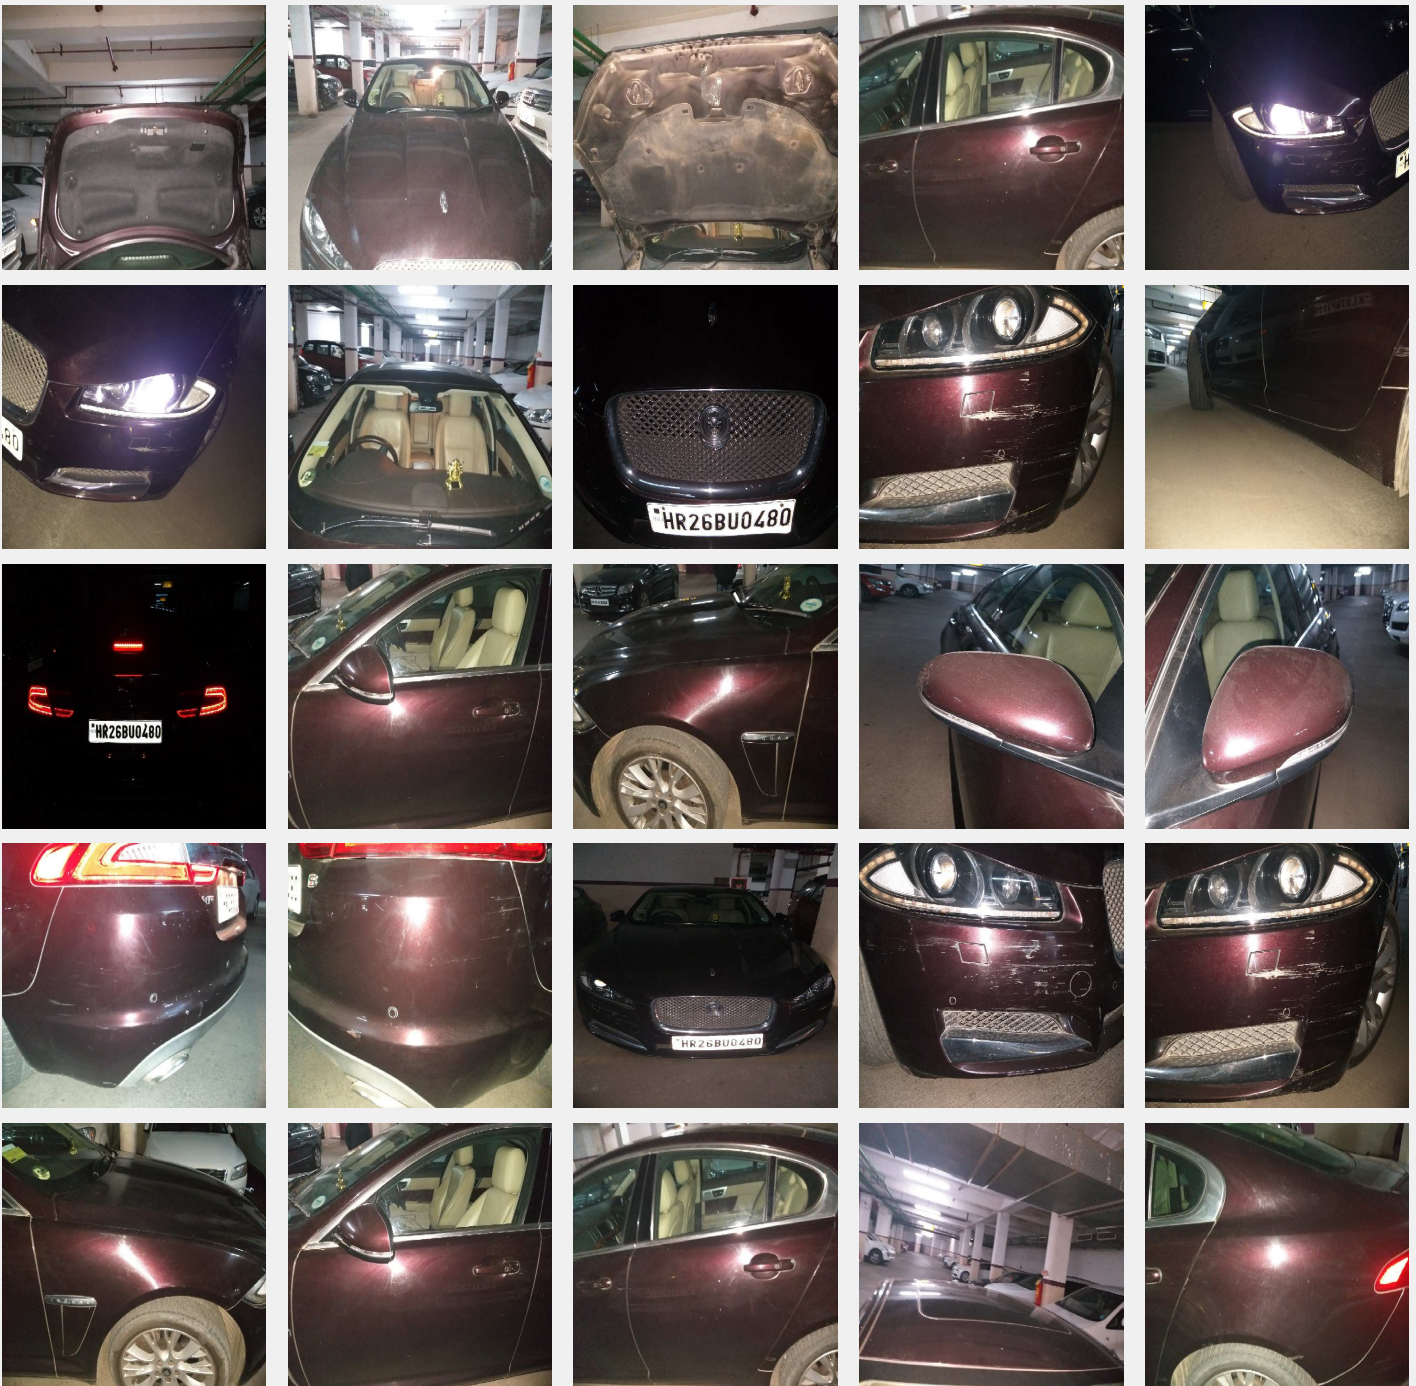
NEED ATTENTION ⚠️

INSPECTION CHECKPOINTS	SCORE(X/10)	REMARKS/COMMENTS	OPTIONAL SPEND EST. (RS)
LICENSE PLATE	8	GOOD	0
FRONT BUMPER	8	NEED TO BE PAINT	25000
HEAD LIGHTS	8	GOODCONDITION AND WORKING PROPERLY	0
GRILLE	8	GOOD CONDITION	0
TURN SIGNAL	8	GOODCONDITION AND WORKING PROPERLY	0
FOG LAMPS	8	NO FOG LAMPS	0
HOOD	8	GOODCONDITION AND WORKING PROPERLY	0
PILLAR	8	GOOD	0
FRONT WINDSHIELD	8	GOODVISIBILITY	0
SIDE VIEW MIRRORS	8	GOODCONDITION AND WORKING PROPERLY	0
LH FENDER	8	GOOD	0
LH FRONT DOOR	8	GOODCONDITION AND WORKING PROPERLY	0
LH REAR DOOR	8	GOODCONDITION AND WORKING PROPERLY	0
LH RUNNING BOARD	8		0
LH QUARTER PANEL	8	GOOD	0
FUEL LID	8	GOODCONDITION AND WORKING PROPERLY	0
REAR WINDSHIELD	8	GOOD VISIBILITY	0
REAR BUMPER	7	MINORS SCRATCHES	5000
TAIL LIGHT	8	GOODCONDITION AND WORKING PROPERLY	0
TRUNK LID/TAIL GATE	8	GOODCONDITION AND WORKING PROPERLY	0
LUGGAGE COMPARTMENT LIGHT	8	GOOD	0

RH QUARTER PANEL	6	NEED TO BE REAPING AND	25000
RH RUNNING BOARD	8	GOOD	0
RH REAR DOOR	8		0

minor scratches minor dent and 1 tyres need to be replace frt
