ECO INSPECTION CERTIFICATE

Order ID : 41504

121 Points Vehicle Inspection Certificate

Mahindra Kuv100 Nxt K8 D 6 STR DUAL TONE, 2018

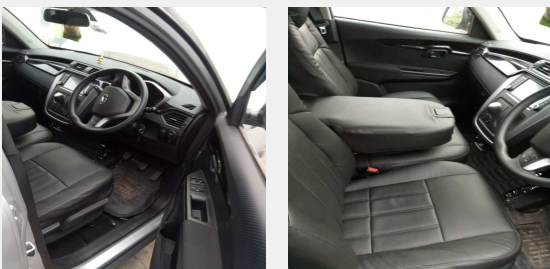
IMAGES

INTERIOR

INSPECTION CHECKPOINTS	SCORE(X/10)	REMARKS/COMMENTS	OPTIONAL SPEND EST. (RS)
DOOR PANEL	8	GOOD	0
DOOR HINGES	8	GOOD	0
CARPET & FLOOR MAT	8	GOOD	0
SEAT & SEAT BELT	8	GOOD	0
DASHBOARD & INSTRUMENT PANEL	8	GOOD	0
HORN	8	GOOD	0
SPEAKERS & MUSIC SYSTEM	8	GOOD	0
HANDBRAKE	8	GOOD	0
STEERING-MOUNTED CONTROLS	8	GOOD	0
PEDALS	8	GOOD	0
CENTRAL LOCK	8	GOOD	0
A/C VENTS & HEATER	8	GOOD	0
NAVIGATION (YES)	8	GOOD	0
ODOMETER	8	GOOD	0
POWER WINDOWS (YES)	8	GOOD	0
HAZARD LIGHT	8	GOOD	0
CUP HOLDERS	0	NA	0

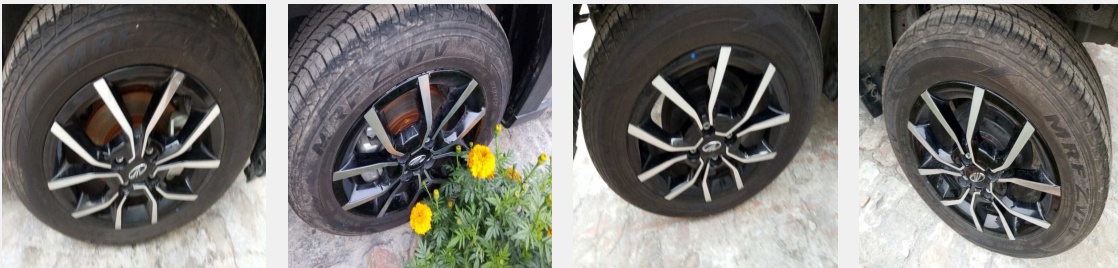
IMAGES

WHEEL

INSPECTION CHECKPOINTS	SCORE(X/10)	REMARKS/COMMENTS	OPTIONAL SPEND EST. (RS)
TYRES	8	GOOD	0
SPARE TYRE (YES)	8	GOOD	0
WHEEL ASSEMBLY (ALLOY RIM)	8	GOOD	0
