ECO INSPECTION CERTIFICATE

Order ID : 42732

121 Points Vehicle Inspection Certificate

Mercedes-Benz S-Class 350 L, 2007

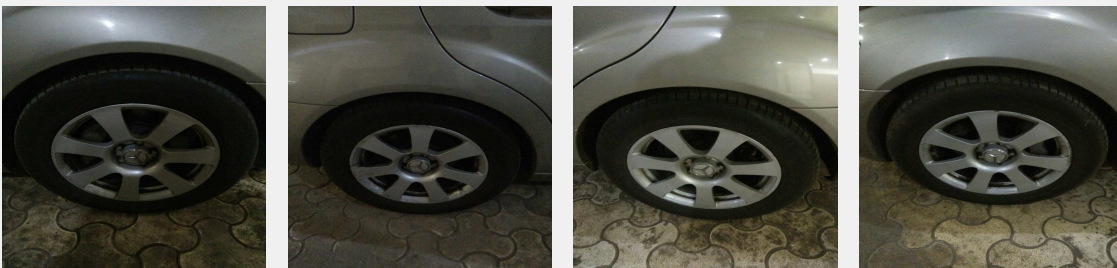
IMAGES

INSPECTION CHECKPOINTS	SCORE(X/10)	REMARKS/COMMENTS	OPTIONAL SPEND EST. (RS)
TYRES	6	ACCEPTABLE TREAD	0
SPARE TYRE (NO)	10		0
WHEEL ASSEMBLY (ALLOY RIM)	6	NO DAMAGE	0

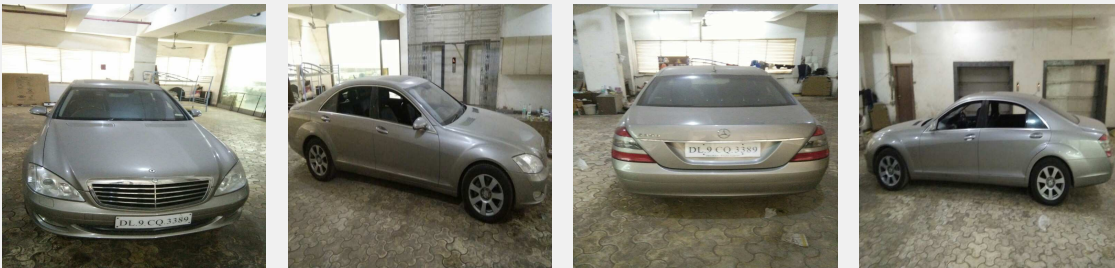
IMAGES

INSPECTION CHECKPOINTS	SCORE(X/10)	REMARKS/COMMENTS	OPTIONAL SPEND EST. (RS)
FRONT BUMPER	4	PAINTING REQUIRE	10000
HOOD	4	SYMBOL NOT AVAILABLE	25000
LH QUARTER PANEL	4	PAINTING REQUIRE	10000
REAR BUMPER	4	PAINTING REQUIRE	10000
RH QUARTER PANEL	4	PAINTING REQUIRE	10000
