ECO INSPECTION CERTIFICATE

Order ID : 42794

121 Points Vehicle Inspection Certificate

Ford Figo Duratorq Zxi 1.4, 2011

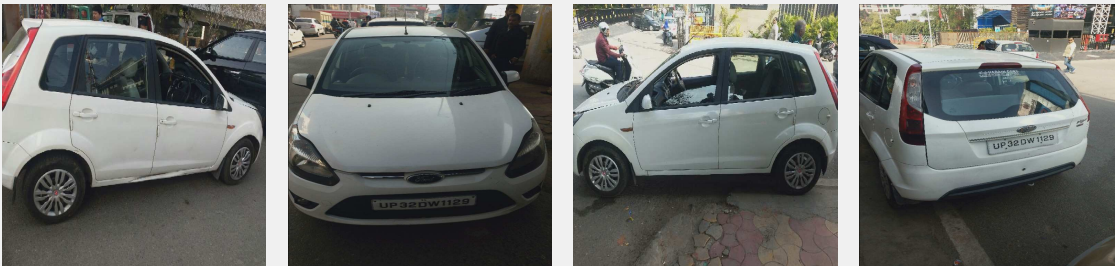
INSPECTION CHECKPOINTS	SCORE(X/10)	REMARKS/COMMENTS	OPTIONAL SPEND EST. (RS)
BODY RUST	6		0
ROOF (REGULAR)	6		0
FOG LAMPS	3	BROKEN	2000
RH RUNNING BOARD	3	DENT EXISTS	3500
PAINT CONDITION	5	SCRATCHES AVAILABLE	25000
