# ECO INSPECTION CERTIFICATE

Order ID : 42850

121 Points Vehicle Inspection Certificate

## Ford Endeavour 3.0L 4X4 AT, 2010

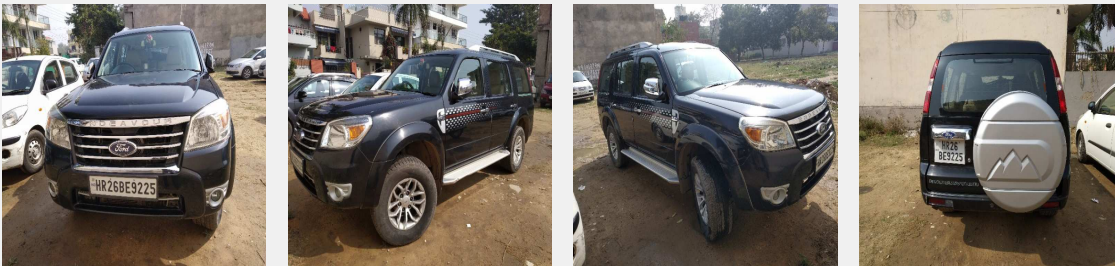
INSPECTION CHECKPOINTS	SCORE(X/10)	REMARKS/COMMENTS	OPTIONAL SPEND EST. (RS)
LICENSE PLATE	7	GOOD	0
FRONT BUMPER	6	MINOR SCTATCHES	300
HEAD LIGHTS	7	GOOD	0
GRILLE	7	GOOD	0
TURN SIGNAL	7	GOOD	0
FOG LAMPS	7	GOOD	0
HOOD	6	MINOR SCRATCHES	300
PILLAR	7	GOOD	0
FRONT WINDSHIELD	7	GOOD	0
SIDE VIEW MIRRORS	7	GOOD	0
LH FENDER	7	GOOD	0
LH FRONT DOOR	6	MINOR SCRATCHES	300
LH REAR DOOR	7	GOOD	0
LH RUNNING BOARD	7	GOOD	0
LH QUARTER PANEL	6	MINOR SCRATCHES	500
FUEL LID	7	GOOD	0
REAR WINDSHIELD	7	GOOD	0
TAIL LIGHT	7	GOOD	0
TRUNK LID/TAIL GATE	7	GOOD	0
LUGGAGE COMPARTMENT LIGHT	7	GOOD	0
RH QUARTER PANEL	8	GOOD	0
RH RUNNING BOARD	7	GOOD	0
RH REAR DOOR	6	MINOR SCRATCHES	500
RH FRONT DOOR	6	MINOR SCRATCHES	500

INSPECTION CHECKPOINTS	SCORE(X/10)	REMARKS/COMMENTS	OPTIONAL SPEND EST. (RS)
RH FENDER	6	MINOR SCRATCHES	500
BODY RUST	7	GOOD	0
ROOF (REGULAR)	7	GOOD	0
PAINT CONDITION	7	GOOD	0
REAR BUMPER	4	NEED TO REPAIR	4000

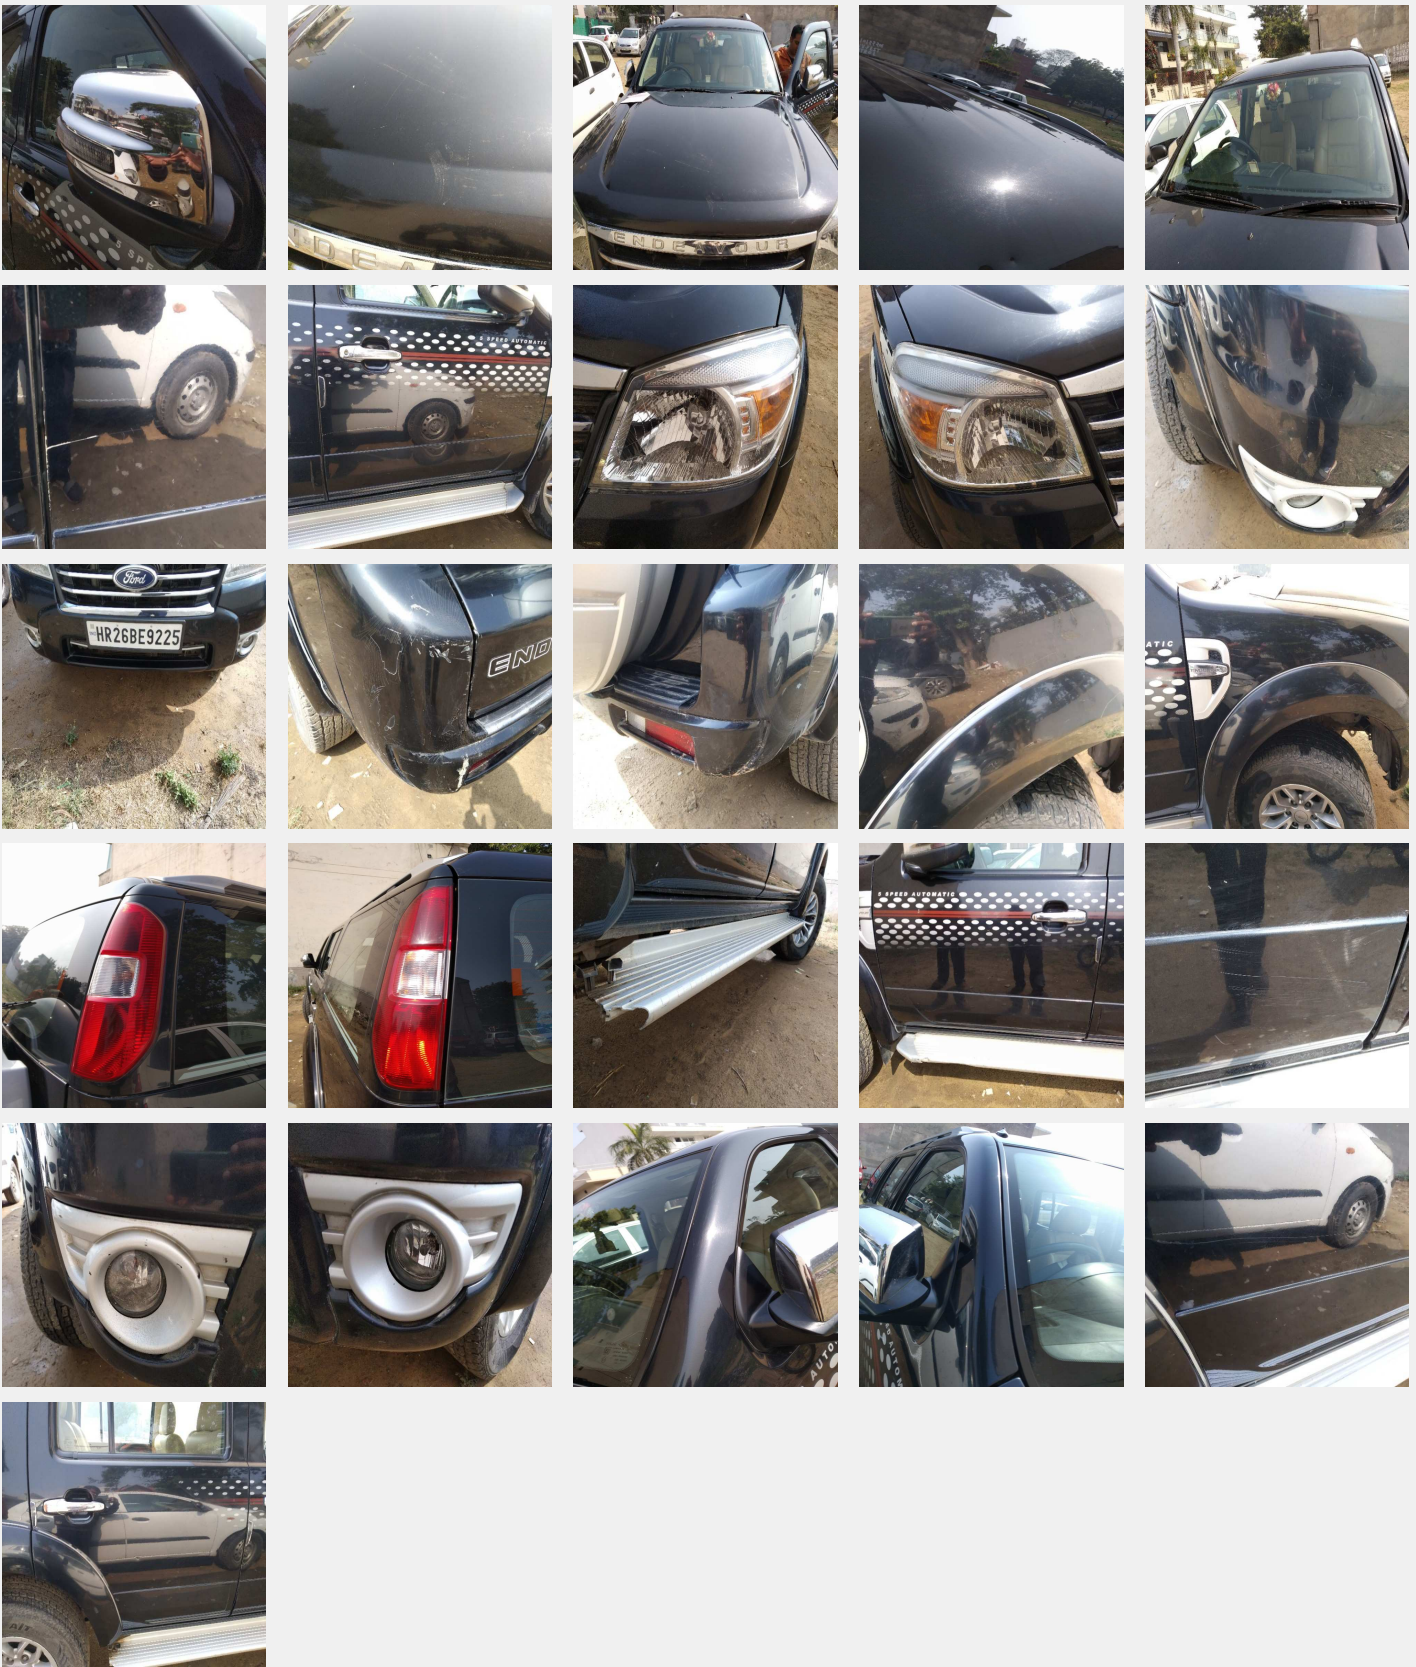
minor scratches and minor dent all tyres already changed
