ECO INSPECTION CERTIFICATE

Order ID : 43194

121 Points Vehicle Inspection Certificate

Ford Ecosport TREND 1.5L TDCI, 2014

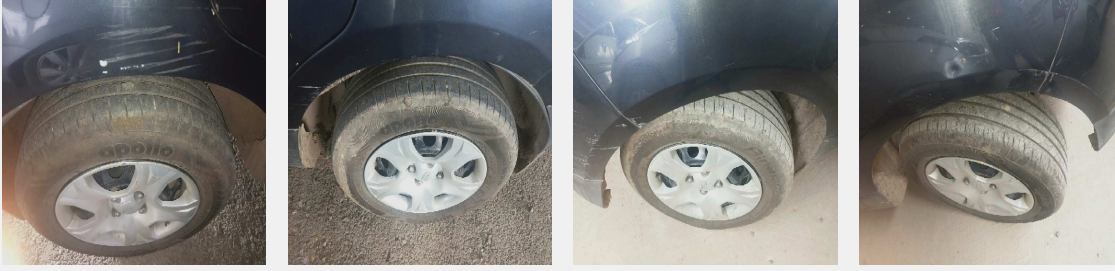
INSPECTION CHECKPOINTS	SCORE(X/10)	REMARKS/COMMENTS	OPTIONAL SPEND EST. (RS)
TYRES	6		0
SPARE TYRE (YES)	6		0
WHEEL ASSEMBLY (STEEL RIM)	7		0

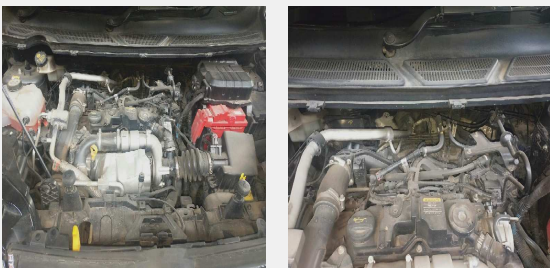
HOOD

INSPECTION CHECKPOINTS	SCORE(X/10)	REMARKS/COMMENTS	OPTIONAL SPEND EST. (RS)
LH APRON	6		0
RH APRON	6		0
RADIATOR	7		0
WIRING	7		0
BATTERY	7		0
BRAKE FLUID LEVEL	8		0
ENGINE OIL	7		0
COOLANT LEVEL	7		0
BRAKE & COOLANT HOSE PIPES	7		0
UNDERCARRIAGE	7		0
EXHAUST SYSTEM	7		0
